AAIR-076/1
19 Jan, 2020

FINAL REPORT

Summit Air Flight SMA 802D, 9N-AMH
Aircraft Industries, LET-410
Lukla, Nepal
14 April 2019

Aircraft Accident Investigation Commission, 2019

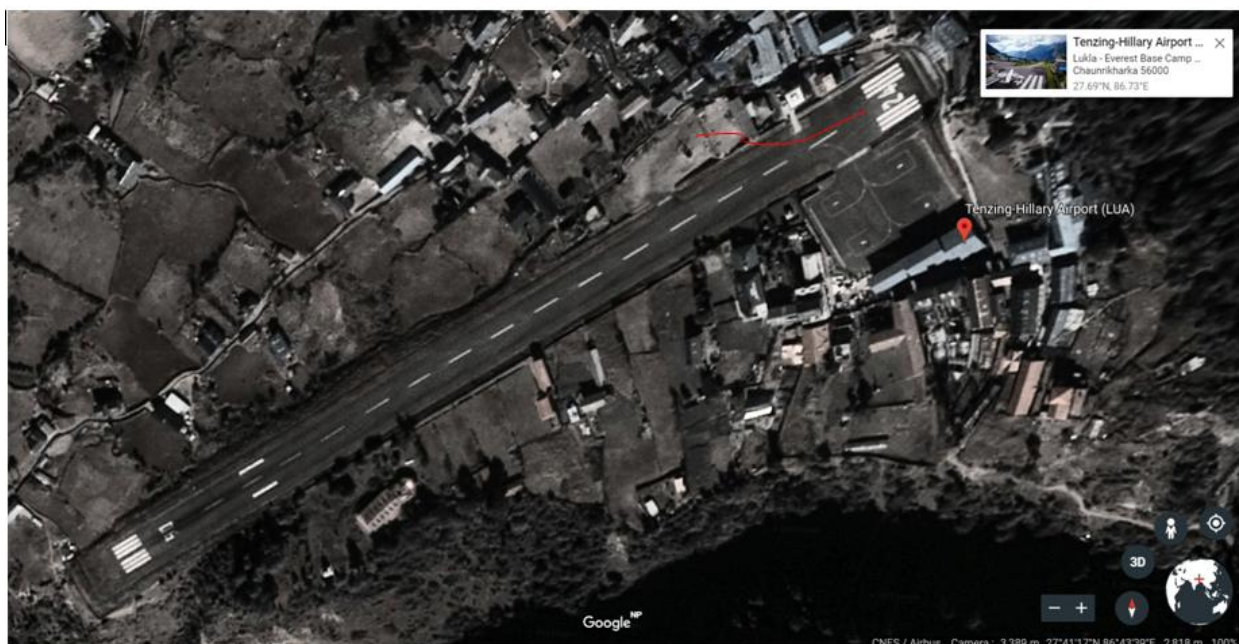
Figure 1 Flight progression from threshold of runway 24 to its final location

The take-off roll commenced at 0322:50 Hrs. CCTV footage captured that within 3 seconds the aircraft veered right and made an excursion. The aircraft exited the runway and travelled about 42.8 ft across the grassy part on right side of runway 24, before striking the airport inner perimeter fence. It then continued to skid for about 43 ft, into the upper helipad, crashing into 9N-ALC.

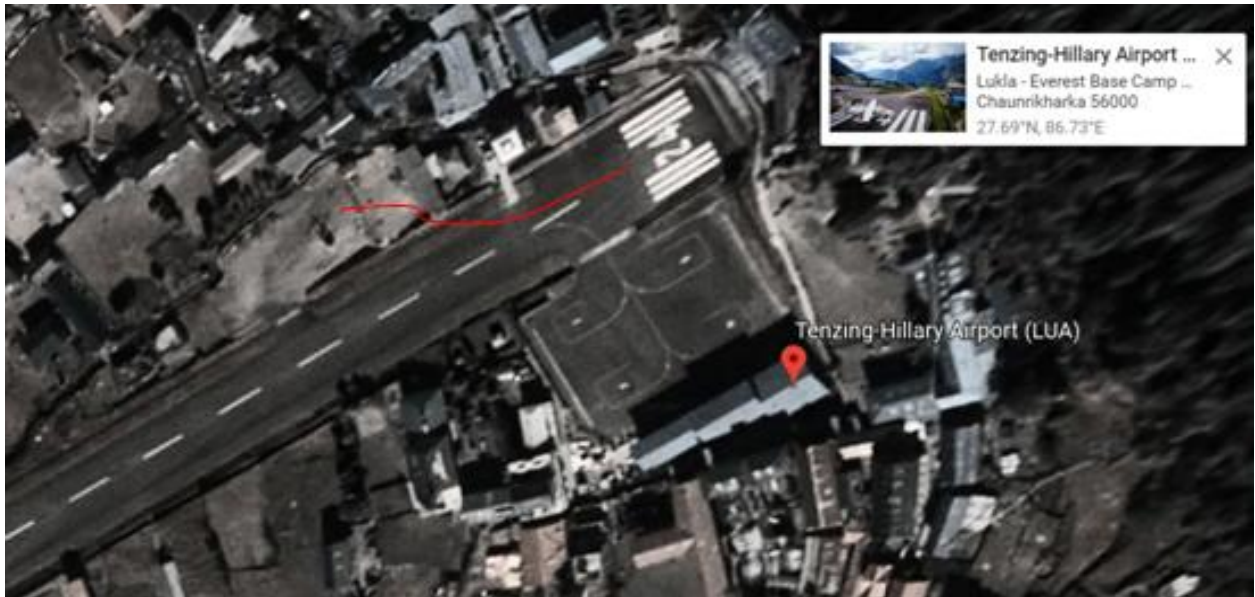
Figure 2 Flight progression from threshold of runway 24 to its final location

Eye witnesses statements, CCTV footages and initial examination of the wreckage showed that rotor blades of helicopter 9N-ALC were on idle when RH wing of the aircraft swept two security personnel (on ground) before slashing its rotor shaft. The moving rotors cut through the cockpit on the right side slaying the Co-pilot immediately. The helicopter toppled onto the lower helipad 6 ft below. The LH wing of the aircraft broke the skid of helicopter 9N-ALK and came to a halt with toppled 9N-ALC beneath its RH main wheel assembly. Due to 2 impact, 9N-ALK shifted about 8 ft laterally and suffered minor damages.

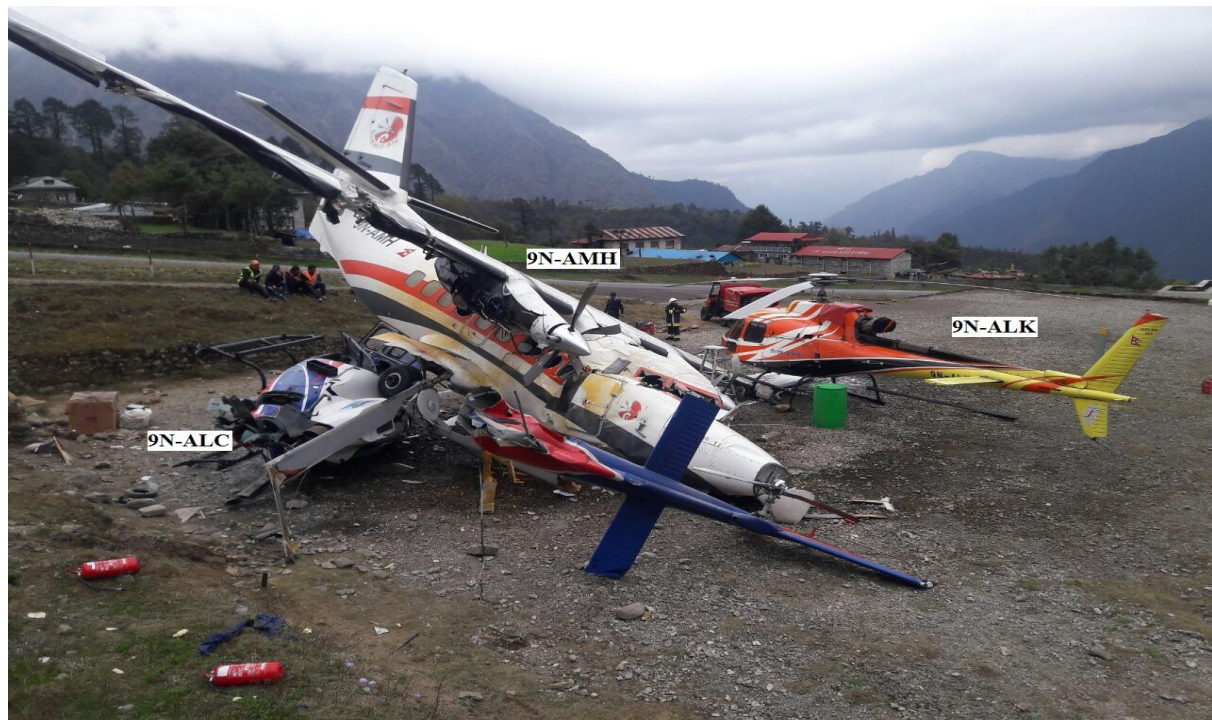
Figure 4 Damage to Aircraft

Aircraft 9N-AMH and helicopter 9N-ALC were substantially damaged while the helicopter 9N-ALK endured partial damages.

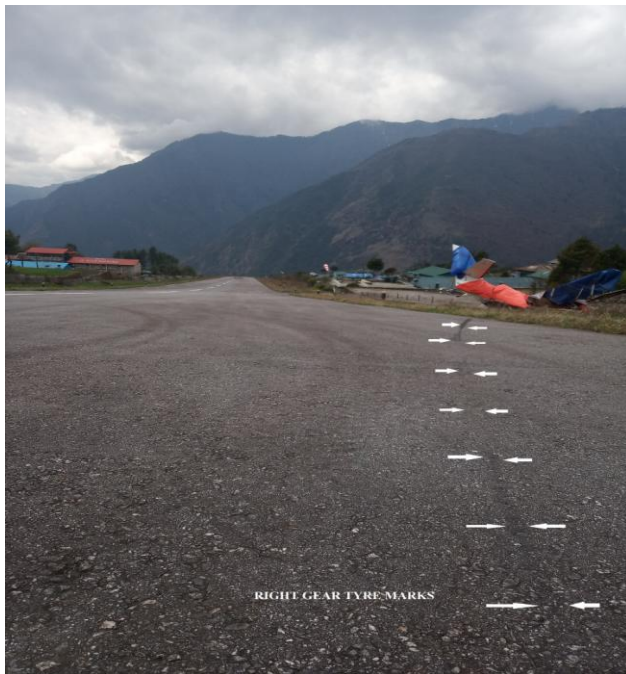
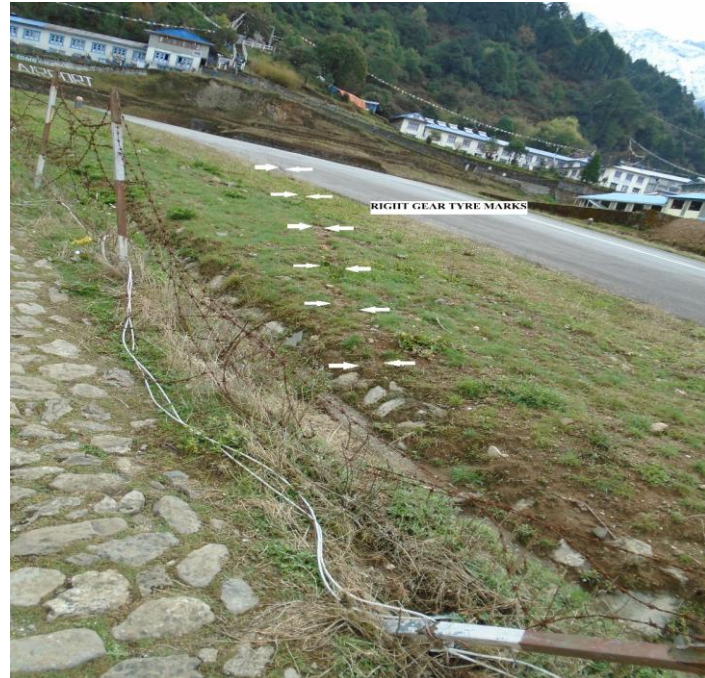
A portion of the aerodrome's inner perimeter fence of the airport was damaged.

Figure 5 Tyre mark on the runway and aerodrome inner perimeter fence damage

The right foot brake tyre marks were found 72 meter from threshold at the right edge of the runway. There were no tyre marks found of left brake use. This action contributed the aircraft to veer more towards the right.

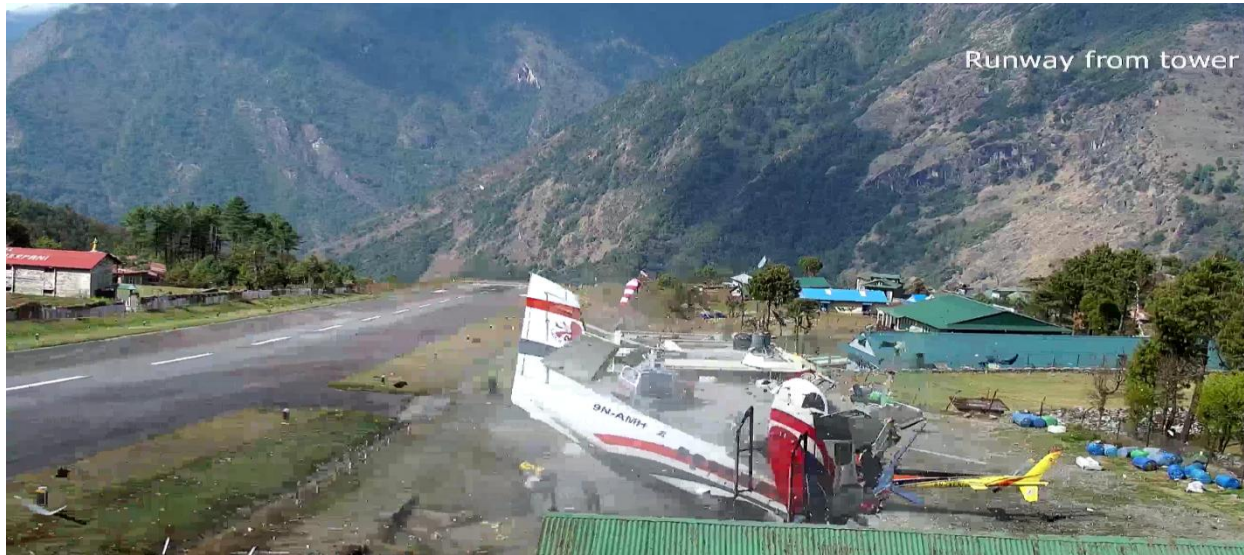
Figure 7 CCTV snapshots of final moments

CCTV video recordings of the particular moments of the aircraft movement was collected and reviewed in depth in order to verify the witness information and supplement the FDR findings regarding the aircraft movement and position. The CCTV video covered all of the final events including rescue operations.

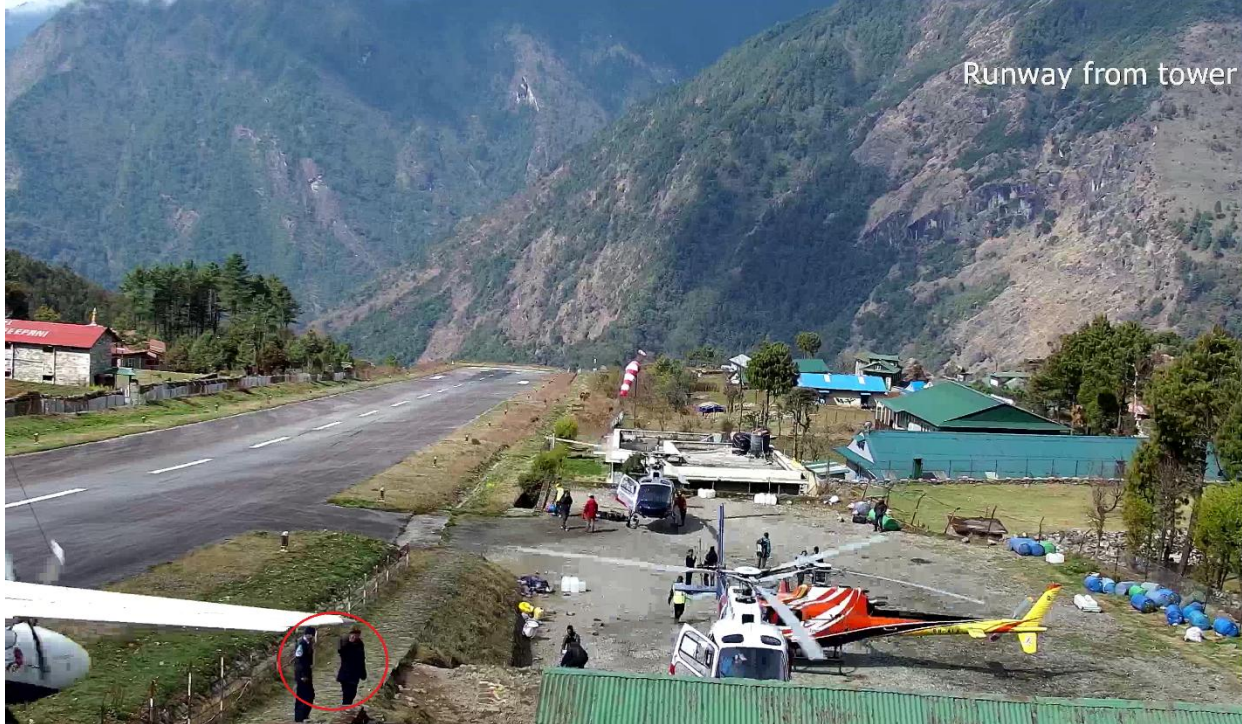
Figure 9 Ground Casualties

The aircraft's RH wing swiped two security personnel who were standing on a walkway outside of the runway fence. They were walking towards tower from the helipad after welcoming high level official who arrived on helicopter 9N-ALC. One security personnel died immediately and another died while on the way to hospital airlifting by helicopter.

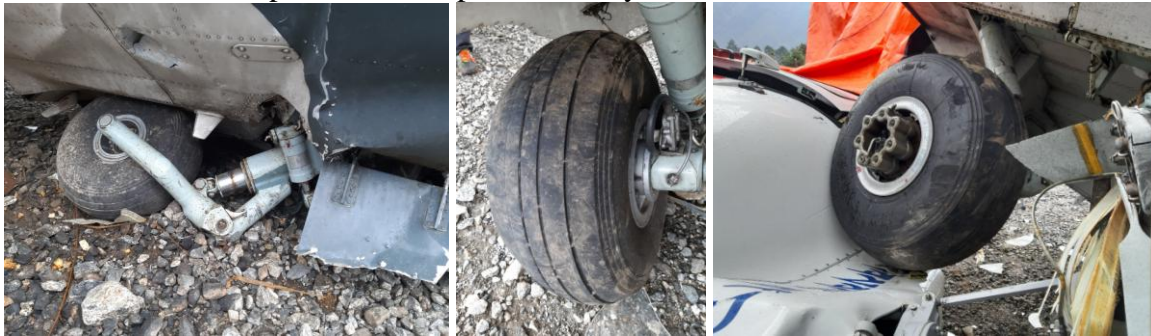
Figure 10 Condition of Nose wheel, LH wheel and RH wheel assemblies

Both the main landing gears and wheel assembly were found normal. No evidence of hydraulic leakage was observed. Both the main tyres were found in inflated condition. Nose oleo was found collapsed due to impact but the tyre was still inflated.

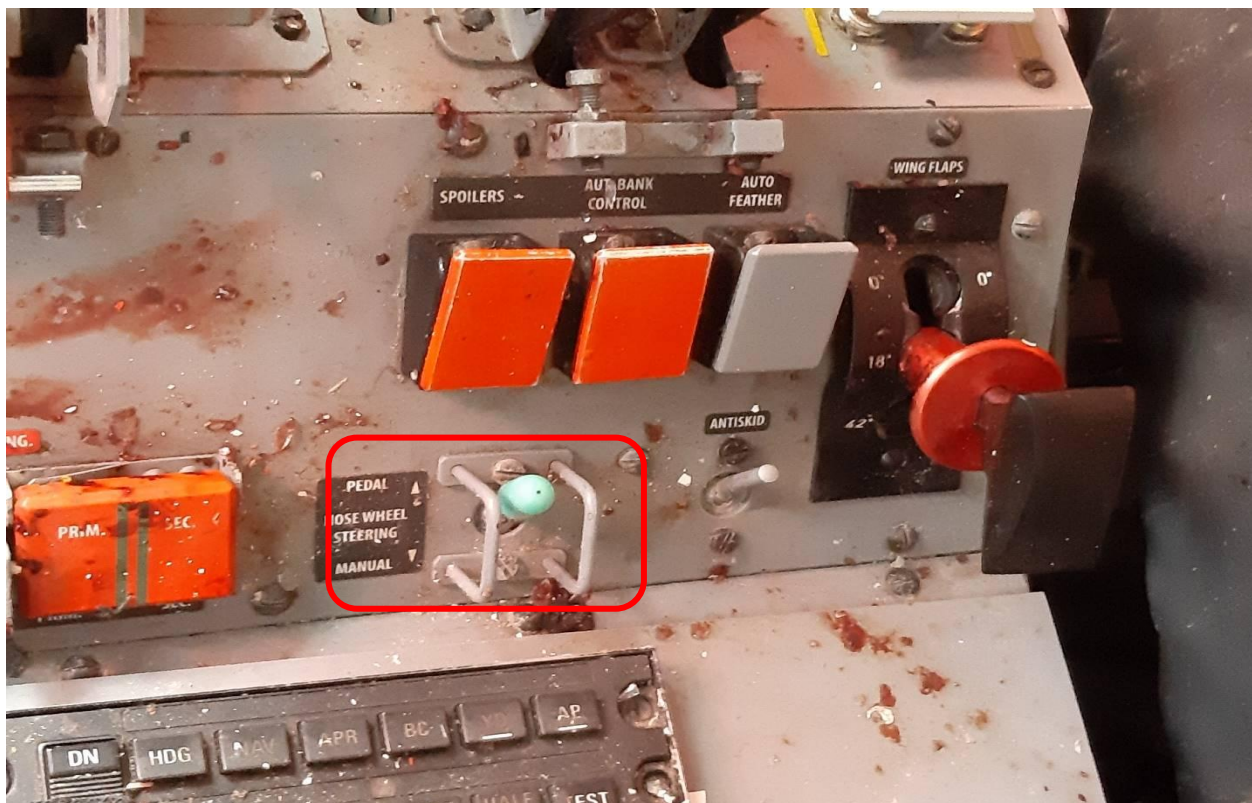
Figure 11 Nose wheel steering switch position of accident aircraft

The Position of the Nose wheel steering switch during Take-Off should be in "PEDAL" position, which during the crash site investigation visit was found in the correct position. Thus, possibility of the aircraft veering to the right due to Steering mechanism malfunction as a result of incorrect switch selection was ruled out by the commission.

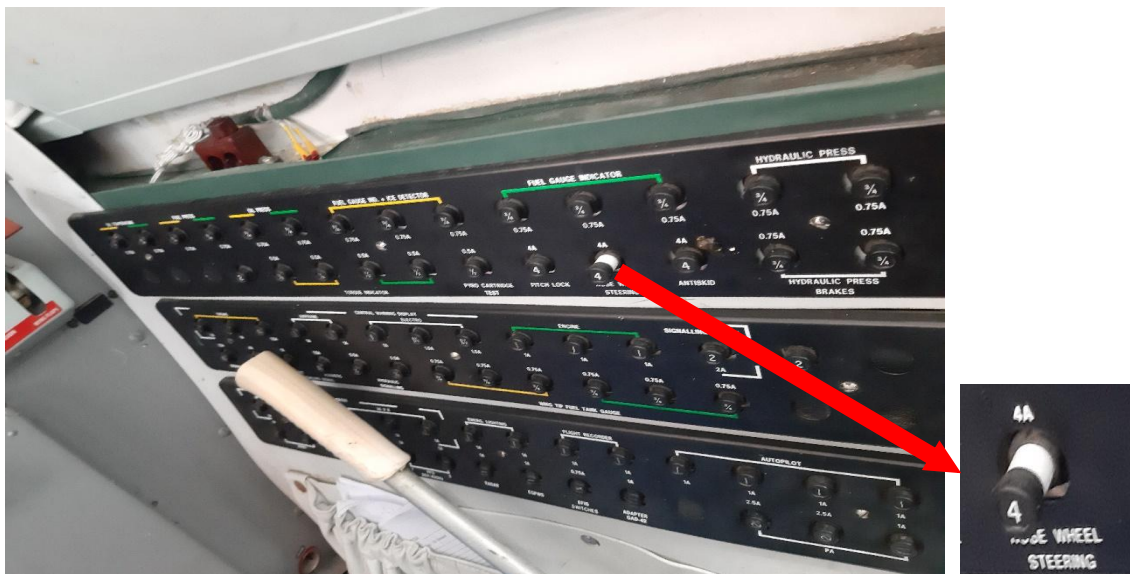
Figure 12 Nose wheel Steering CB was found Popped Out

The veering to the right due to the failure of Steering mechanism as a result of incorrect switch selection was ruled out in observation 1. The observation that pop out of CB Nose Wheel Steering might have led to the malfunction in the Steering mechanism resulting the aircraft to veer to the right was evaluated. However, if the CB had popped out after Line Up when the Nose wheel Steering Switch is positioned to "PEDAL", this would have not triggered annunciation green light "PEDAL STEERING" in CWD and the PIC would have aborted the initiation of take-off. Moreover, during post-accident interview with PIC, he stated that there were neither abnormalities on the Steering mechanism annunciation nor any reported defects earlier. Thus, the commission ruled out the possibility of Nose wheel steering CB pop out before take-off.

very hard to determine probable causes, because every component (Weight on Wheels - WOW switch, clutch, valve, relay, protection diodes) of this circuit represents potential short circuit risk. Hence, the commission narrowed down the likelihood of CB pop out is due to short circuit in the WOW micro switch circuit (common component for Manual & Pedal Part of Nose Wheel Steering circuit) as a result of nose oleo collapse after impact.

17. Nose wheel steering CB was found popped out.

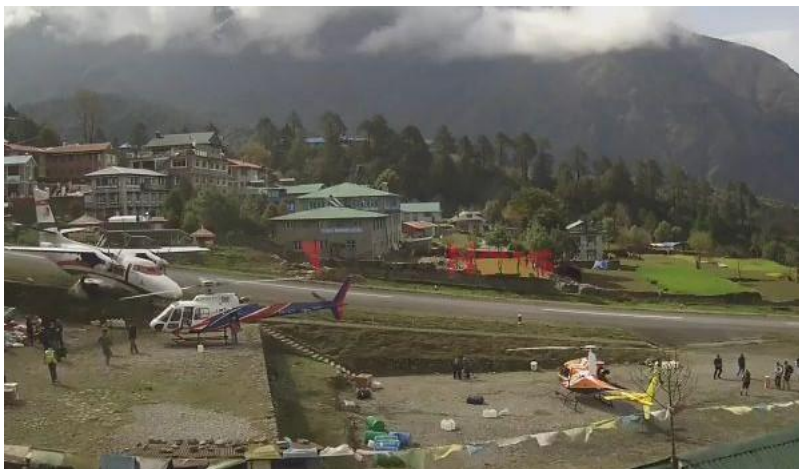
Scene 2 (9N-AMH veered to the right of RWY 24 after 4 secs T/O Roll is initiated)

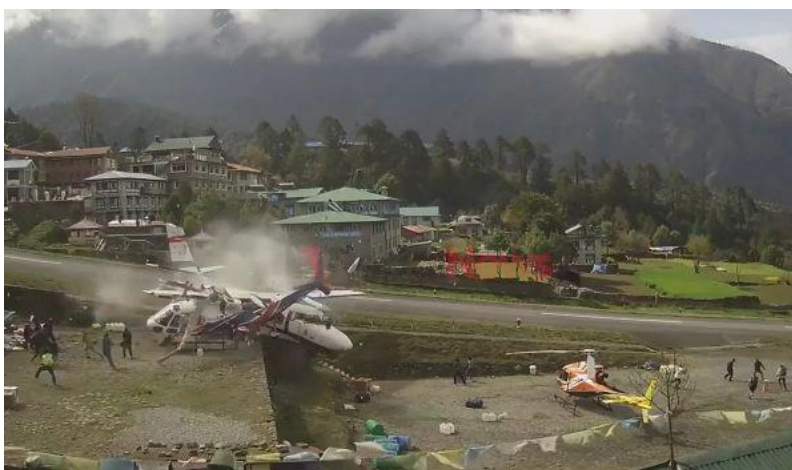
Scene 3 (9N-AMH first hit Manang Air 9N-ALC helicopter)

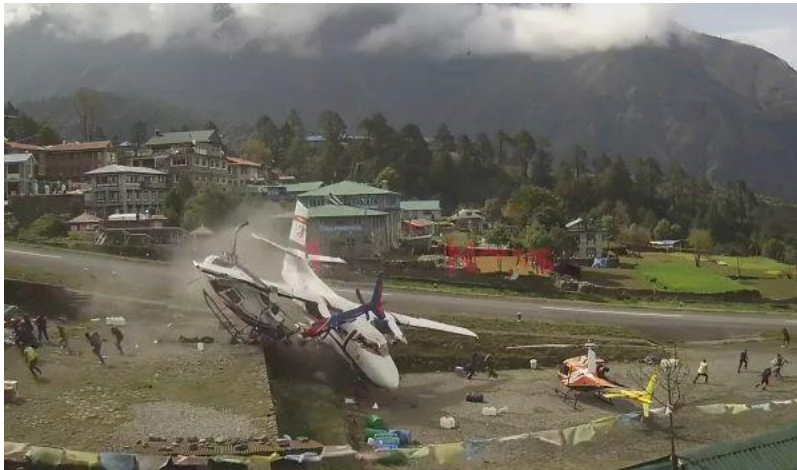
Scene 4 (9N-AMH and 9N-ALC both crushed to ground)

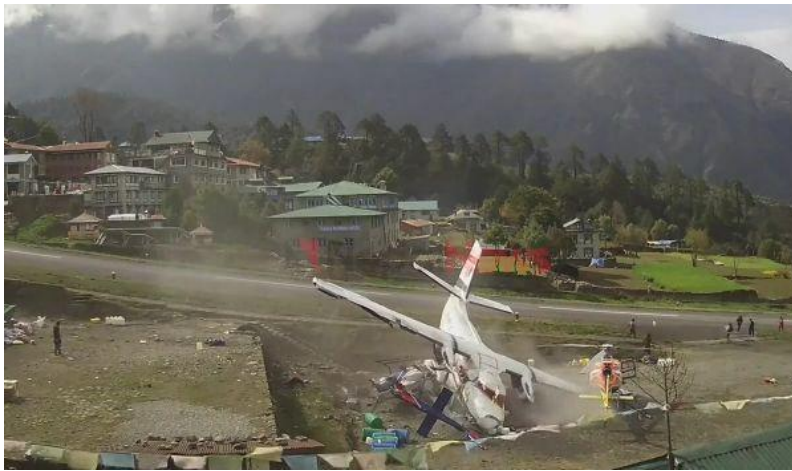
Scene 5 (Both 9N-AMH and 9N-ALC then collided with Shree Air's 9N-ALK helicopter which was parked)
