**GOVERNMENT OF NEPAL**  
**AIRCRAFT ACCIDENT INVESTIGATION COMMISSION**

**FINAL REPORT**

**9N-AMI H125 (AS350 B3e) Helicopter**  
**Owned & Operated by Air Dynasty Heli Services Pvt. Ltd.**  
**at near SisneVir, Pathivara, Nepal**  
**On February 27, 2019**

**COMMISSION FOR THE ACCIDENT INVESTIGATION**  
**TO**  
**THE GOVERNMENT OF NEPAL**  
**MINISTRY OF CULTURE, TOURISM AND CIVIL AVIATION**  
**23/02/2020 (2076/11/11 B.S.)**

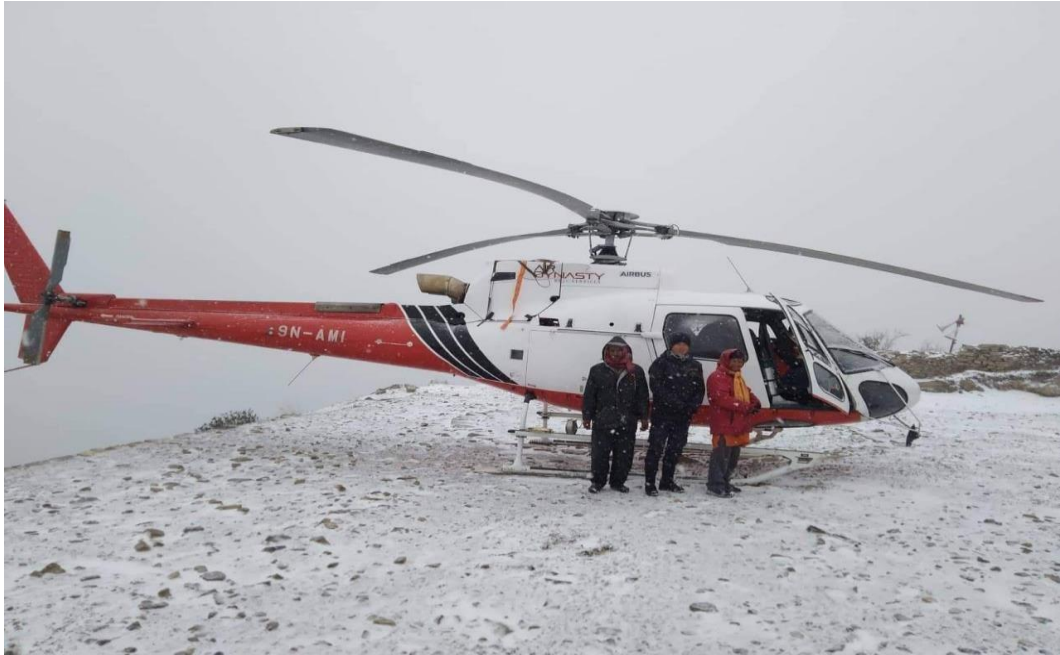
Figure 10 Weather at Pathibhara

At the time of occurrence, the weather around the crash site was low ceiling with cloud base from ground level, gusting strong wind with light to moderate snowfall, sky and mountain ridges invisible according to nearby eyewitnesses.

As per the eyewitness weather at Pathibhara was: wind- strong, gusty and variable, Visibility- marginal because all around covered up by cloud and light snowfall. This statement was supported by the photograph captured just before departure. The PIC was in contact with Taplejung Tower few minutes before take-off and the tower reported that visibility was 2 Km, all around covered up, airport closed.

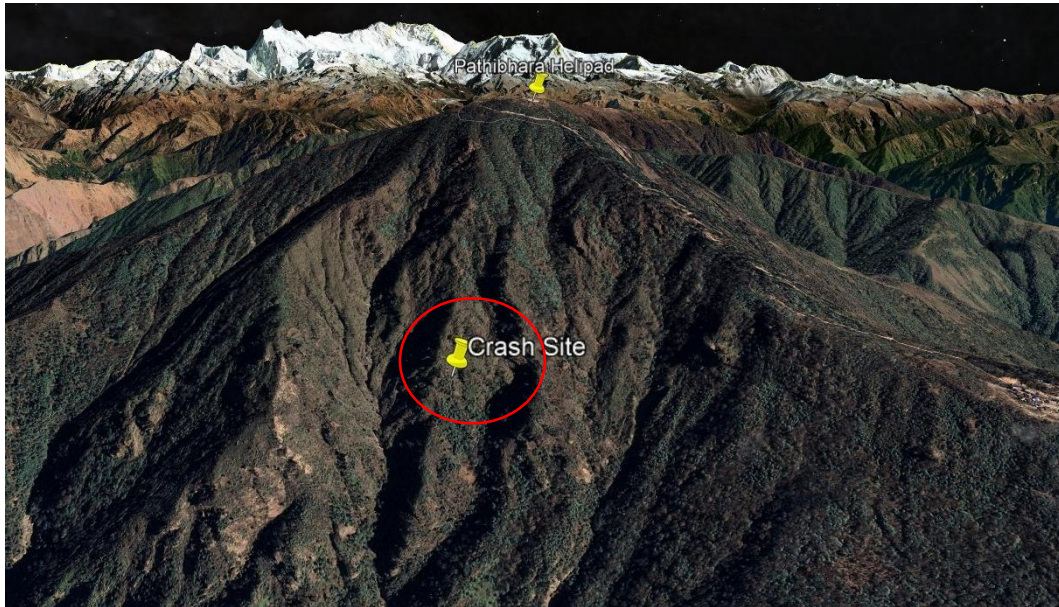
*Figure 13 Crash Site Location*

The crash site is located at Sisne Khola Bhir, Pathibhara, Taplegunj District, Province No. 1 coordinates N27°25'42" E087°45'59" at an elevation of 10,350 feet, which is about 5.49 NM NNE from Taplejung airport.

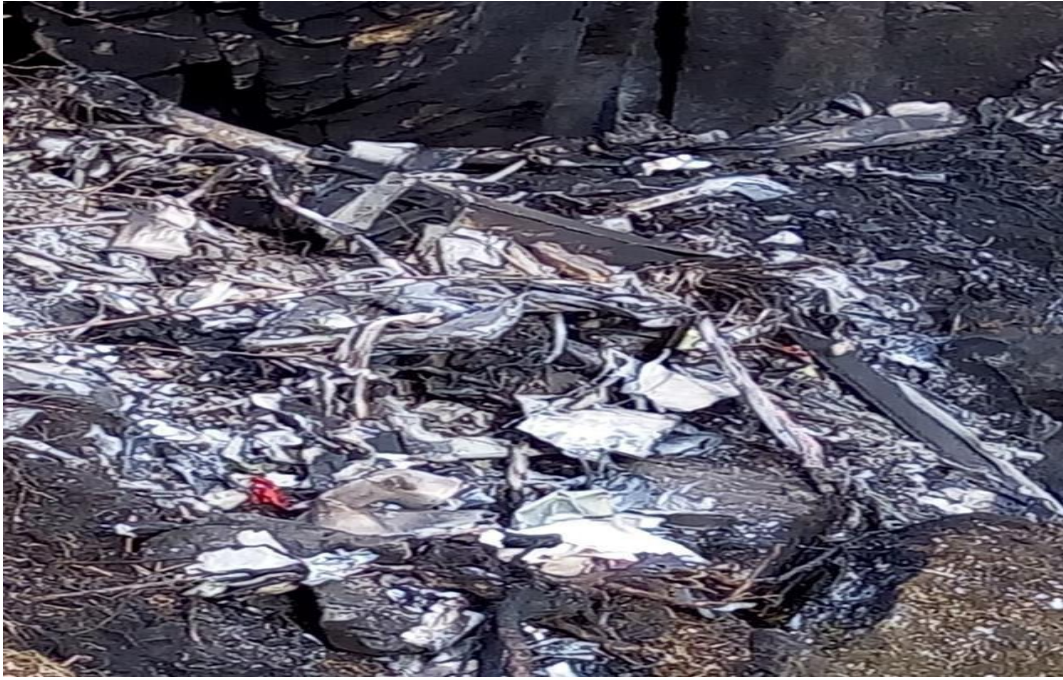
*Figure 14 Helicopter Wreckage*

The helicopter was found as a wreckage with crumpled fuselage section, detached tail structure, dispersed main rotor and tail rotor blades, engine and cowlings. The fuselage, resting on its upper side, was mostly consumed by the fire. The instrument panels were damaged by the impact force and partially destroyed by fire and all the cowlings and fairings were in a damaged condition. Based on the data collected via picture taken by rescue team and aerial observation during the crash site visit by the commission members; the following observations were made:

- The helicopter initially impacted with its tail portion which was then separated from the main structure.
- The point of first impact was approximately 10 meters from the main fuselage resting position refer Appendix-C.
- Moving from the location of where the helicopter hit the ground, the fuselage, the MRB and engine touched the ground after impact.
- The wreckage were scattered within 25 square meter area at the crash site.

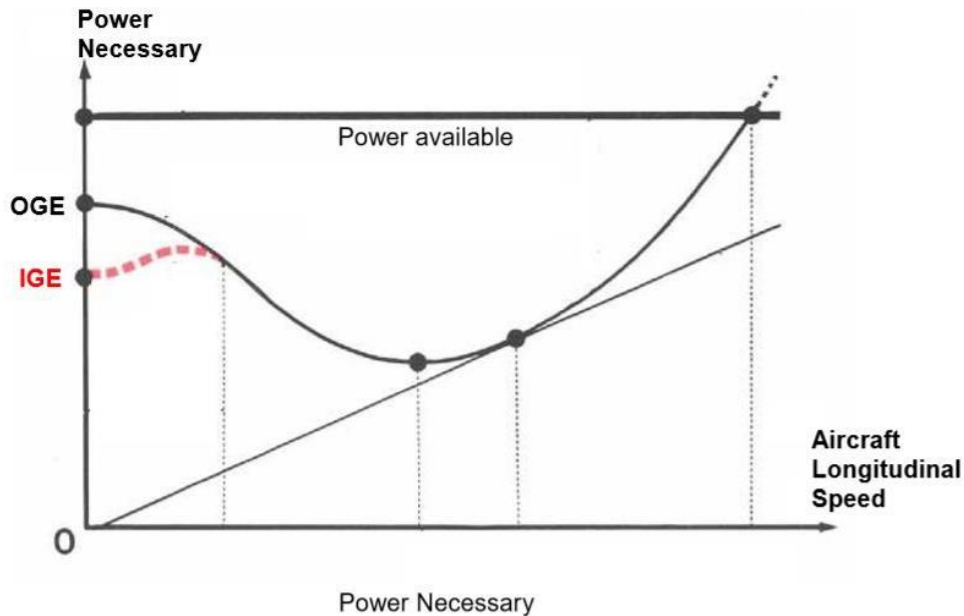
At Pathivara helipad as per the helicopter flight manual IGE take-off weight is 2250 Kg and OGE take-off weight is limit to 2120 Kg, in both cases though weight was within limit due to topography of Pathivara hilltop and layout of the helipad possibility of IGE take-off is very remote. At the time of take-off from Pathivara all up weight of the helicopter was 2025Kg as per calculation. From the power margin graph as shown in above, in OGE configurations the power available for the maneuver could be limited, which can restrict the pilot for the desired maneuver of the helicopter which has contributed to further deterioration of controls due to forward C of G being outside of prescribed limit

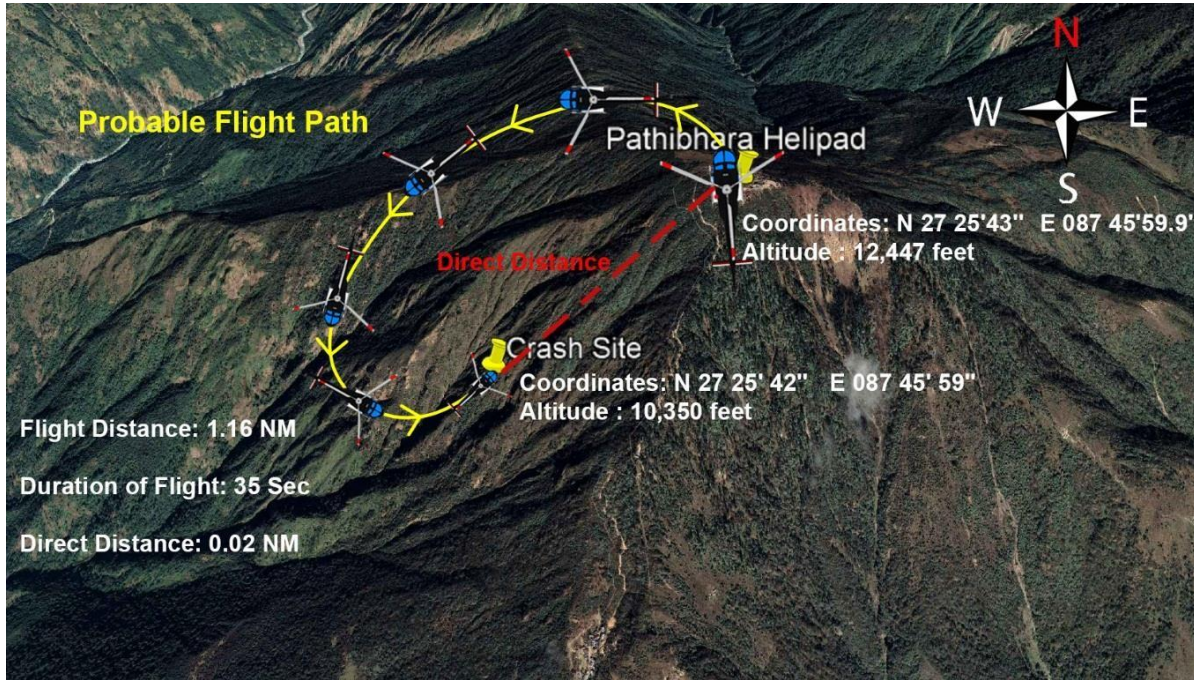
Figure 15 Flight Path

After departure from Pathibhara at an elevation of 12427 feet AMSL helicopter took off on a north north-westerly heading and started to turn left then continued turning at a high speed descent at the rate of about 3600 feet per minute and impacted at a distance of 0.02 NM west from Pathibhara helipad at an elevation of 10,350 feet. The likely flight path of the ill-fated helicopter was reconstructed on the basis of V2 track data, Elapsed time (ET) and account of nearby local people.
