*Final Report on the accident of ATR72/212A version 500 (Registration:9N-ANC) that occurred on
January 15, 2023 near Pokhara International Airport*

FINAL REPORT

**9N-ANC (ATR 72-212A, MSN : 754) AIRCRAFT OPERATED BY YETI AIRLINES PVT.
LTD OCCURRED AT
POKHARA (AT THE BANK OF SETI RIVER - GHARIPATAN), KASKI DISTRICT, NEPAL ON
15 JANUARY 2023**

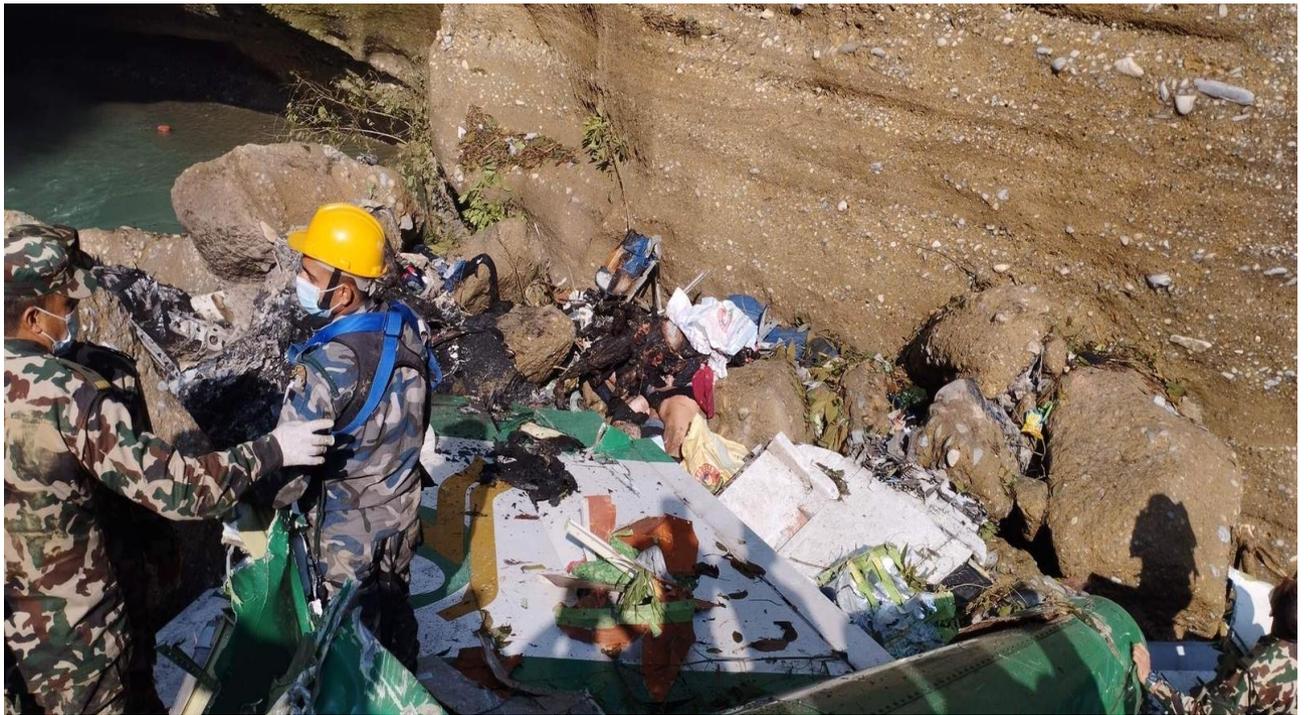
Figure 6 Wreckage within the gorge

The aircraft was completely destroyed due to the impact and post impact fire. Most of the fuselage structure, engines and its components were consumed by the fire. The propeller blades were found damaged, detached from the engine at various locations near the point of first impact. The wreckage was located at a gorge on the bank of the Seti Gandaki River and around the bank.

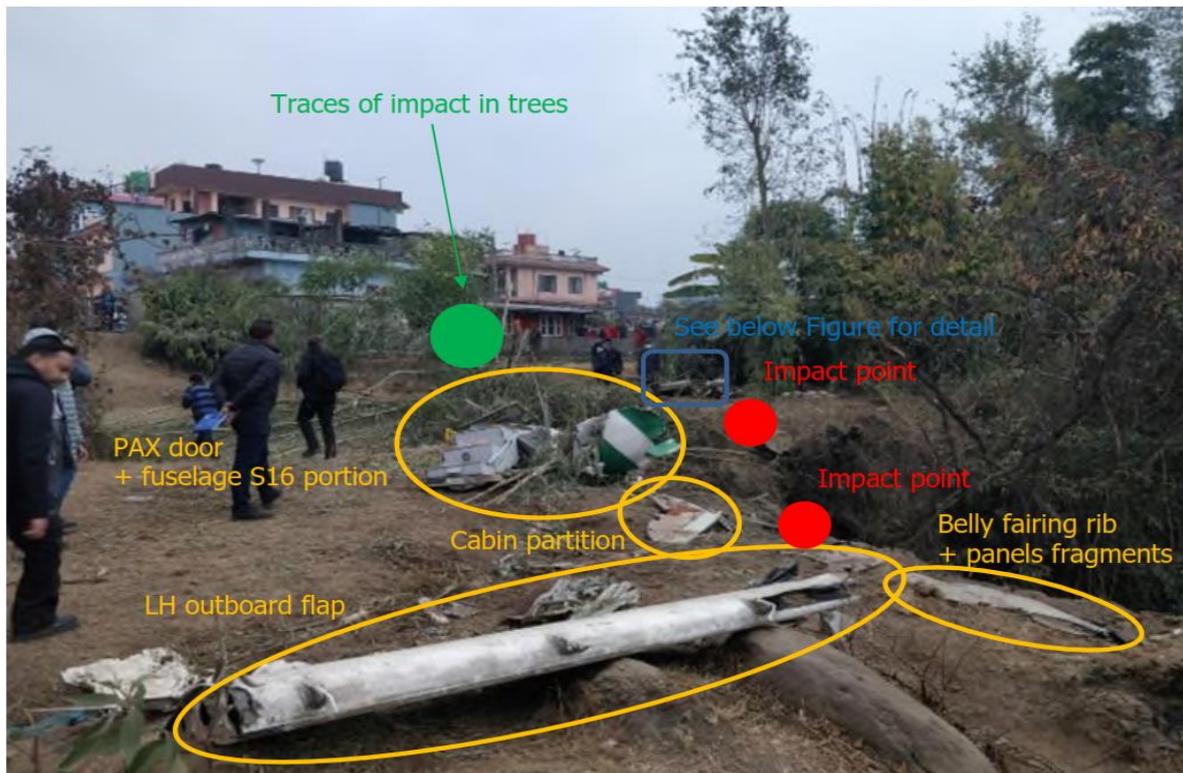
Figure 13 Site A- Identified impact points and parts

Site A: identified aircraft impact points plus aircraft parts such as PAX door and LH outboard flap, miscellaneous belly fairing panels and cabin partition, LH outer wing box, panel segment, leading edge, LH aileron tip and portion of aileron box.

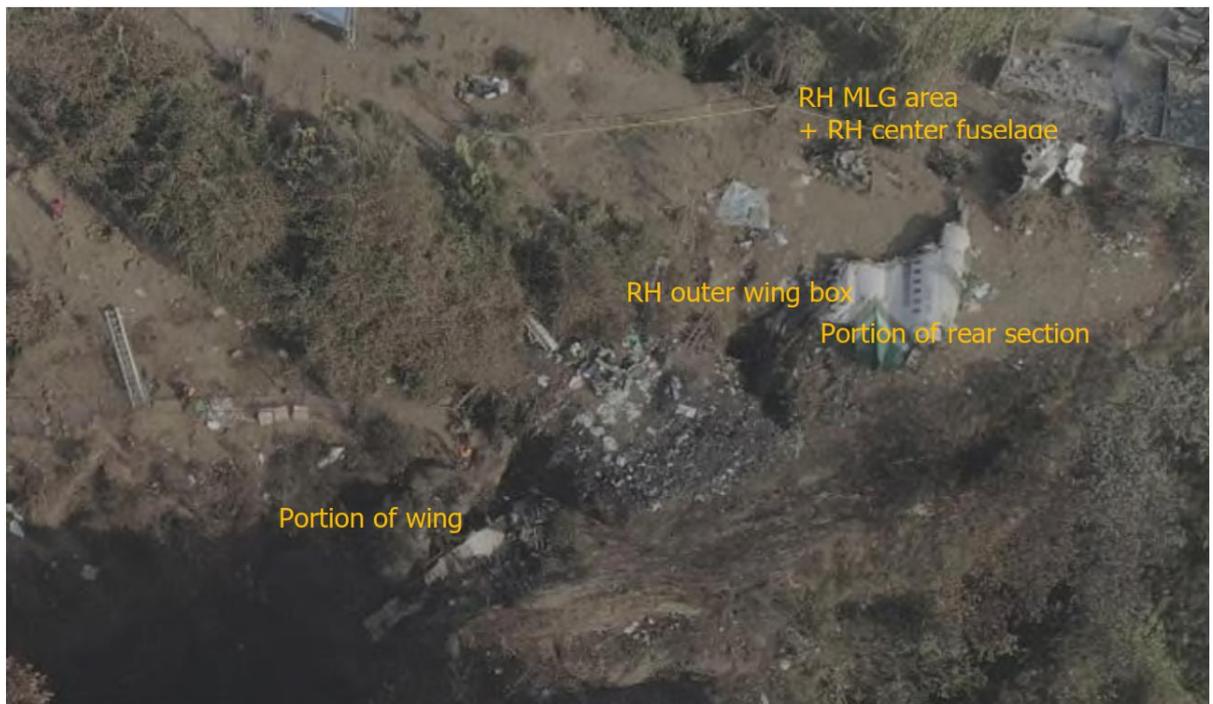
Figure 16 Blown up aerial view of components in Site B

Site B – identified rear section, RH MLG area, portion of wing (RH side plus LH/center upper area) and RH outer wing box plus miscellaneous cabin/seats items, portion of wing/nacelle/engine (RH side plus LH/center upper area), plus fragment from LH MLG shock absorber.

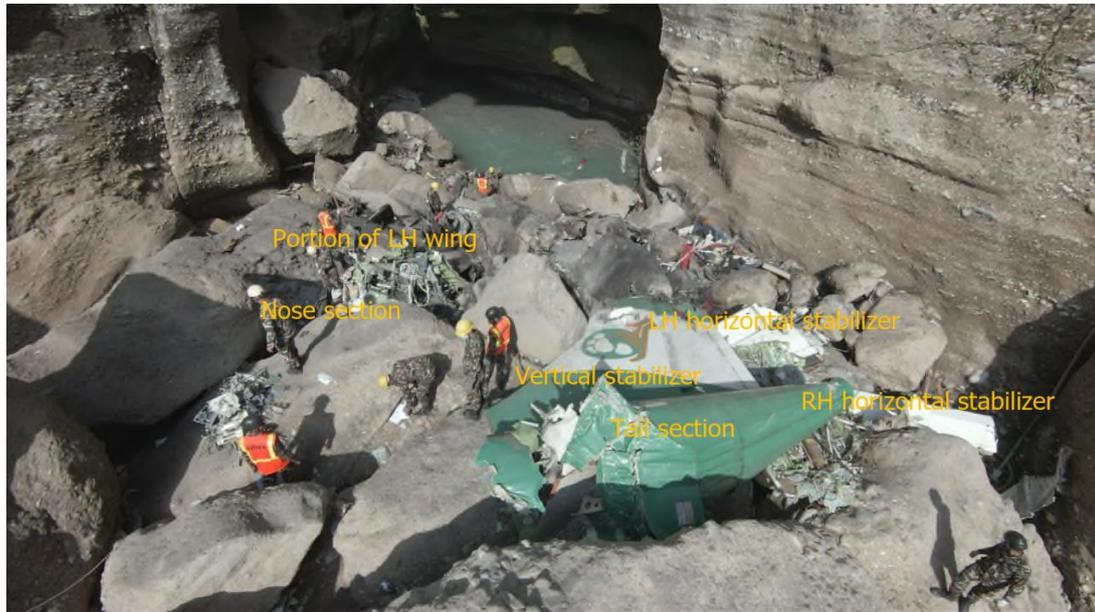
Figure 17 Wreckage identified at Site C

Site C – showing identified tail section, vertical and horizontal stabilizers, portion from LH wing/nacelle/engine/propeller plus portion of nose fuselage/cockpit, nose section and cockpit indicators.

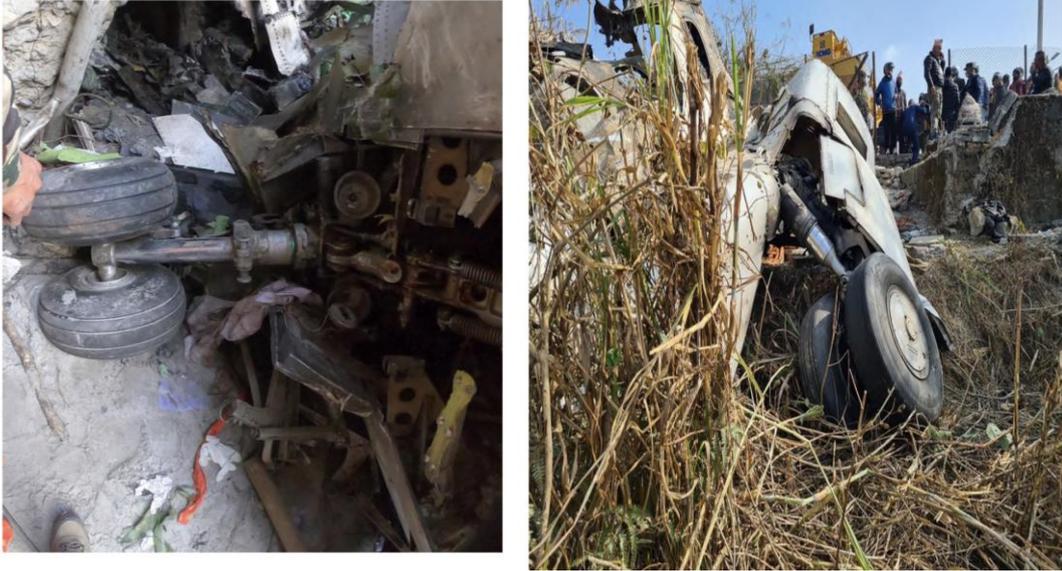
Figure 19 Landing gears

Landing gears were detached from the main body. They were moved from their original positions during search and rescue process.

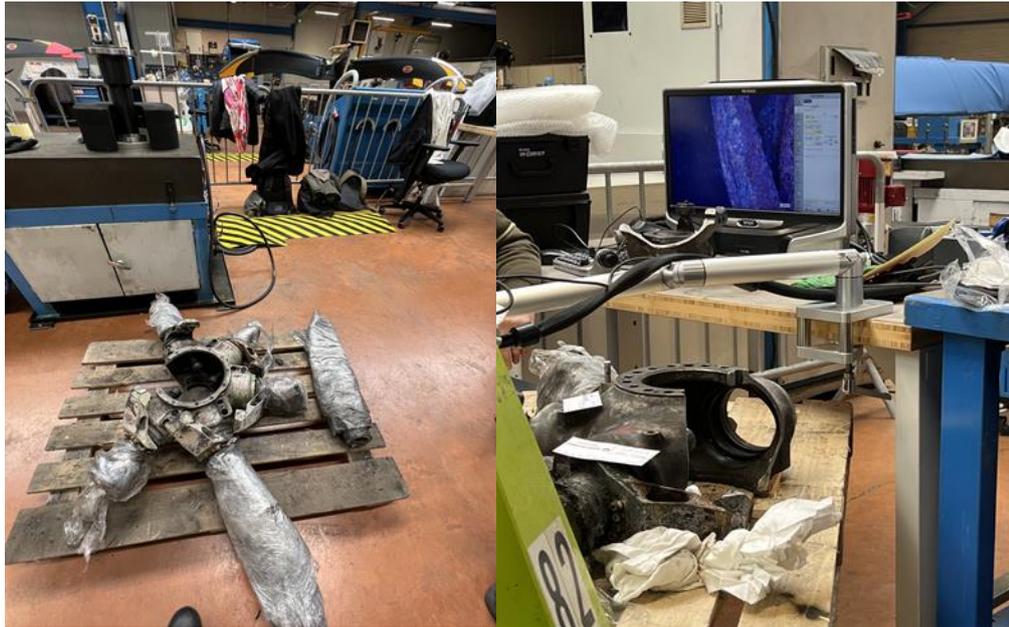
Figure 22 Propeller hub and blades examination at Figeac, France

Of the six propeller blades, two of them (4 and 5) were found stuck in a position where the counterweight arm was close to the plane of rotation, therefore in a position close to that of the flag. Damage to the hub to the right of blade 5 due to the counterweight of this blade was also noted. The repositioning of the counterweight in relation to this damage was also noted. The repositioning of the counterweight in relation to this damage corresponded to a blade close to the flag position. The other blades were partially free to rotate around their axis. The pitch change device piston (located in the centre of the hub) was slightly offset from the position corresponding to that of the flag.

The blades were all in a position where the counterweight arm was close to the plane of rotation, therefore in a position close to that of the flag. Two blades (1 and 4) were stuck in this position while the other blades were free to rotate. The pitch change device piston (located in the center of the hub) was slightly offset from the position corresponding to that of the flag.

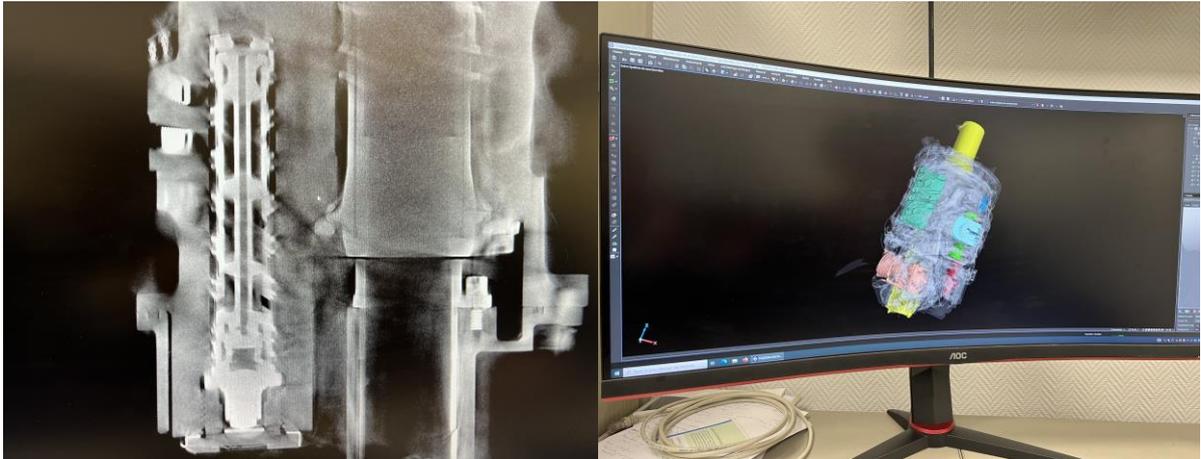
Figure 24 PVM as seen on X-ray during examination

The PVM was examined at BEA's laboratory using Computed Tomography scan and X-ray examination. Upon examination the spool of the protection valve within the PVM appeared to be mobile due to lack of hydraulic in the system. When the PVM was turned upside down, the spool followed the direction of gravity forces. Therefore, the spool position at the time of the event could not be determined rendering the information inconclusive to determine the propeller pitch command at impact.

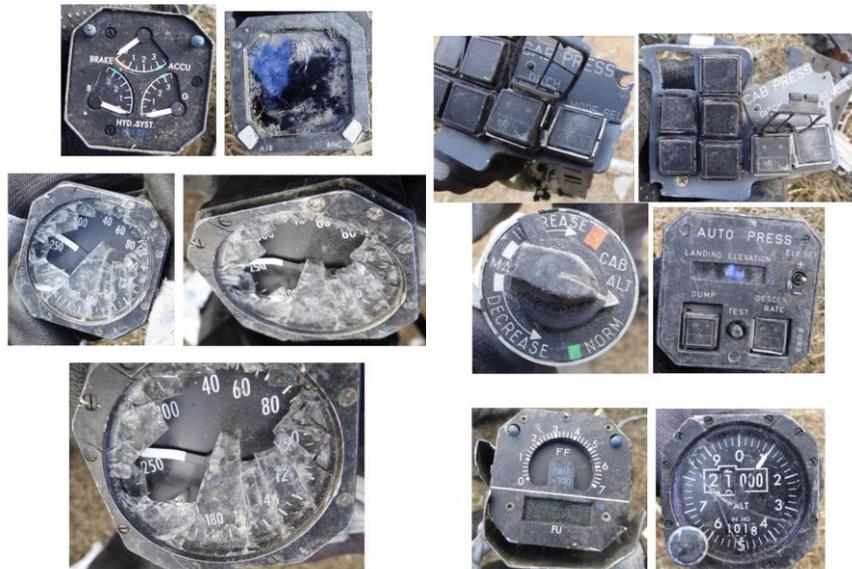
Figure 30 Instruments recovered from Site C

Fuel Flow Indicator: The needle was missing; no indication observed.

Flap Position Indicator: The needle was missing. The blue “EXT” indication was visible.

Hydraulic Triple Pressure Indicator: All three needles were present and were free to move. No needle marks observed on the face.

Interstage Turbine Temperature (ITT) Indicator: The needle was missing and no indication on the face.

Airspeed Indicator: The needle was free to move above 255 knots. Marks consistent with needle impact traces were observed pointing towards 260 knots.

RH Propeller Torque Indicator: The two needles were hard to move, but no evidence of needle trace was observed.

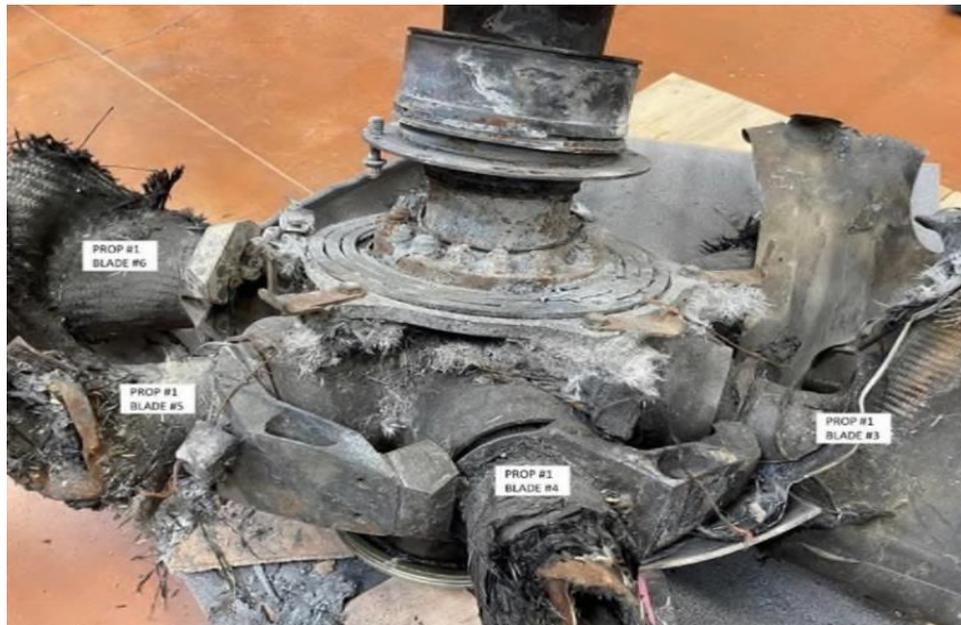
Figure 25 Prop #1 hub assembly

"Most of the blades on the RH propeller hub were observed to be in feathered position; however, the indices were slightly less obvious on the LH propeller hub. Two blades on the LH hub were in line with the feather setting while the other blades were free around their pitch change axes. The position of the actuator was not at the expected position for feathered propeller, but the actuator could have moved upon impact."

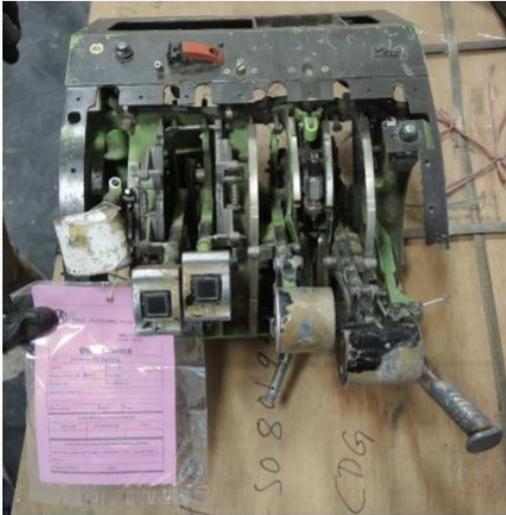
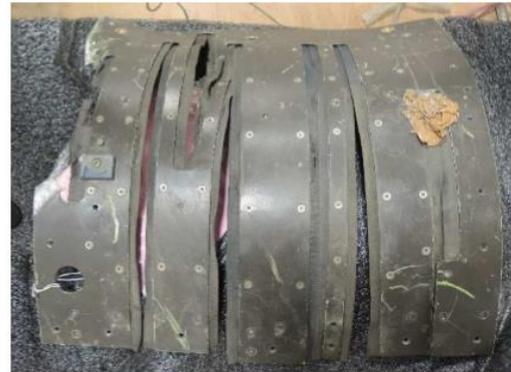
Figure 26 Control Pedestal of 9N-ANC

The witness marks from the pedestal indicates that the left condition lever was in the feathered position. Although the right hand condition lever did not have witness marks it is probable that the lever was also in the feathered position based on the FDR data and MFC examination corroboration.

- The flap lever was locked in the 30° position, with damage to the lever consistent with the application of a high force from the rear during the accident. As a result, the lever was clearly in the 30° position at impact.
- Traces and impact on the Condition Lever 1 rail are consistent with a FEATHER position at impact (no other impact on other position on the rail of Condition lever 1);
- No trace on the Condition Lever 2;
- Traces and damage on Power levers 1 and 2 are consistent with a position forward (zone corresponding to high power).
- The Gust Lock lever was moved rearward upon impact during the accident sequence and deformed. The lever was therefore forward before impact (normal position in flight).

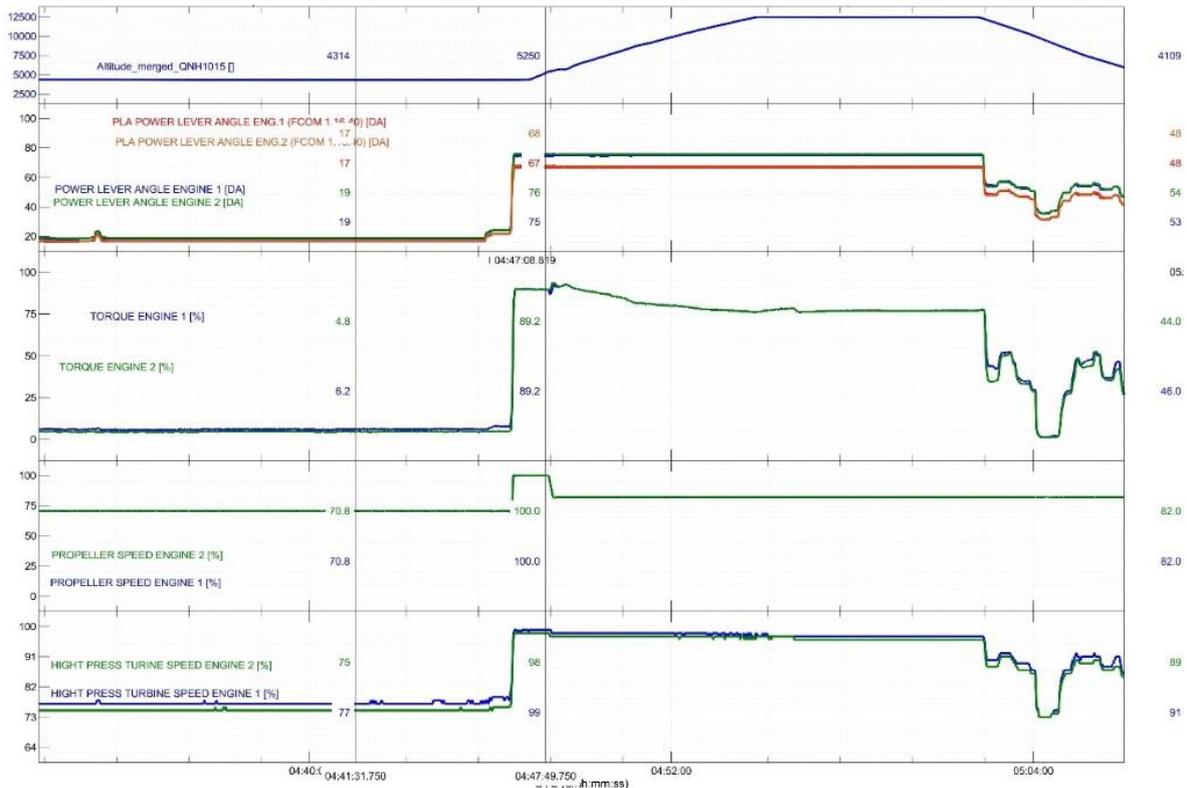
Figure 35 Engine and propeller parameters as per FDR

flap 30 was called (yet not acknowledged by the other crew) on the accident flight, the flaps were not deployed; rather both propellers went to feather resulting in loss of torque in both engines. However, when the flaps 30 were finally deployed, there were no recorded callout from either cockpit crew.
