**ACCIDENT INVESTIGATION REPORT**  
**ON**  
**9N-AJU Cessna Grand Caravan (Charter Flight)**  
**OPERATED BY**  
**MAKALU AIR AT EKLABHUJ KHARKA, SOUTH OF SIMIKOT AIRPORT**  
**DISTRICT, NEPAL**  
**ON 16<sup>th</sup> MAY 2018**

**SUBMITTED BY**  
**AIRCRAFT ACCIDENT INVESTIGATION COMMISSION**  
**TO**  
**THE GOVERNMENT OF NEPAL**  
**MINISTRY OF CULTURE, TOURISM AND CIVIL AVIATION**

*December, 2019 (Poush, 2076 B.S.)*

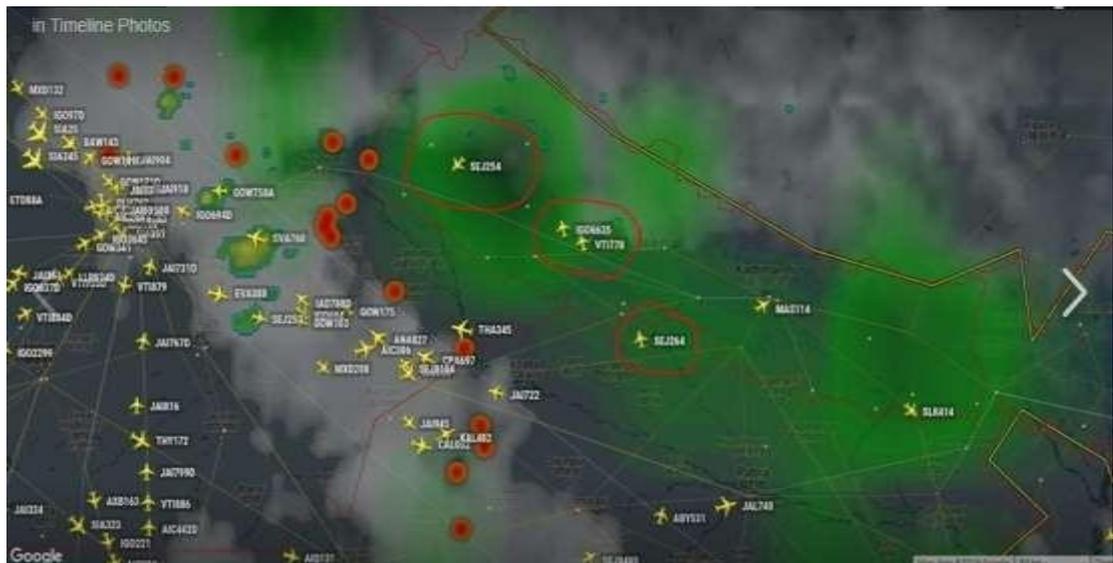
Fig: Air traffic scenario of 13 May evening. Several air traffic deviated to Nepal due weather.

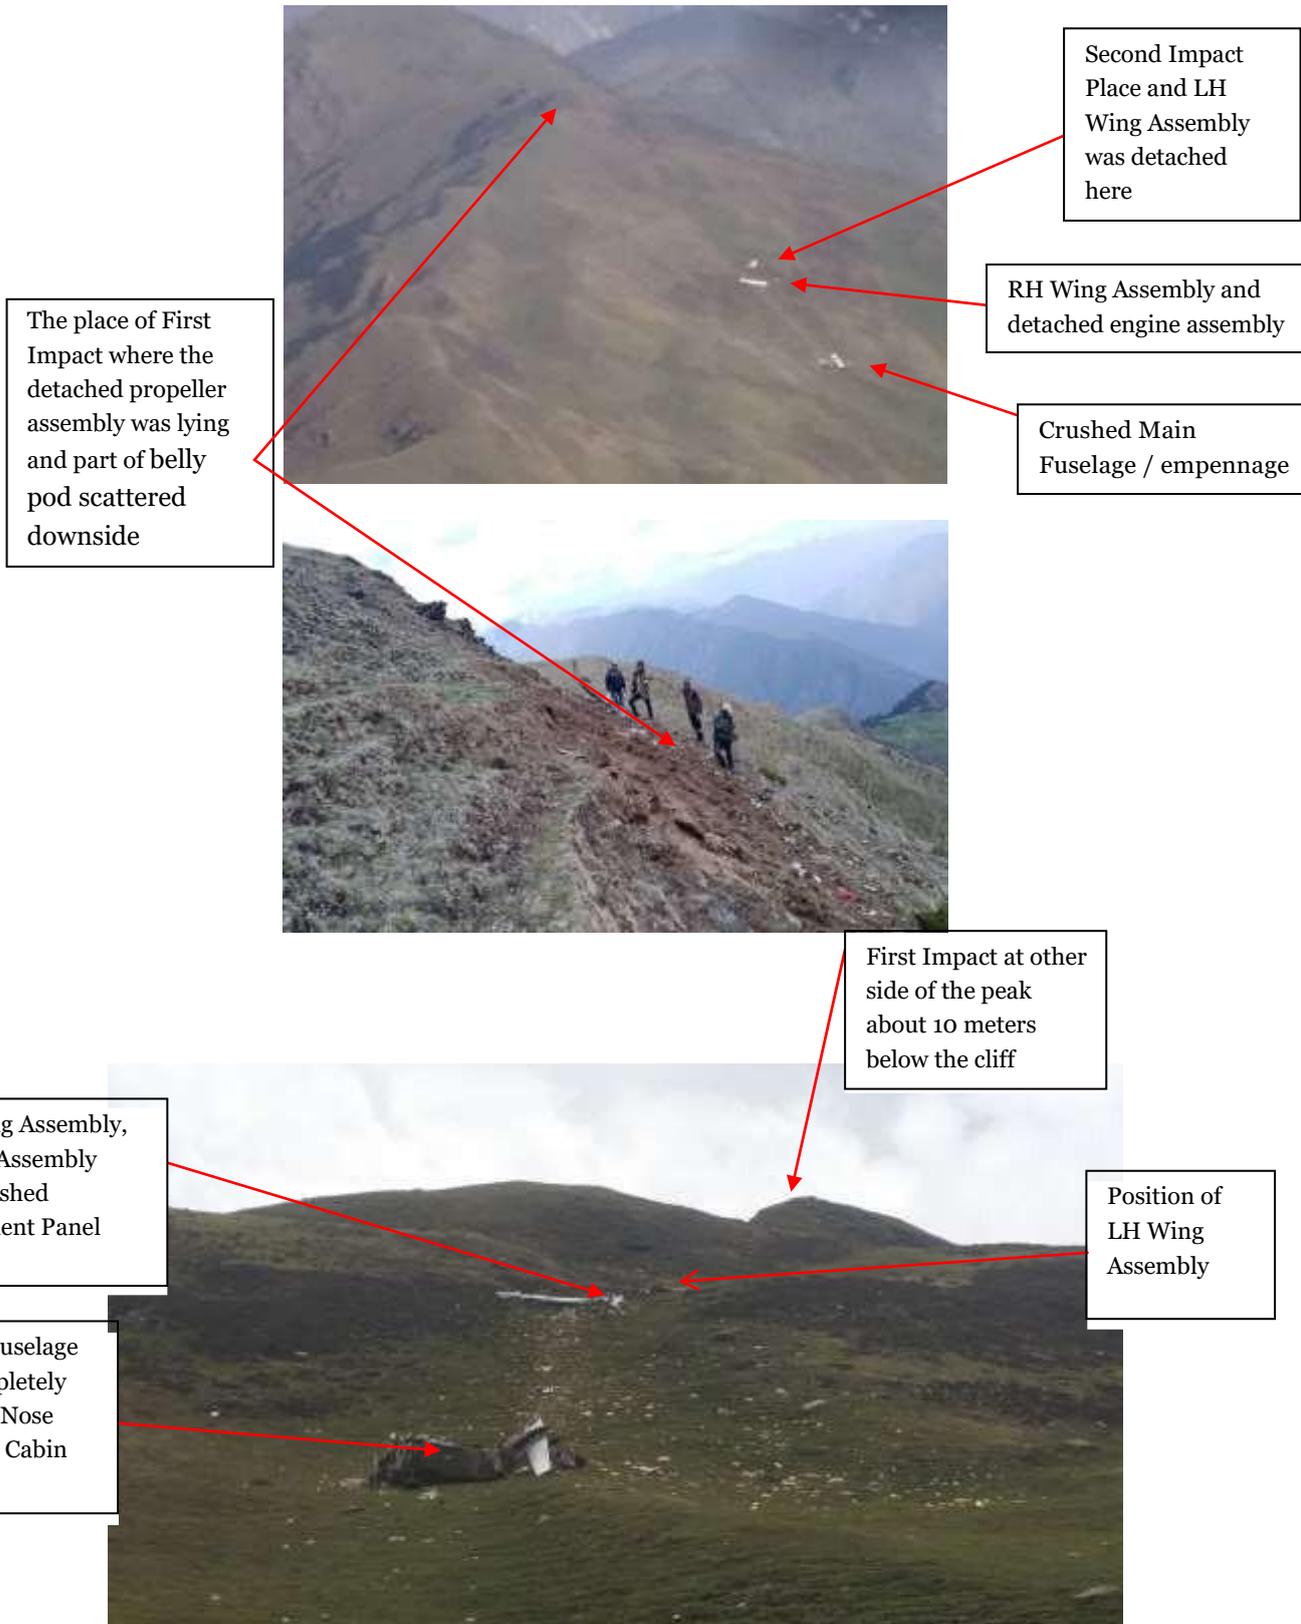
- iv. The propeller and the nose section of the fuselage hit the ground first and then flipped over the other side of the ridge, landed at about 100 meter beyond other side of the ridge where its engine and wings assemblies were detached. The remaining part of the fuselage came to rest about 150 meters from the first impact point. (Refer Figure of crash site location Appendix)

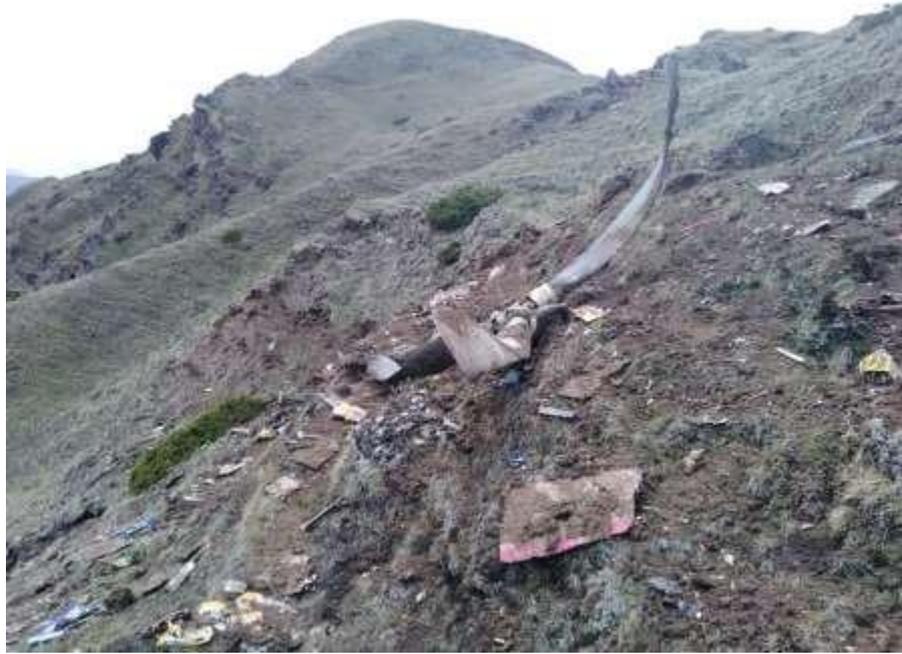
- i. The propeller was separated from the engine at the point of first impact and found stuck with its propeller blades in fine position. The aircraft belly pod was damaged and scattered at the windward side of the impact point.

Detached Propeller Assembly

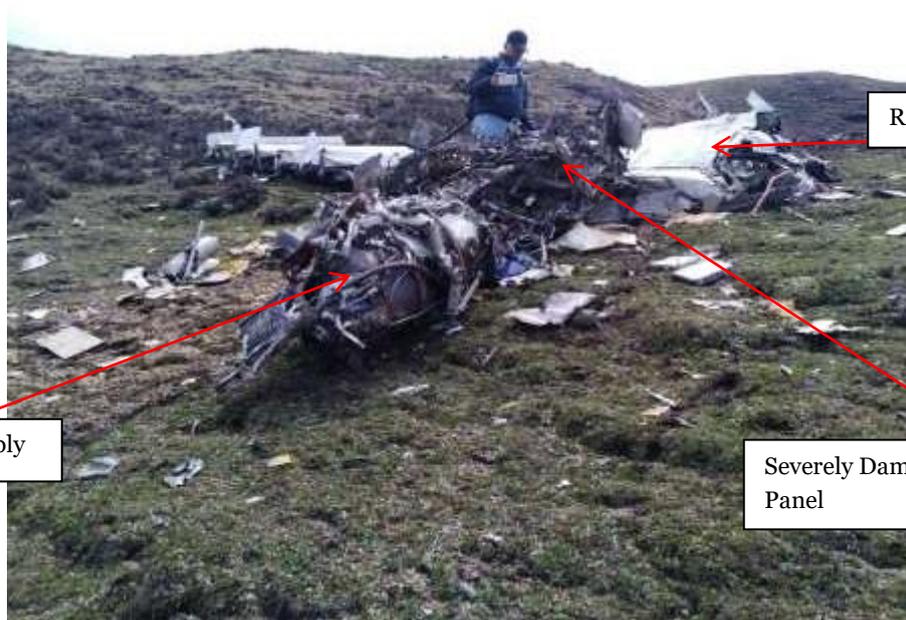
Engine Assembly

As per the preliminary report from the Pratt & Whitney, Canada, the engine does not show any evidence that could have precluded normal operation prior to impact. All gears and bearings were found in good condition and there was no evidence of compressor or turbine blade fracture. Some evidence of rotation on both the compressor and power turbine rotors at impact; rubbing marks were found on turbine disks and blades as well as all of the compressor components.
