Accident Investigation Final Report

9N-ALS H125 (AS350 B3e) Helicopter

Owned & Operated By Altitude Air Pvt. Ltd.

On 8th September 2018

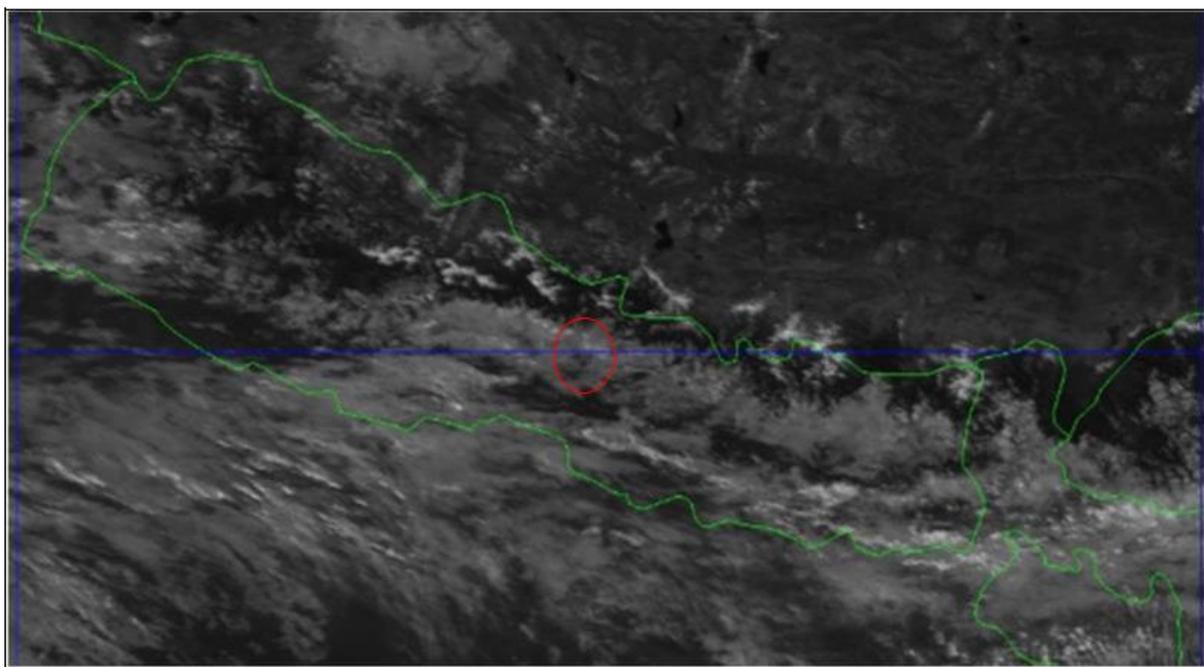
Source:- Himawari-8, JMA

most substantial impact on the flight, and ultimately is the leading cause of this mishap. PIREP of 9N-AMS, witness interviews, and the Commission's own observation of the crash site for an extended period revealed that weather at Samgaon valley was clear and the weather condition was CAVOK beyond 32 NM from VNKT. The Report from DHM showed developing cloud of weak monsoon. According to the first responders (Helicopter Pilots, Rescue Technicians, Medics), there were fair amount of cloud in the area where 9N- ALS crashed and long line technician could not be dropped off at the site for aerial rescue and recovery. A group of responder consisting of Mountain guides, Police and Army officers set on foot from the near Barsungchet Mailungpakha Forest, Medhang-1, Nuwakot District, Nepal.

Note:-The encircled area in red is visually estimated crashed site.

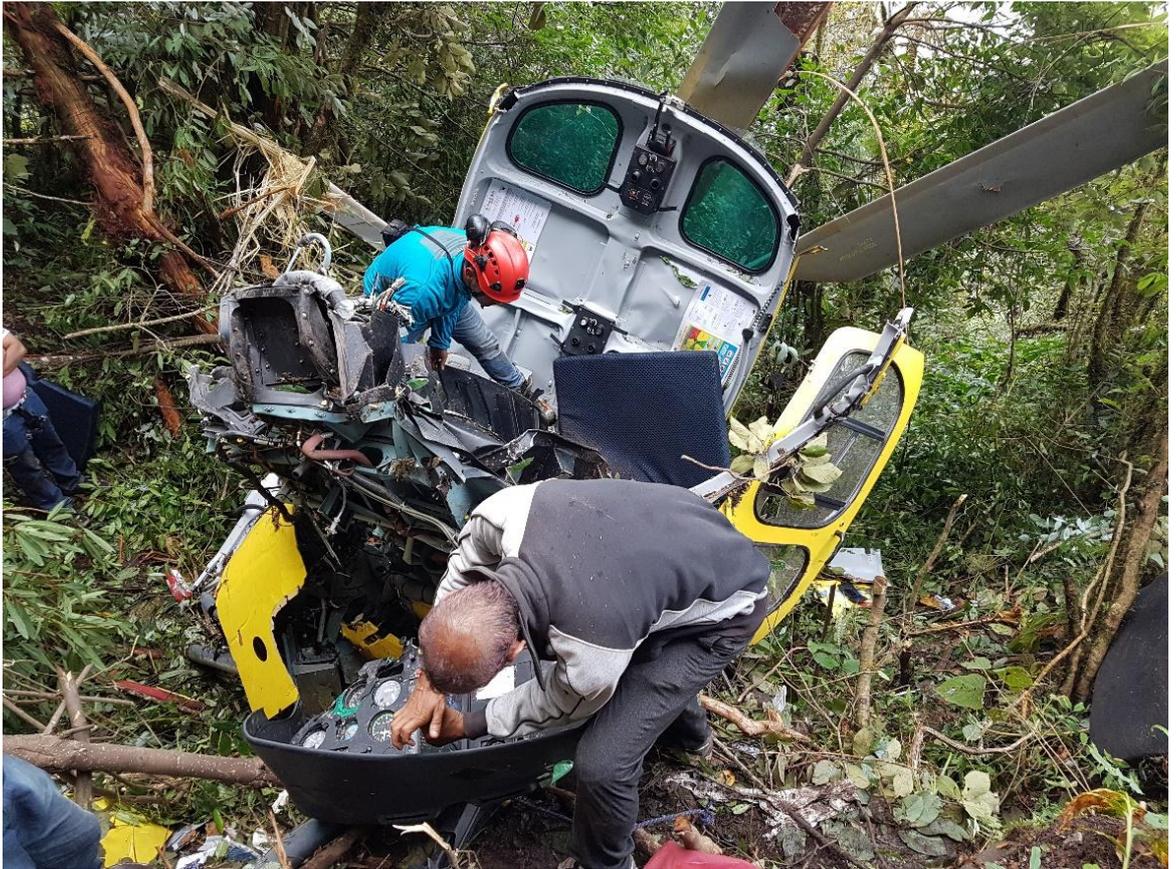
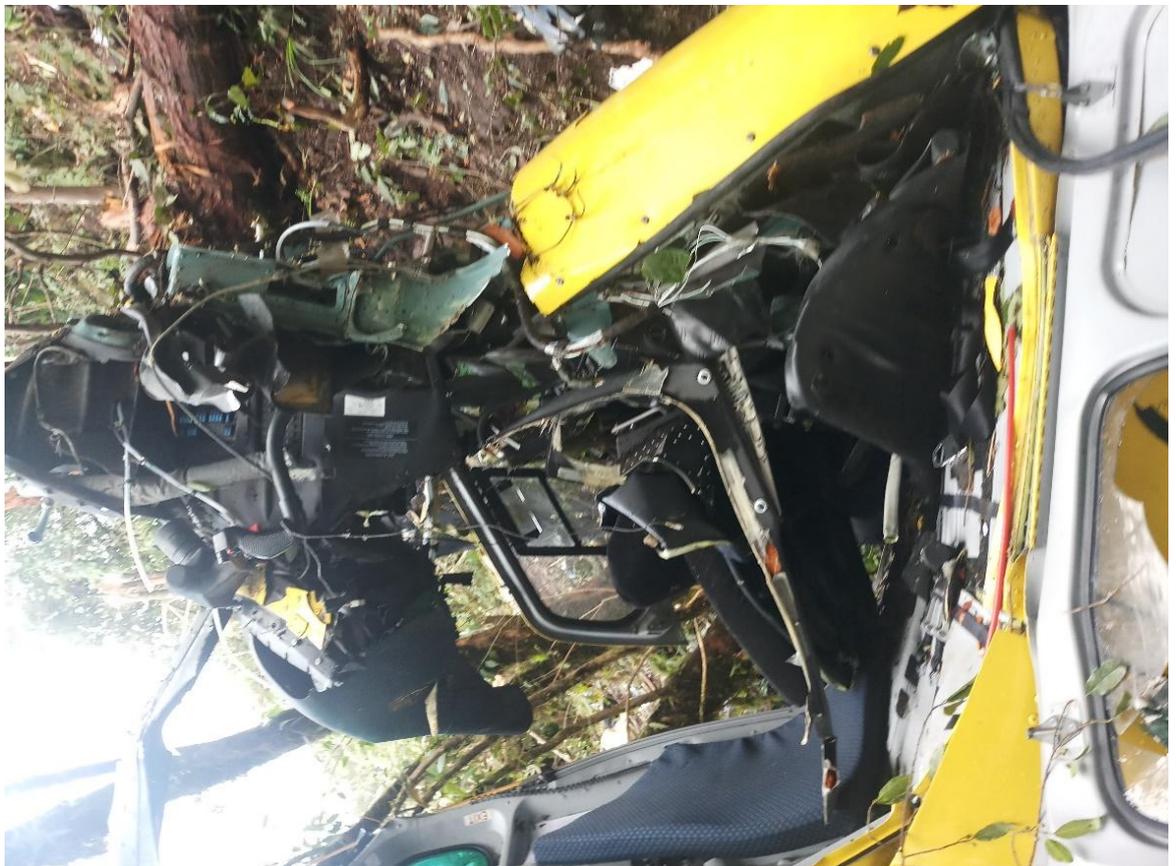
2.6 Wreckage and Impact Analysis

Because of high speed Impact, Helicopter parts scattered up to 50 meters from the spot of the main wreckage. Trees in vicinity were also hit based on aerial surveillance carried out during the visit to the site. Crash site is in the dense forest with no normal route or access and as such, it was difficult to speculate if parts were further away.
