**Government of Nepal  
Aircraft Accident Investigation Commission, 2022**

**Final Report**

**Accident Investigation of 9N-AET, DHC-6/300  
Owned and Operated by Tara Air Pvt. Ltd.  
At Sanusare, Mustang on 29<sup>th</sup> May 2022**

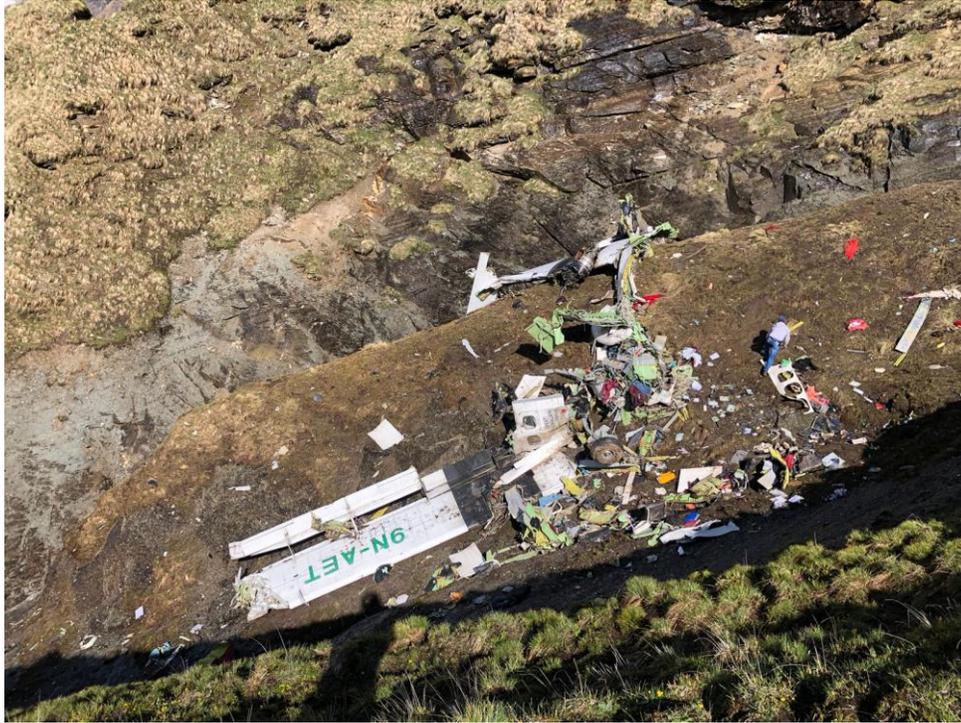
The aircraft was completely destroyed due to the impact with terrain.

Figure 2 Aerial shot of the wreckage

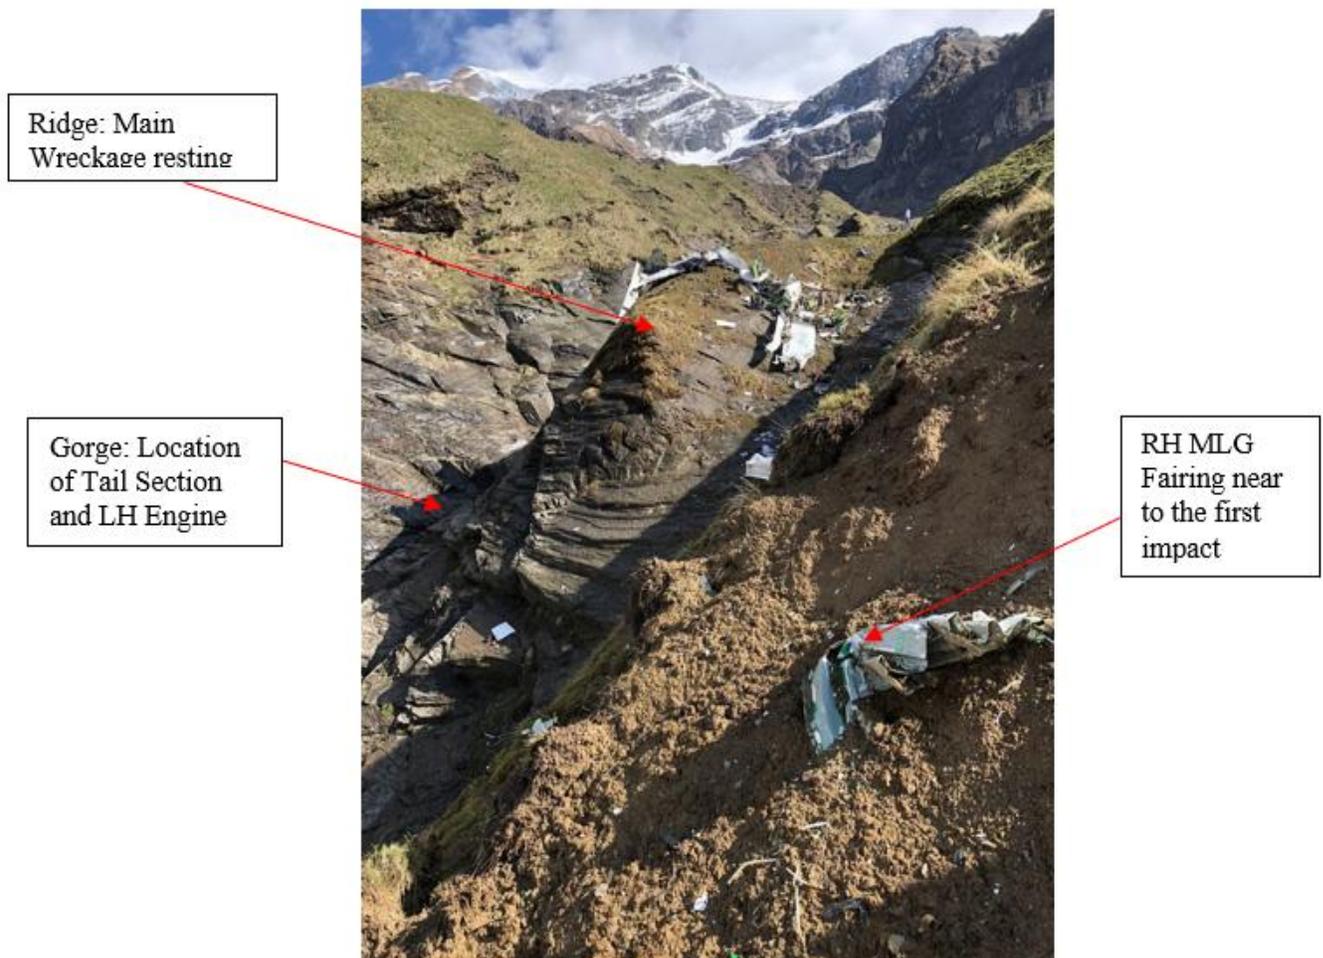
The main wreckage consisted of wings and damaged portions of cabin & cockpit. The left main landing gear, with its wheel assembly intact, was found near the main wreckage.

The LH Wing was found lying upside down at right side of the ridge with its tip severely damaged near the main fuselage wreckage. The left engine with its propeller assembly was found in the gorge, left side of the ridge. The right wing was found lying on top of the ridge along with a part of fuselage attached.

The main wreckage was found around 20 meters ahead of the first impact position at LH side of its flight path. The RH Wing assembly was found on the top of the ridge with RH Engine lying beside. The tail section of the fuselage was found LH side of the ridge.

Figure 8 Wreckage Distribution

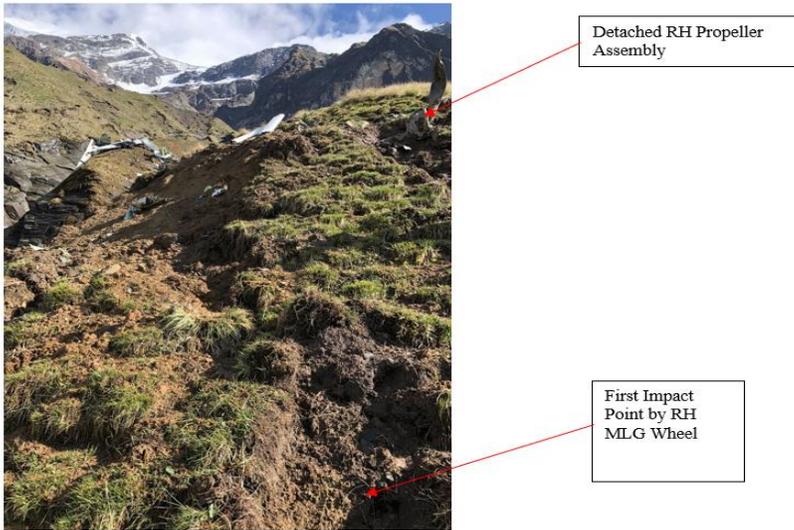
RH propeller assembly was found stuck in the ground with its blades in relatively FINE position detached from the engine in the flight path direction with reference of simultaneous first impact of RH MLG Wheel Assembly.

The airplane initially impacted with its right main landing gear wheel and right propeller. The point of first impact was approximately 30 meters right side downstream from the main wreckage.

Figure 9 First Impact position

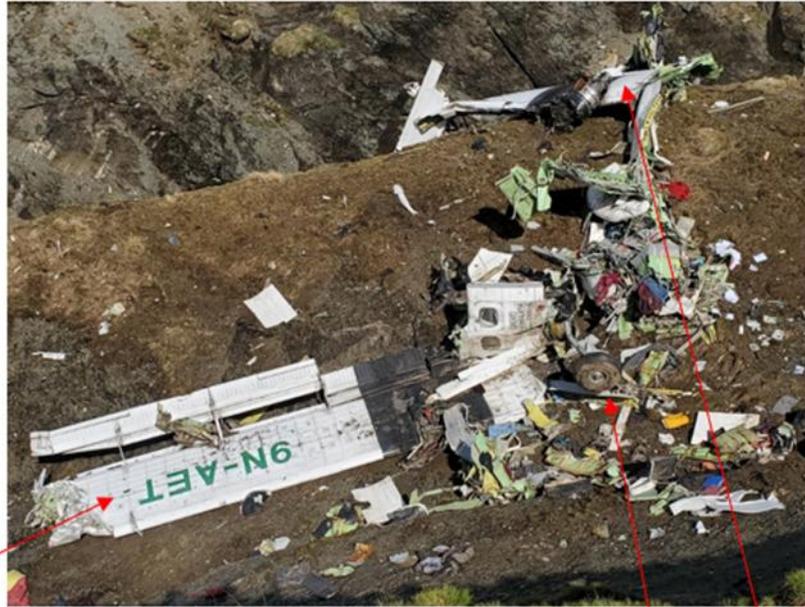
Figure 11 Wreckage Distribution

Left Wing Box with damaged wing tip

LH Main Landing Gear and its Wheel Assembly

RH Wing Box and engine with a portion of attached fuselage

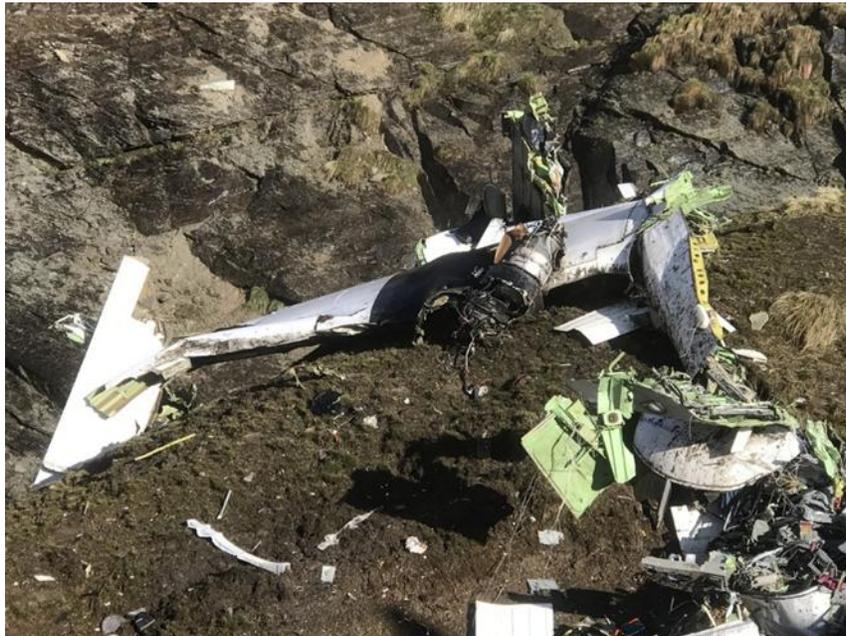
Figure 12 Right hand Wing and Engine

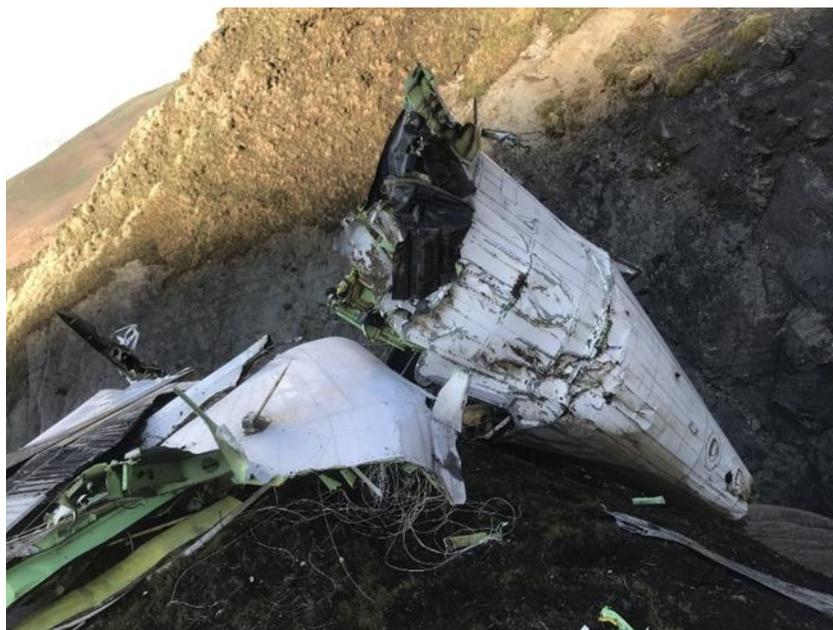
Figure 13 Tail Section lying left side of the ridge

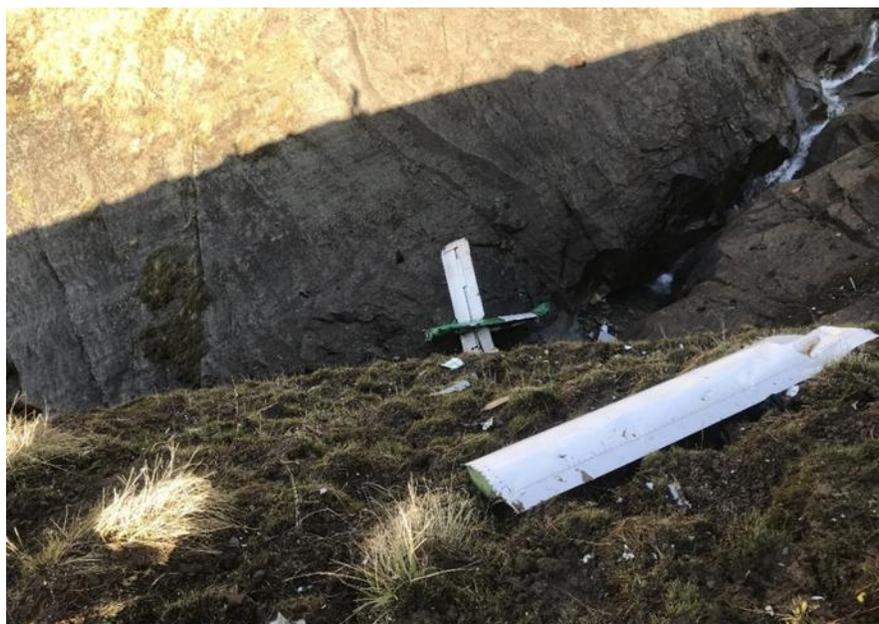
Figure 14 Figure 14 Tail Section in gorge

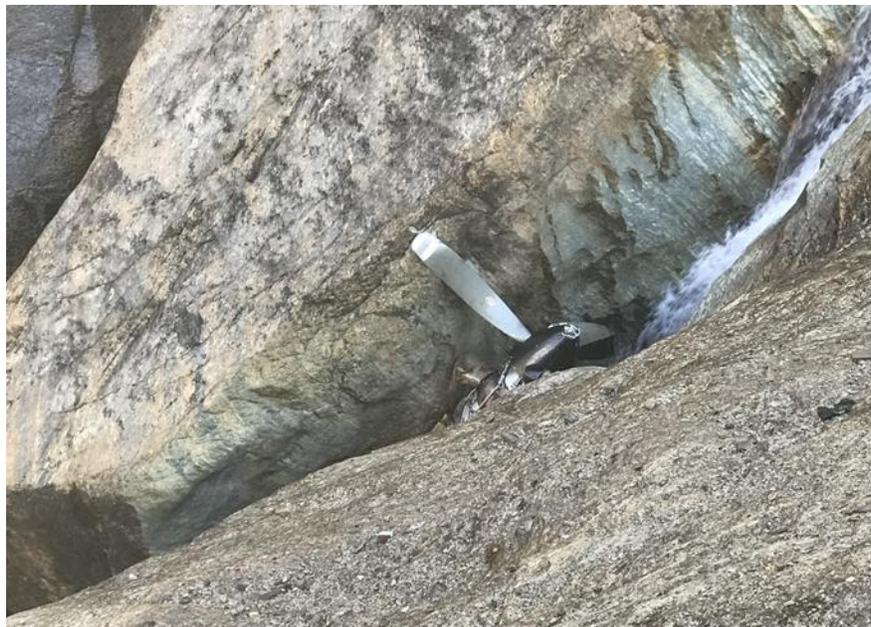
Figure 15 Left Hand Engine with Propeller Assembly

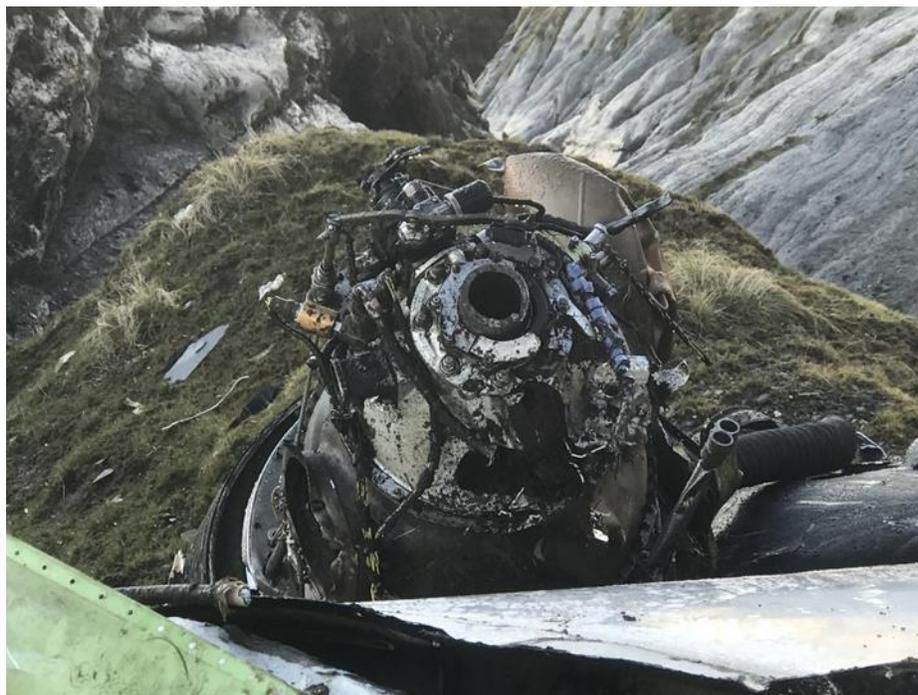
Figure 16 RH Engine with sheared propeller shaft

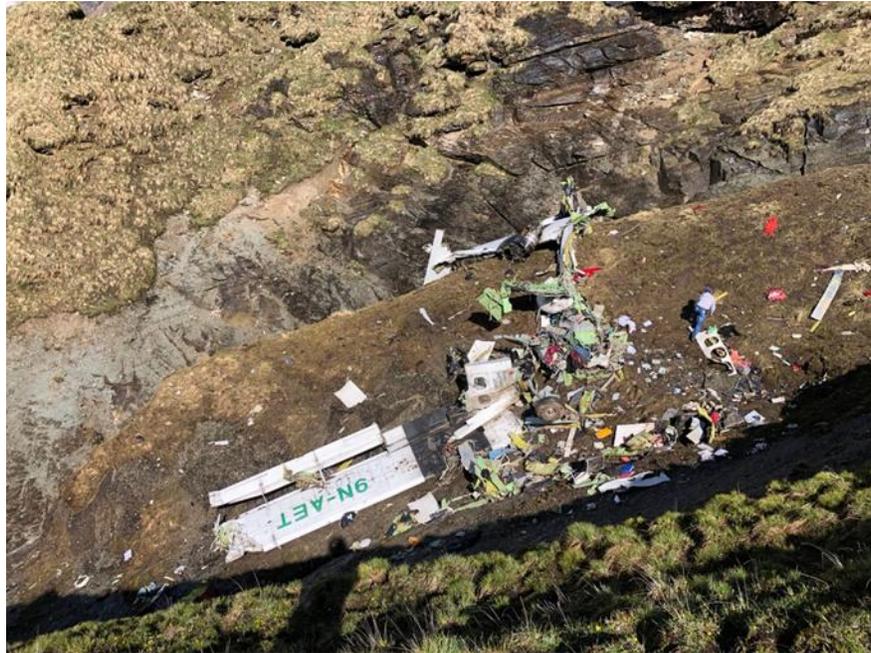
Figure 17 Main Fuselage wreckage

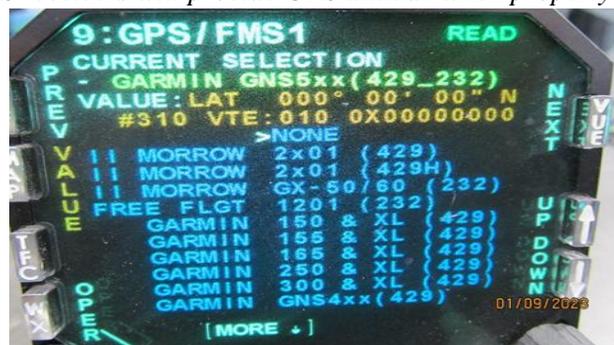
Figure 20 GPS/FMS 1 Data

The recorded parameter data for the aircraft DHC-6 Twin Otter 300, 9N-AET shows that the GPS1 was configured to as “GARMIN GNS5XX (429\_232)”. However the recorded data in all of the flight showed that the data items from the RS\_232 interface was always ‘Timed-Out’. This is a preferred source for Altitude into the TAWS. The reason for not receiving the GPS Altitude by the TAWS unit could be various but is likely caused by the misconfiguration of the RS-232 output format from the Garmin GPS receiver.

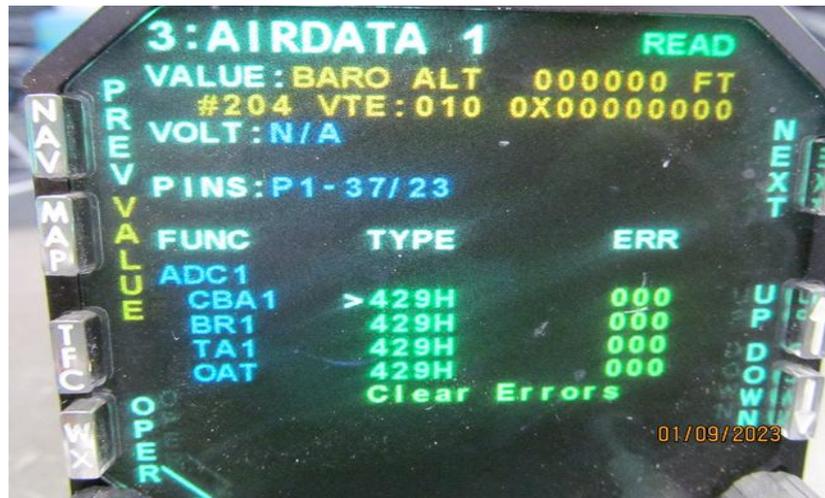
Figure 21 AIRDATA 1 Data

The recorded parameter data for this aircraft shows that the ADC1 was configured to as “429H” for all of its inputs items.

The Air Data Computer [ADC] did not have any inputs from Altimetry System other than OAT and Pitot Static Air. To properly compute Corrected Barometric Altitude (CBA), a regional barometric pressure setting must be available to the ADC, and the pilots must enter the current regional barometric pressure value. Without this input, the ADC in this aircraft was unable to provide an accurate CBA value. Moreover, the Initial Post Installation Test Records for these systems show the test items for Correct Barometric Altitude as NOT APPLICABLE.

The above listed issues of missing GPS Altitude causing the Correct Barometric Altitude to be the Primary Altitude source and then having CBA settings that induced nuisance alerts introduced a lack of trust in the proper alerting of the ST3400 TAWS unit.
