**GOVERNMENT OF NEPAL
AIRCRAFT ACCIDENT INVESTIGATION COMMISSION, 2014**

**FINAL REPORT ON THE
ACCIDENT INVESTIGATION OF
9N-ABB TWIN OTTER (DHC6/300) AIRCRAFT
OWNED AND OPERATED BY--NEPAL AIRLINES CORPORATION
AT
DIHIDANDA, MASINALEK
ARGHAKHANCHI DISTRICT, NEPAL
ON
16 FEBRUARY 2014**

[FINAL REPORT]

**SUBMITTED BY
Commission For The Accident Investigation
To
The Government of Nepal
Ministry of Culture, Tourism and Civil Aviation
25/08/2014 (2071/05/09 B.S.)**

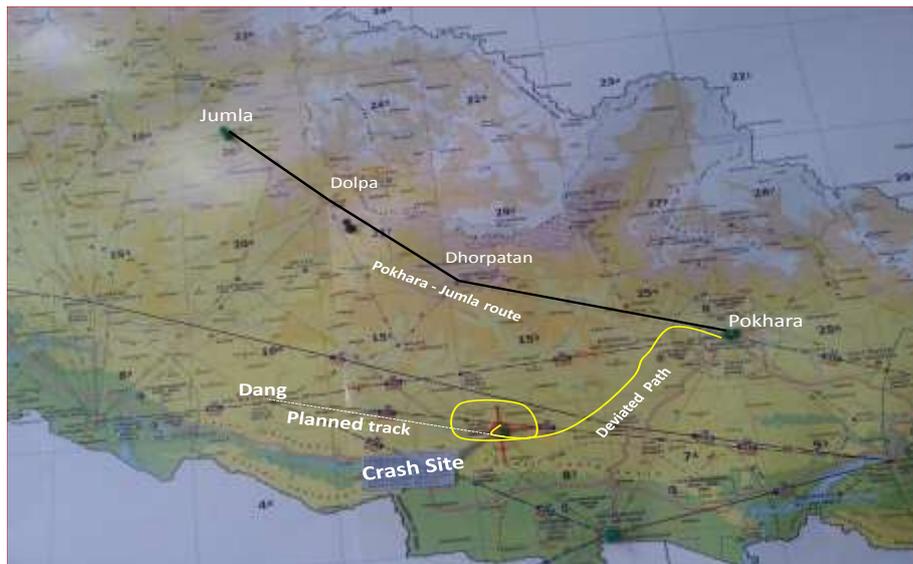
Fig 1: Flight Path and crash site

The geographical reference of the crash site is as given below:

N 27 deg 54'43'' Latitude
E 83 deg 06' 56" Longitude
Elevation: 7190 feet AMSL
