GOVERNMENT OF NEPAL
AIRCRAFT ACCIDENT INVESTIGATION COMMISSION

FINAL REPORT

9N-AHH TWINOTTER (VIKING DHC6-400) AIRCRAFT ACCIDENT
OPERATED BY TARA AIR PVT LTD

SOLIGHOPTE, DANA VDC MYAGDI DISTRICT, NEPAL

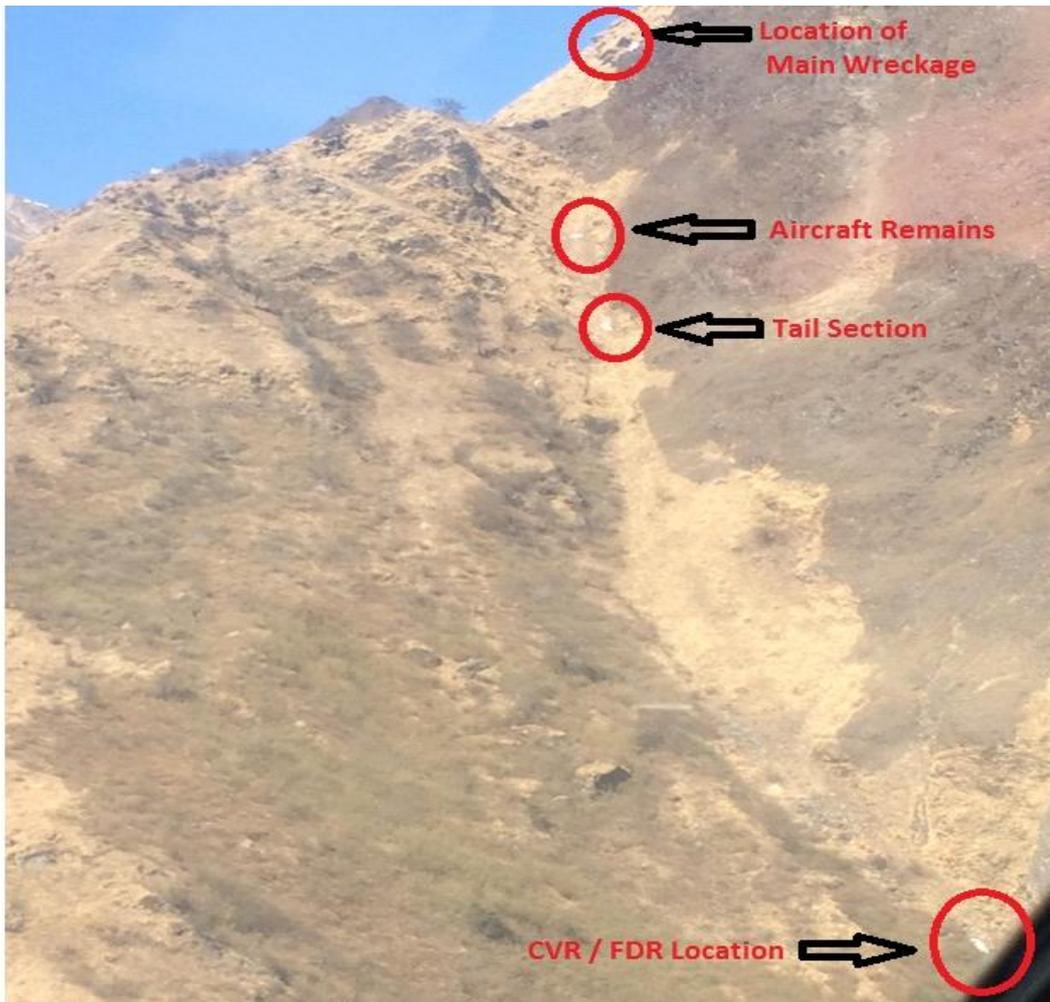
Figure 15: Scattered Debris

The aircraft was found with single fuselage section, detached tail structure and dispersed main landing gear, propellers and cowlings. The fuselage, resting on its upper side, was mostly consumed by the fire. The instrument panels were damaged by the impact force and partially destroyed by fire and all the cowlings and fairings were in a damaged condition. Based on the data collected during the crash site visit by the commission members; the following observations were made:

- The measurements of the main impact area were 400 meters long by 50 meters wide, with the wreckage aligned on a heading of flight.
- Moving from the location of where the airplane hit the ground, the fuselage, the right wing and right engine touched the ground after belly impact and left engine was the last items that might have impacted after some time on the wreckage path. The fuselage came to rest mostly intact on its right side and was located about 75 meters from the first impact point. Both wings, with the engine attached, was lying inverted just in the fuselage wreckage. Both engines were found attached to the fuselage with evidence of propeller breakage after impact. Both engines propeller assembly were in attached condition with burn marks. Both engines and propellers had evidence of rotation and power at impact. (Refer Figure of crash site location Appendix-B)

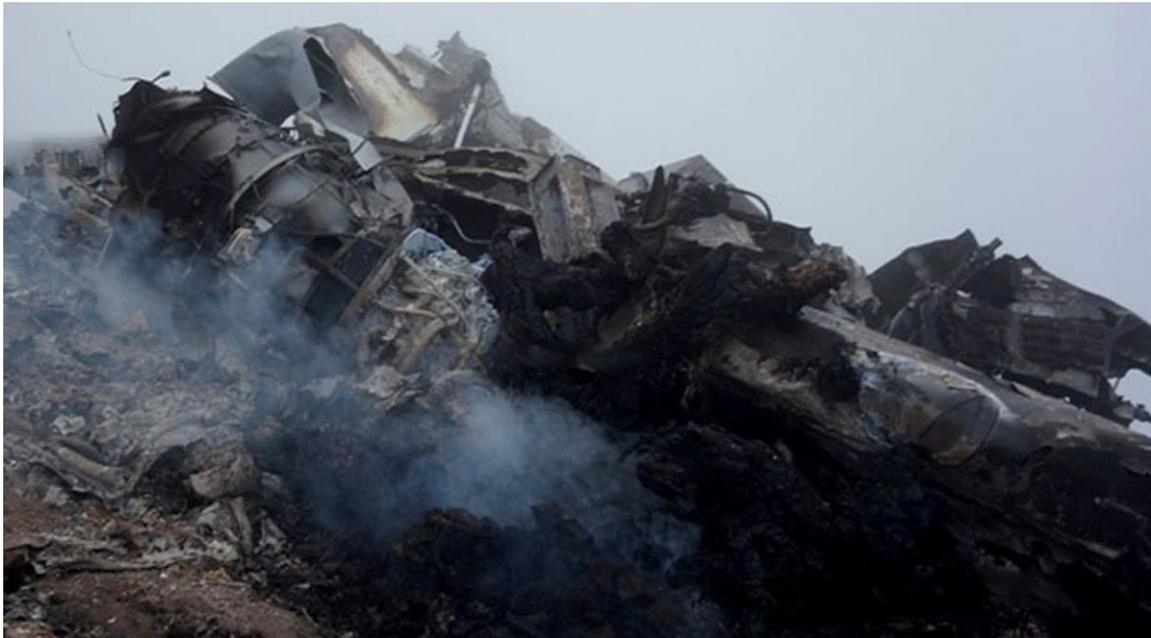
Figure 16: Post impact fire

The investigation of the crash site, scatters of debris on flight path and available evidence showed that the fire was the post impact event caused by engine combustion and spilled fuel around the vicinity of the crash site.

Post impact fire was evident mainly at the fuselage area and as the fuel is stored in the belly of the main fuselage area the whole main fuselage structure was consumed by the fire. The rescue team who reached the crash site also reported that the fuselage area was still burning at the time they arrived the site which was more than 5 Hours after the accident. The FDR and CVR record reveals that there was no evidence of fire before impact and examination of the wreckage confirms that the fire occurred only after the impact.

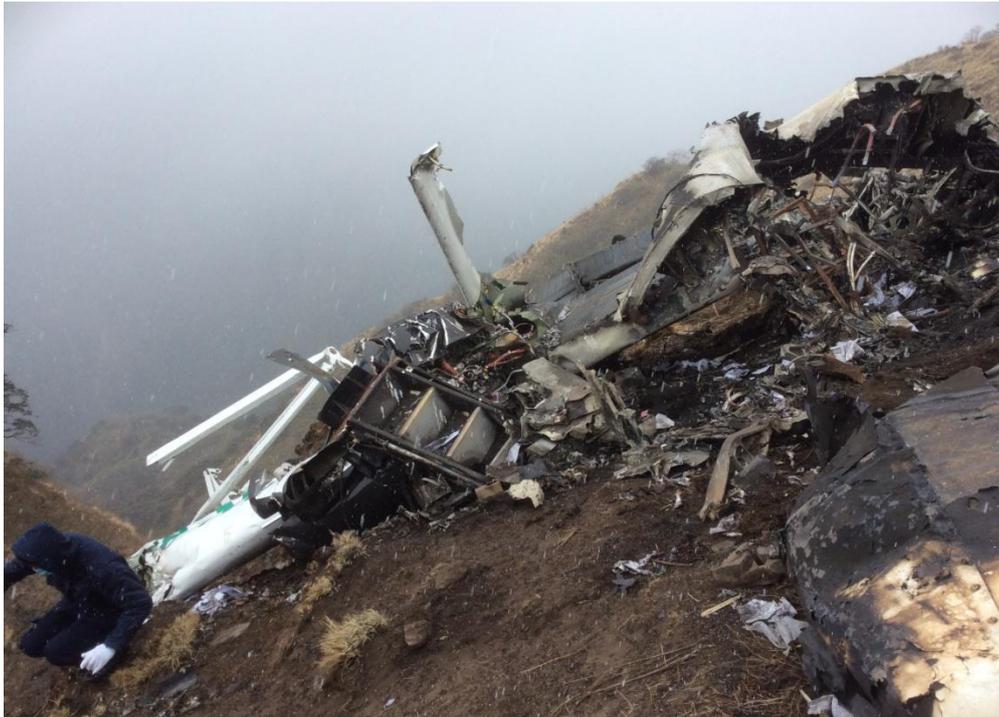
Figure 17: Main wreckage area

As per the FDR data, the aircraft hit the ground at speed of 92 knots CAS. The impact of the collision with the terrain caused the immediate death of all the occupants of the aircraft. The remains of the main fuselage area is depicted below:

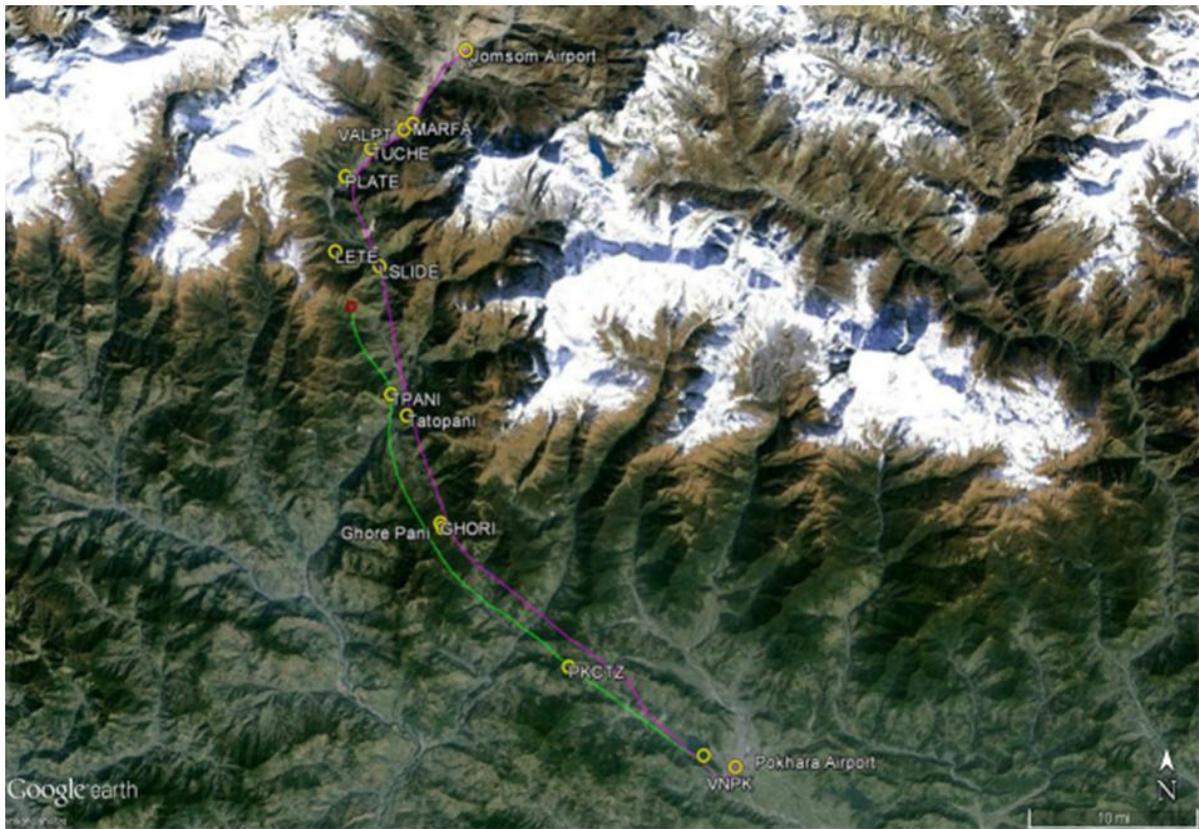
Figure 18: Flight path to Jomsom from Pokhara

Last 3 minute of the FDR data showed that the aircraft frequently changed its pitch and roll attitude in an attempt circumvent cloudy weather. Following picture illurates the actual flight path flown by the aircraft on the day of the accident (Green Coloured line) in

comparison to the flight path of the aircraft the day before (Magenta Colour line). The CVR revealed the fact that the pilot had assumed the track to follow was to the left, which could be due to the wrong interpretation of the Track and Heading function of the EFIS.

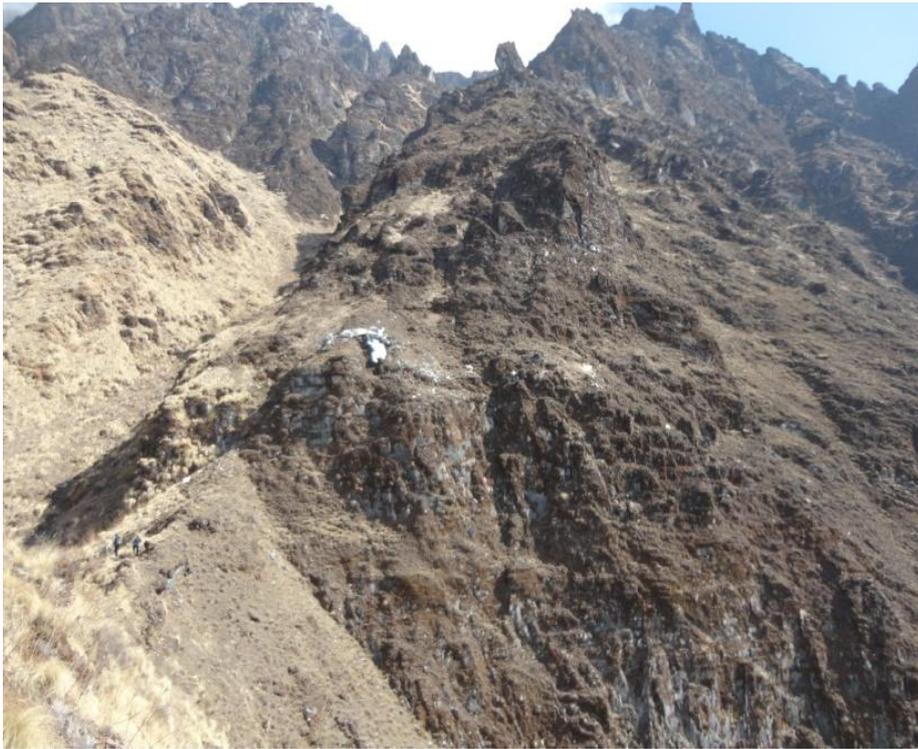
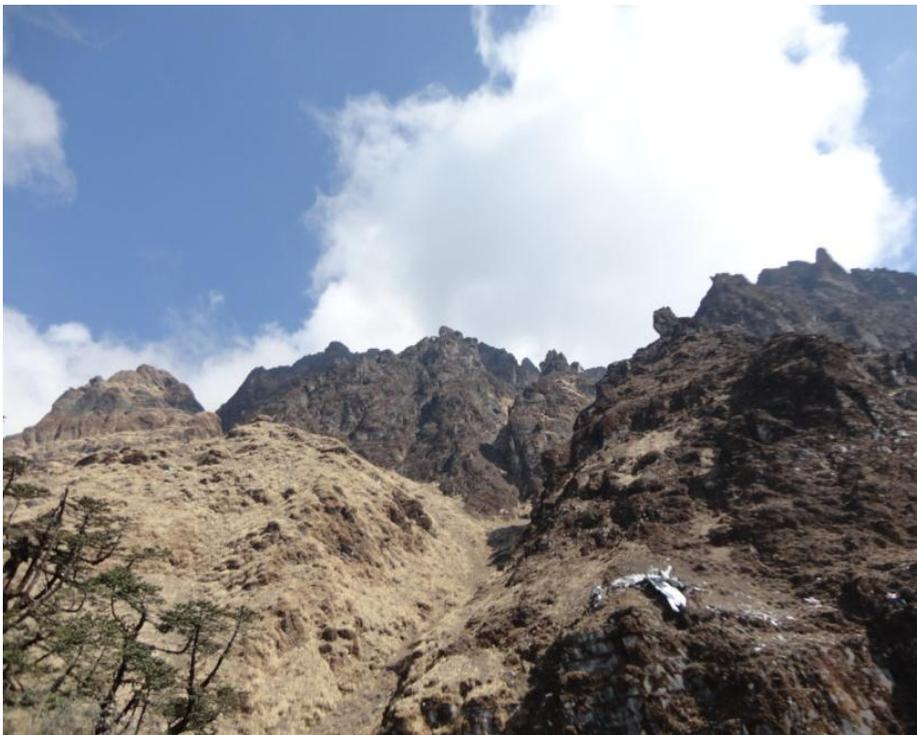
Appendix-A: Damage to the Aircraft

Aircraft was completely destroyed due to the impact and post impact fire (Refer Appendix-A). The aircraft’s main structure like wings and tail portion were severely damaged. Most of the fuselage structure was consumed by the post impact fire.

RH Engine and its accessories were found in burnt condition, RH propeller was detached from the engine and blades were scattered at various locations near the point of first impact as shown in Appendix – B. LH engine and propeller were found unburnt in main wreckage area with twisted blades.

Note: Aircraft was completely damaged and main fuselage caught fire and remaining unburned wreckages were resting finally as shown in the photos.

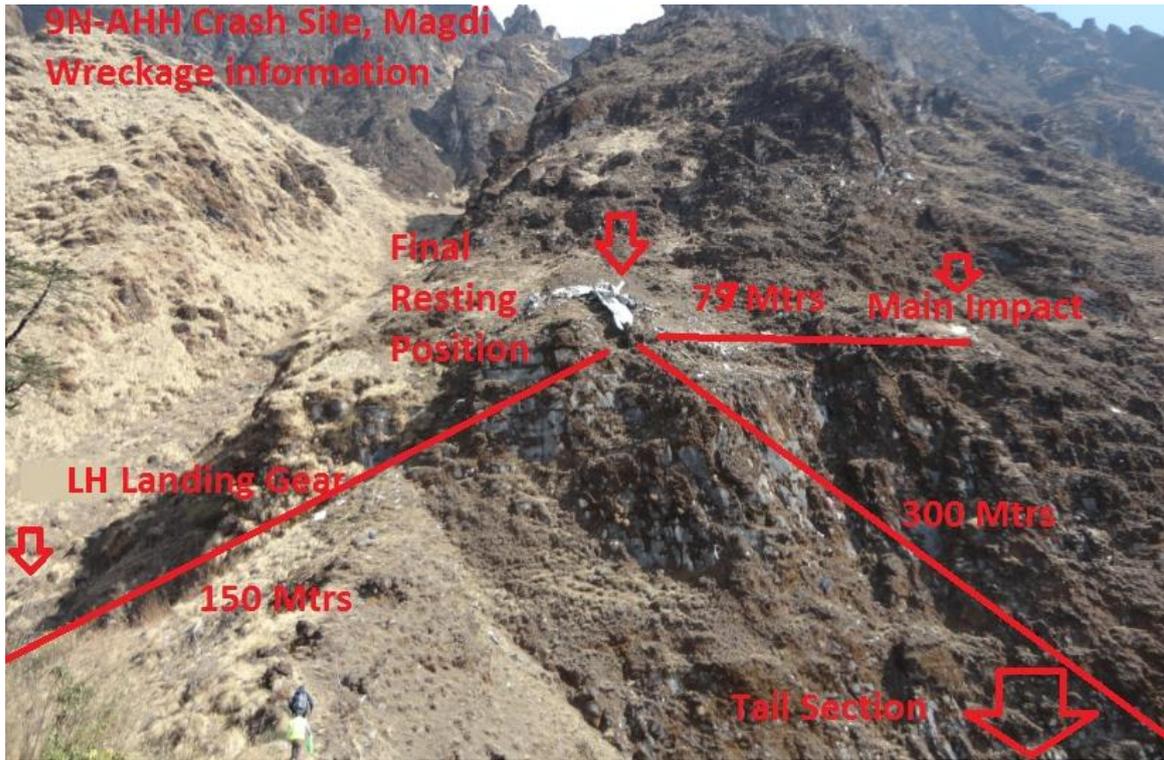
Wreckage Distribution

The fin and tail portion of the aircraft were lying around 300 meters downhill from the first impact point. The main landing gears were detached from the fuselage and left landing gear was found 150 meters ahead downhill from the main wreckage position, right landing gear and nose wheel were located below the first point of impact as shown in Appendix - B. FDR, CVR and ELT were located intact at their installed position along with a section of empennage which was approximately 1000 m downhill from the crash site.

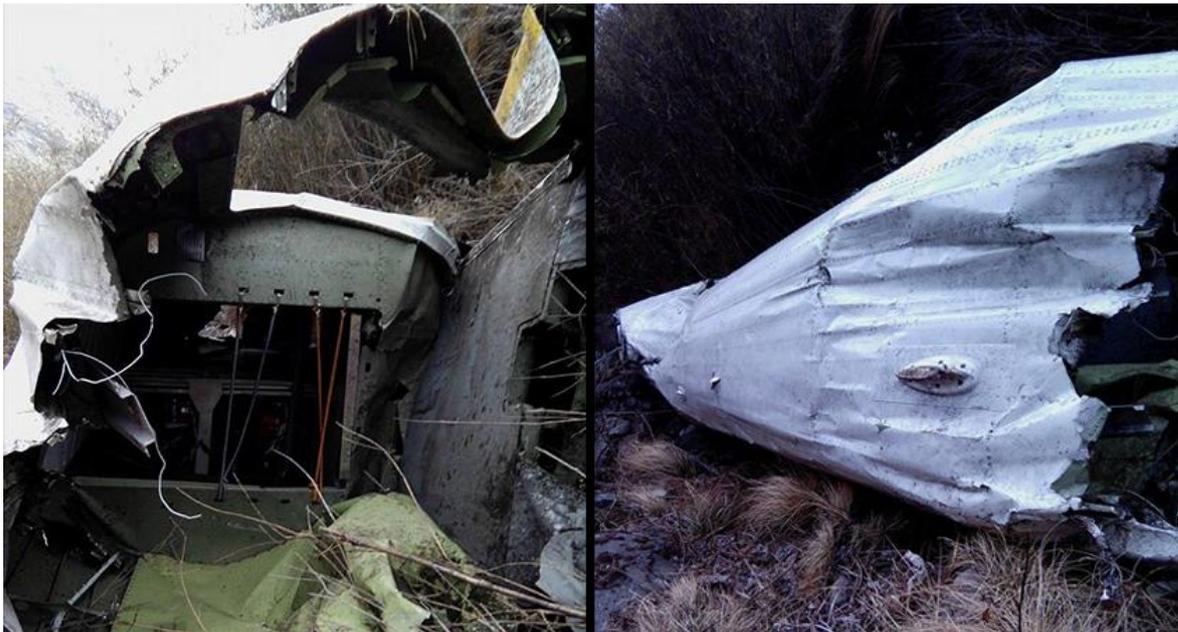
Empennage and CVR/FDR/ELT location

- FDR/CVR/ELT were located along with aft fuselage area around 1000 m away downslope of the main crash area
