**GOVERNMENT OF NEPAL
AIRCRAFT ACCIDENT INVESTIGATION COMMISSION**

FINAL REPORT

**9N-AKY LET 410 AIRCRAFT ACCIDENT
OPERATED BY GOMA AIR PVT LTD**

27 MAY, 2017

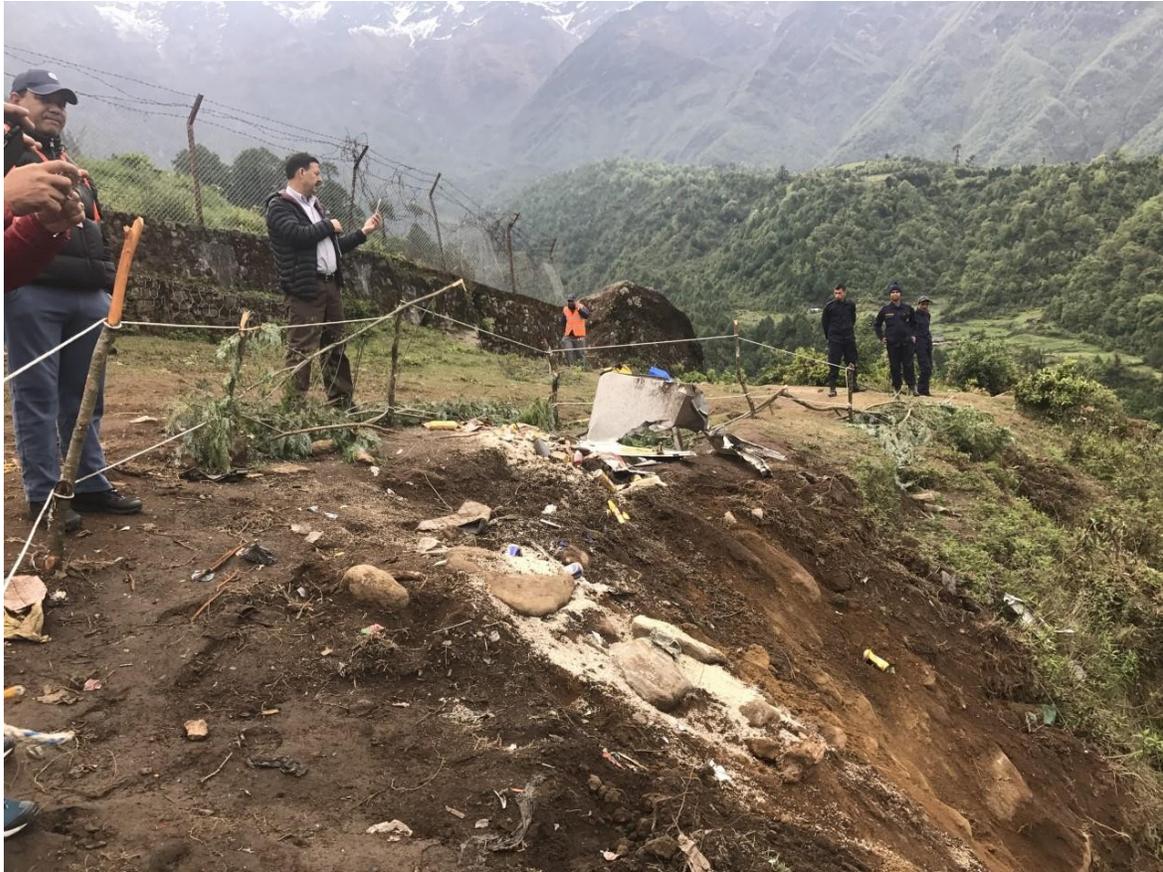
Figure 2 : Point of ultimate impact

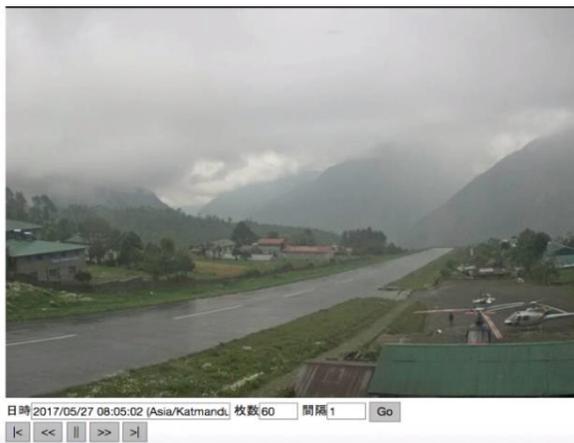
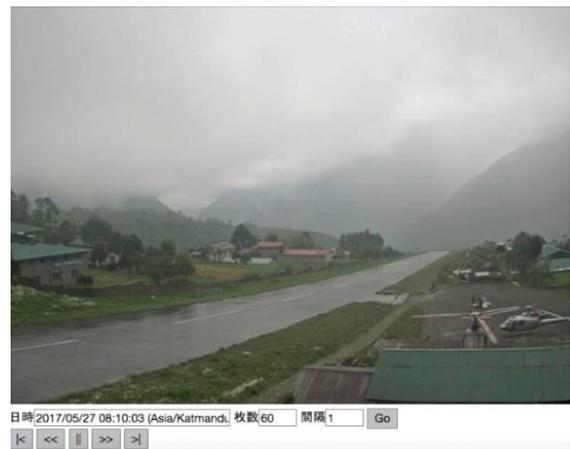
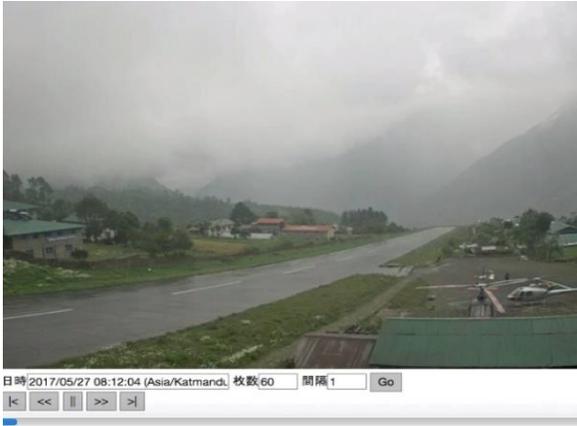
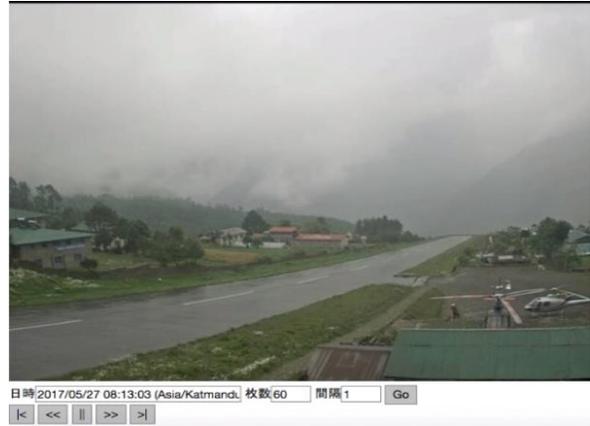
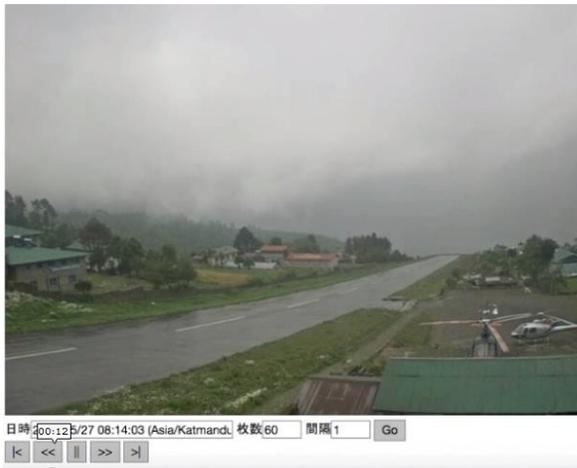
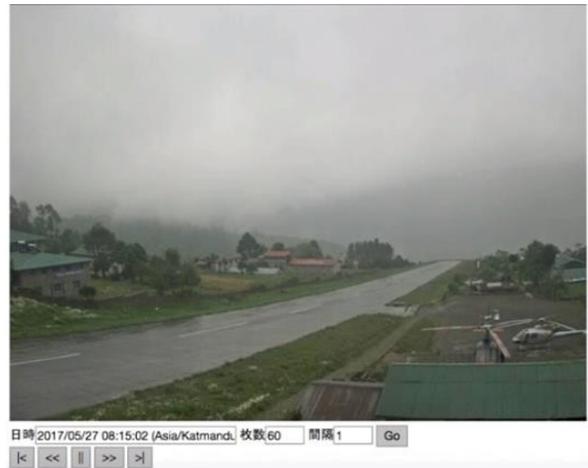
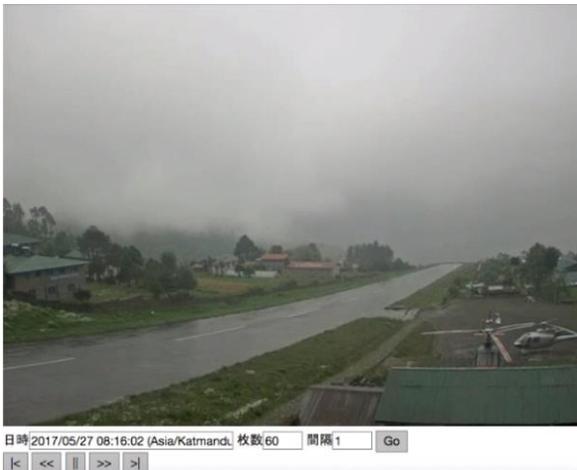
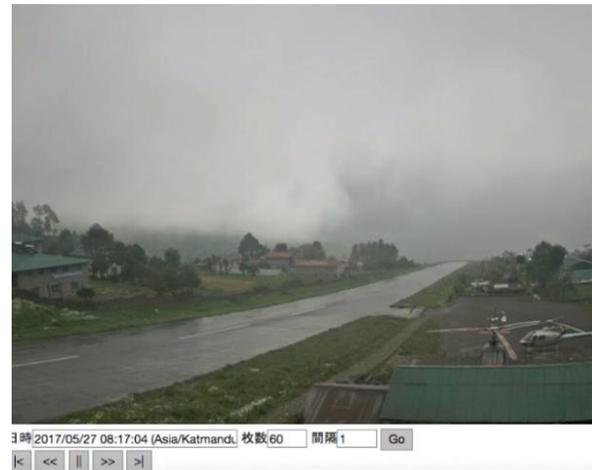
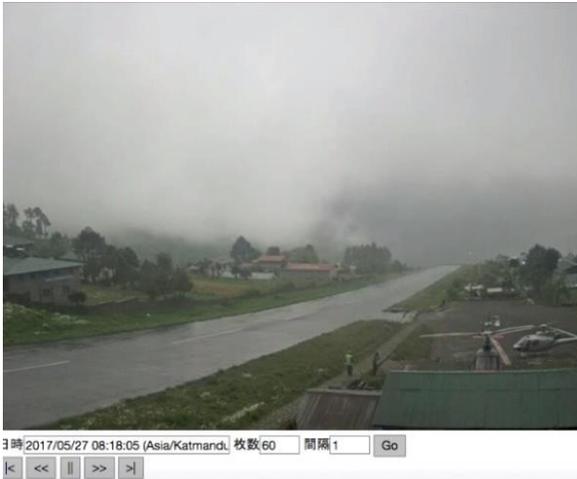
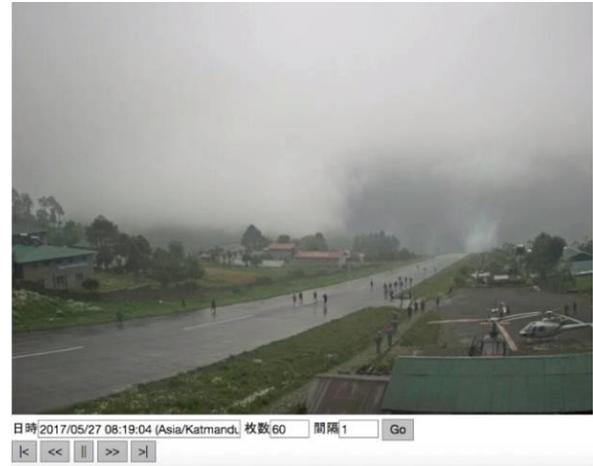
Thus, the moving low cloud in approach path of Runway 06 and vicinity, as evidenced by eye witness accounts, ATC observations, reports supplemented by CCTV real time imageries provided by Weather News International, might have impaired visibility resulting increased workload (being engrossed in the cockpit instruments) and loss of situational awareness. That was the reason PIC (PF) failed to notice the drop of altitude below the threshold height and deviated from the final track leading to the fateful mishap. As such, bad weather during the approach is found to be contributory factor for the occurrence of CFIT.

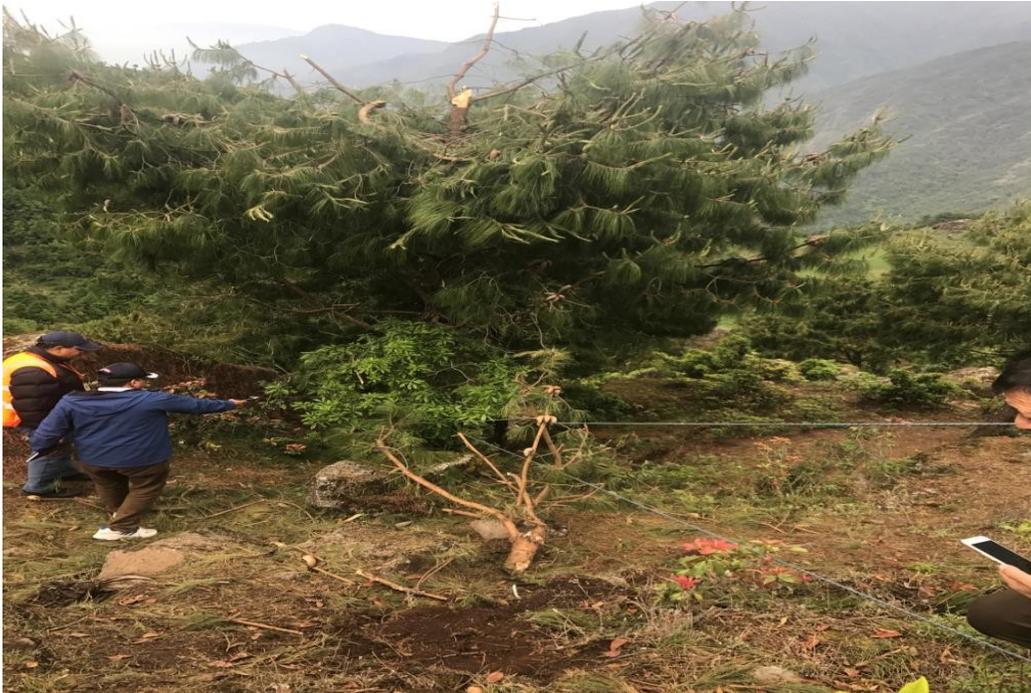
The commission visited crash site on 30 May, 2017 and a preliminary examination of wreckage was carried out onsite. As the aircraft was stalled, the nose up and tail down position of the aircraft hit the sloppy terrain by its fuselage belly (underneath nose section). The ultimate impact was at 8870 feet and then slid down the hill. The airplane was on rest position at 8800ft AMSL with the left wing up and right wing down still attached with the fuselage. Nose portion was on twisted position to the right. There were also few light scratch mark in the flat rock in between the tree and the aircraft rest position. Cabin compartment inside the fuselage was full of cargo and completely smashed. However, latching of bulky cargo was intact. Before the impact the left wing of the aircraft had chopped down a branch of the tree 140 feet short of the threshold. A piece of the tree branch detached from the impact was found about 10 feet apart from the main branch. Length of the detached tree branch was 6 feet and about 6-inch diameter.

Figure 13: Picture of detached tree

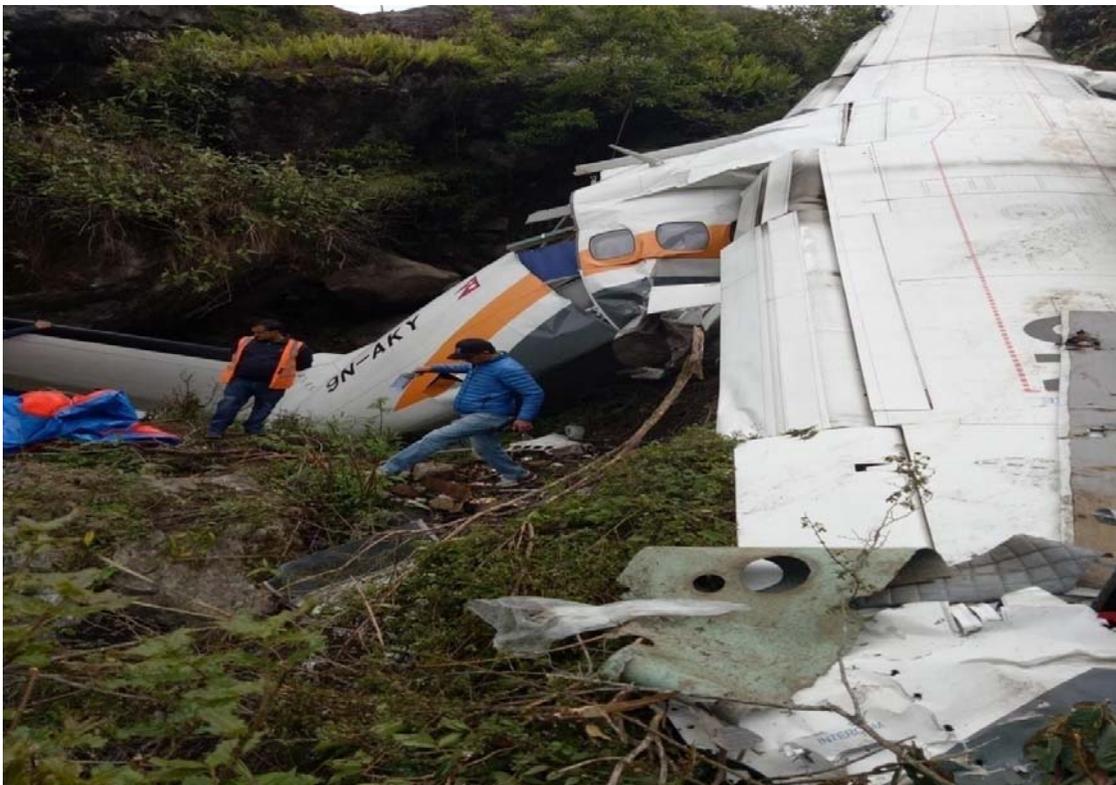
Figure 14: Photo of wreckage

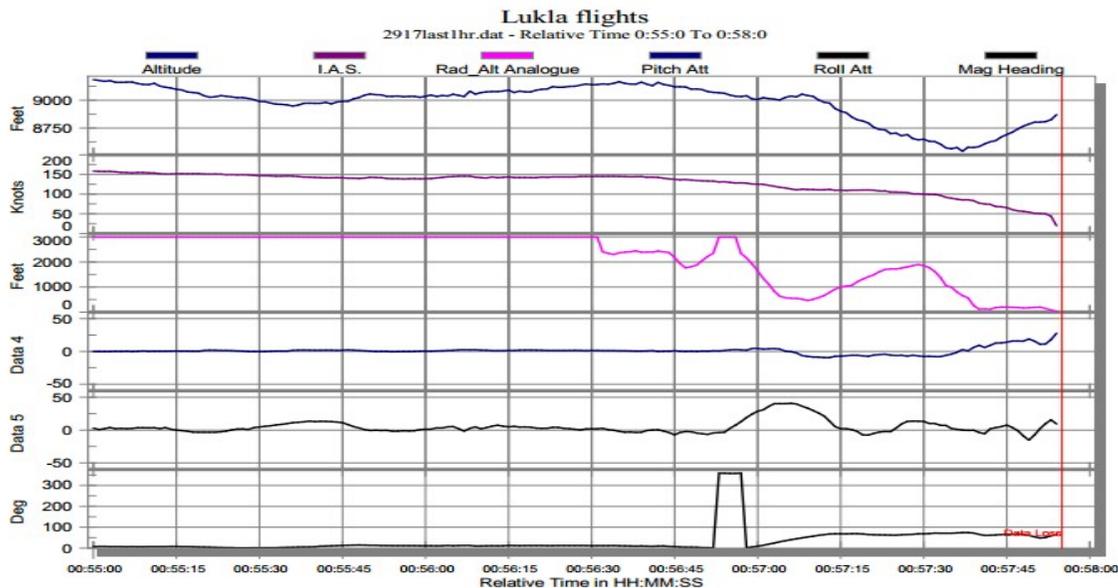
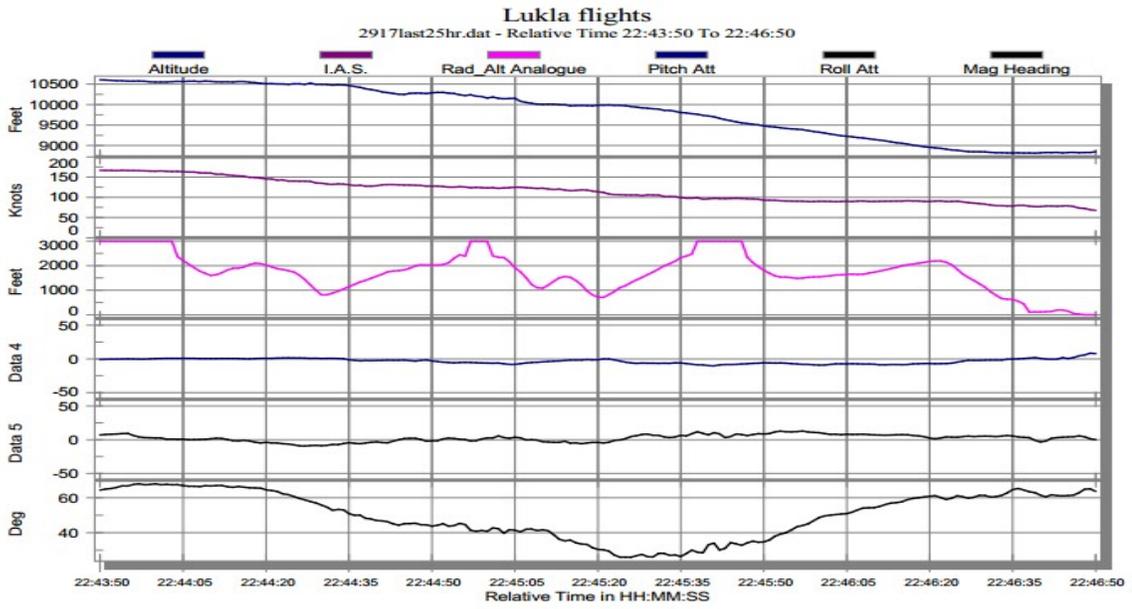
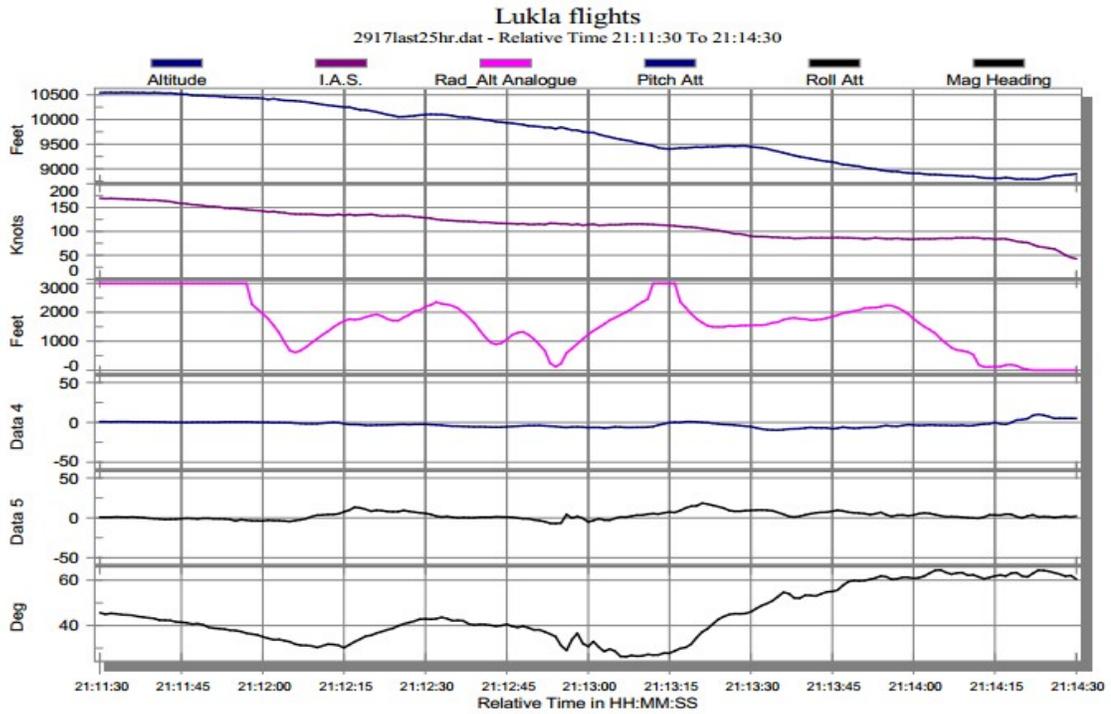
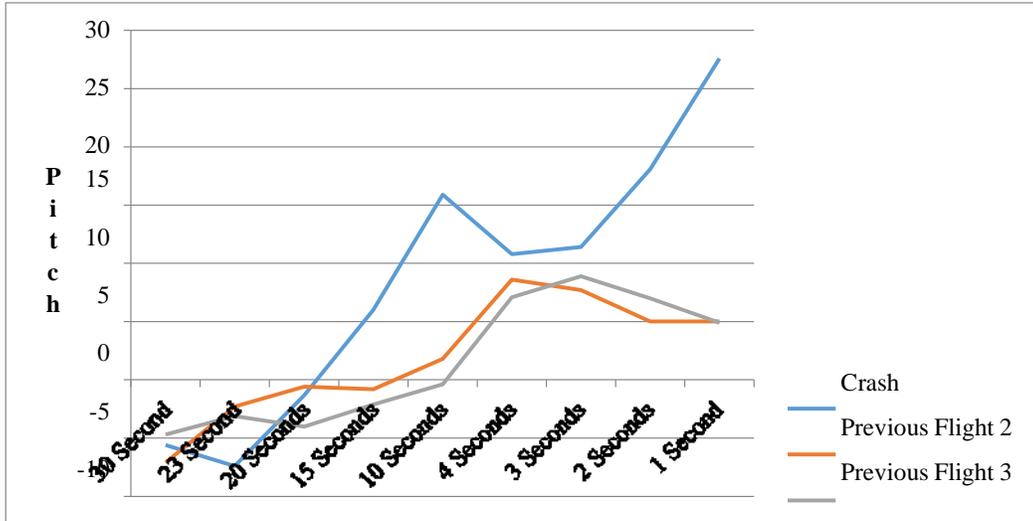
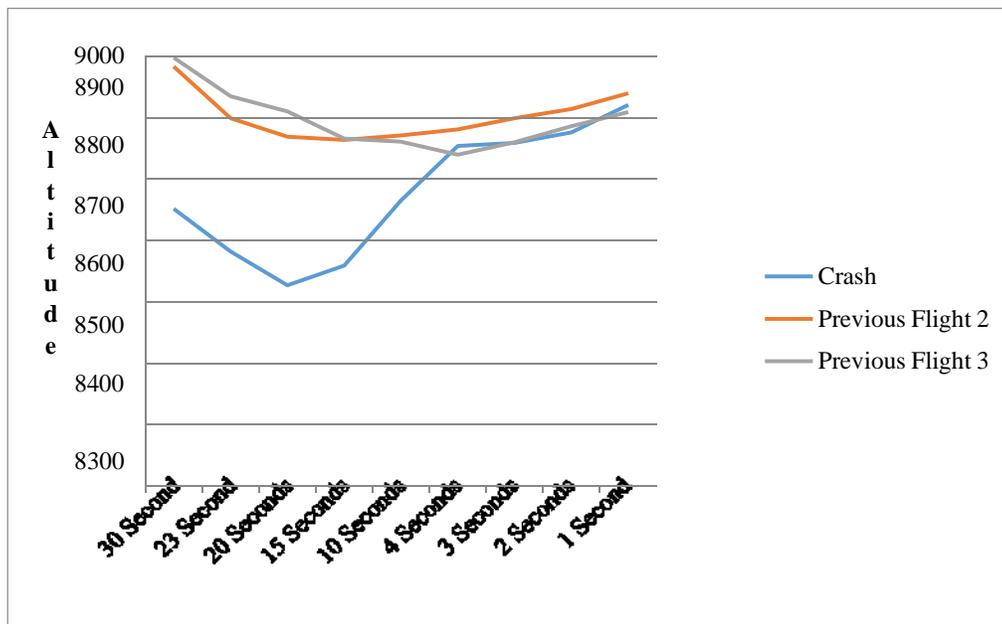
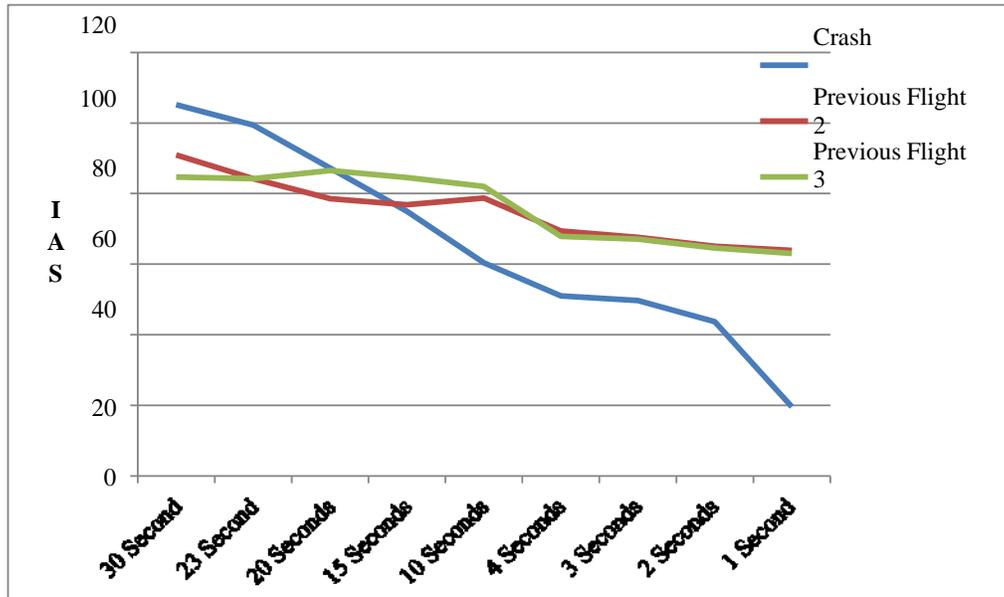
Referring to above charts, the aircraft was flying low during final moments of its flight. On the final minute IAS was significantly low which dropped below 50Kt during final few seconds then further down below 20 kt. Pitch attitude was at maximum during final seconds. Magnetic heading was abruptly changed in the last moment. Following comparative chart will further elaborate the final parameters of crashed flight and other two flights previous to the occurrence.

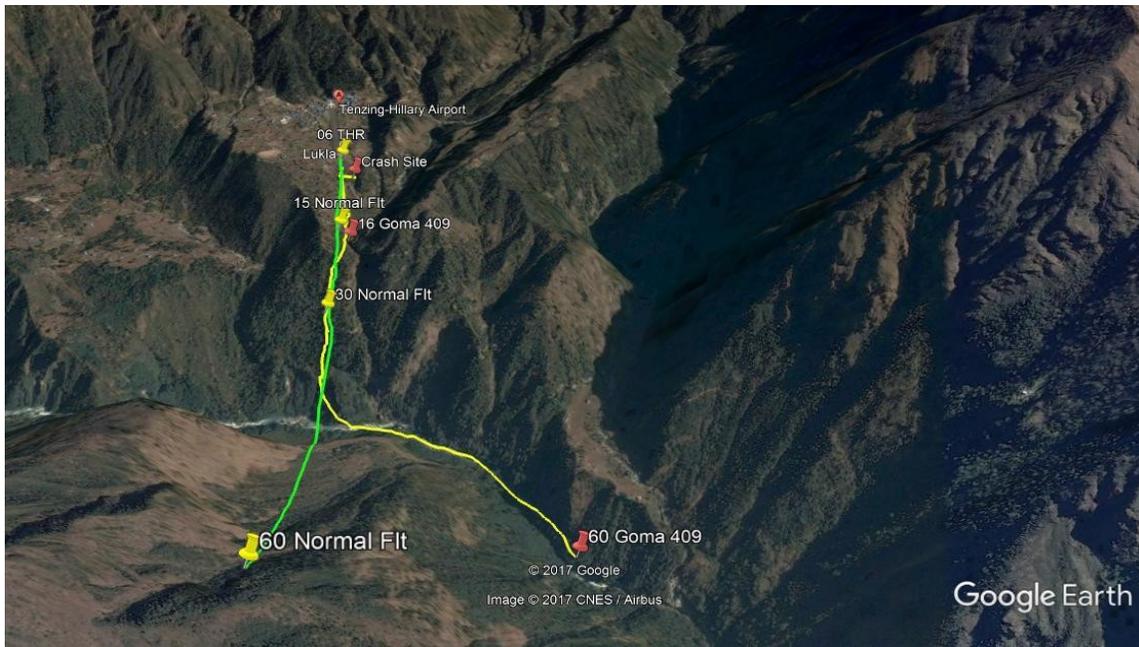
Figure 22: The track on the right-hand side was followed by ill-fated GOMA AIR aircraft 9N-AKY (commencing 60 seconds before impact). The track on the left-hand side is a hypothetical aircraft commencing normal approach to Lukla Airport.

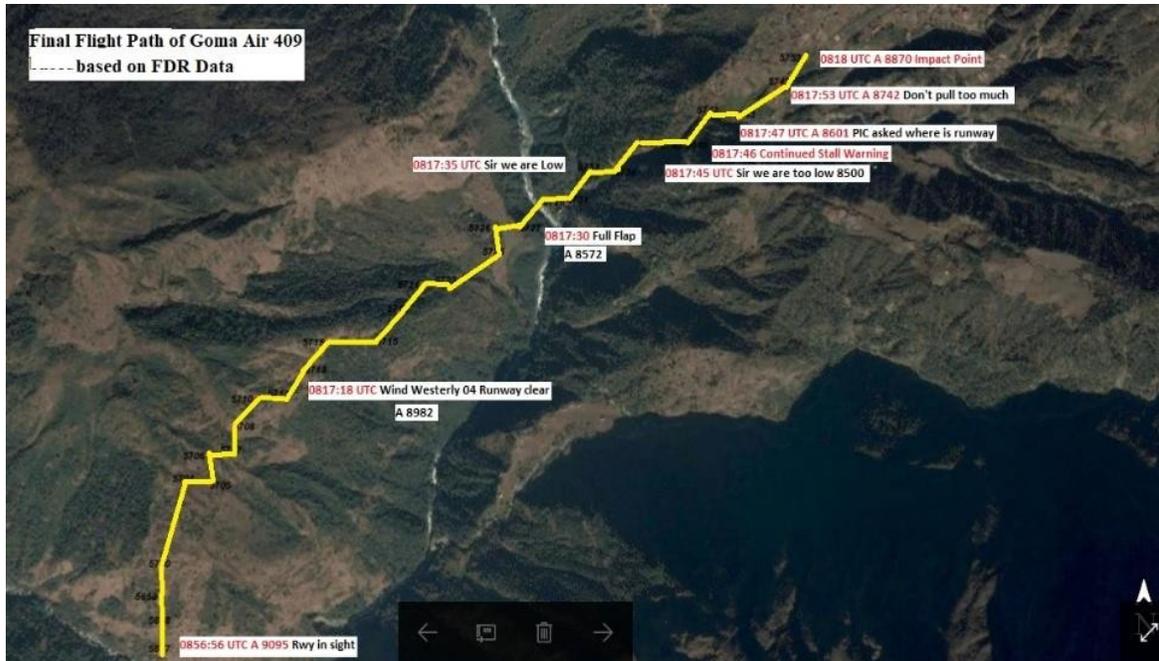
The most desirable action in this situation would be to apply max power to counter the stall. But in spite of the continuous stall warning sound, the pilots did not apply the required torque as PIC was not sure where the runway was. Engine torque which was 13 % (20 seconds before impact) reached up to 93 % when the aircraft stalled, however IAS continuously dropped below 20 kts. That was probably because, in their attempt to climb immediately, the angle of attack of the aircraft exceeded the critical point. Carrying out a standard go - around from that point was not possible due terrain.

Figure 23: Final flight path of Goma Air 409 along with time stamp of critical CVR records synchronized.
