AAIR-076/1
19 Jan, 2020

FINAL REPORT

Summit Air Flight SMA 802D, 9N-AMH
Aircraft Industries, LET-410
Lukla, Nepal
14 April 2019

Aircraft Accident Investigation Commission, 2019

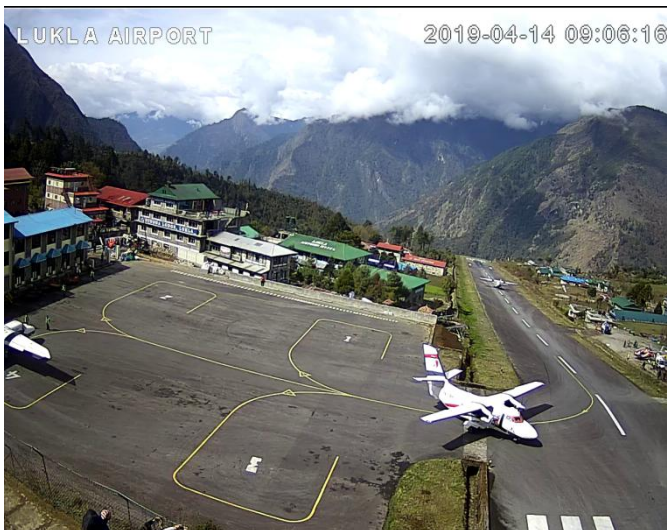
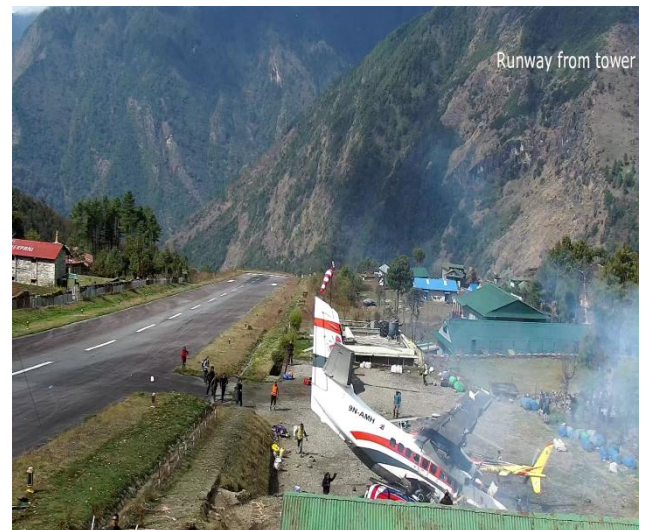
Figure 6 Weather at the time of accident

The weather at the time of accident was fair.

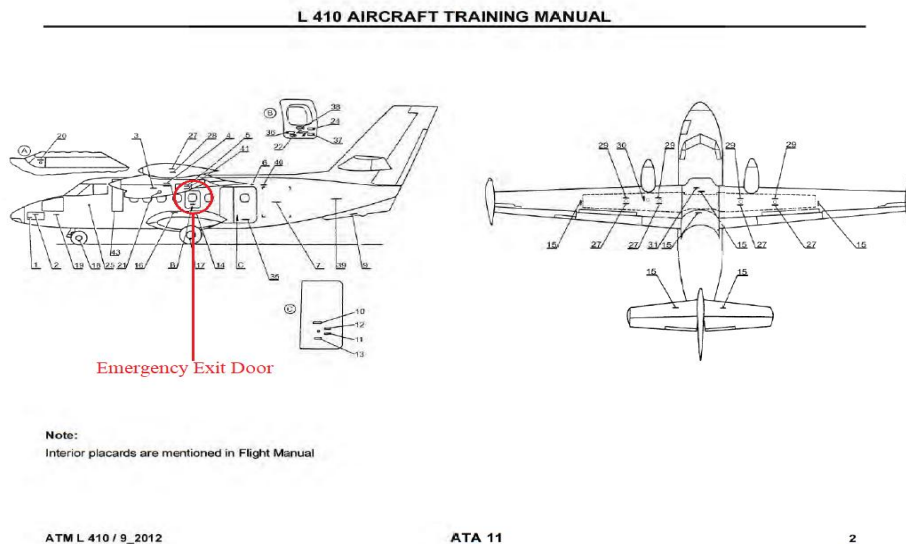
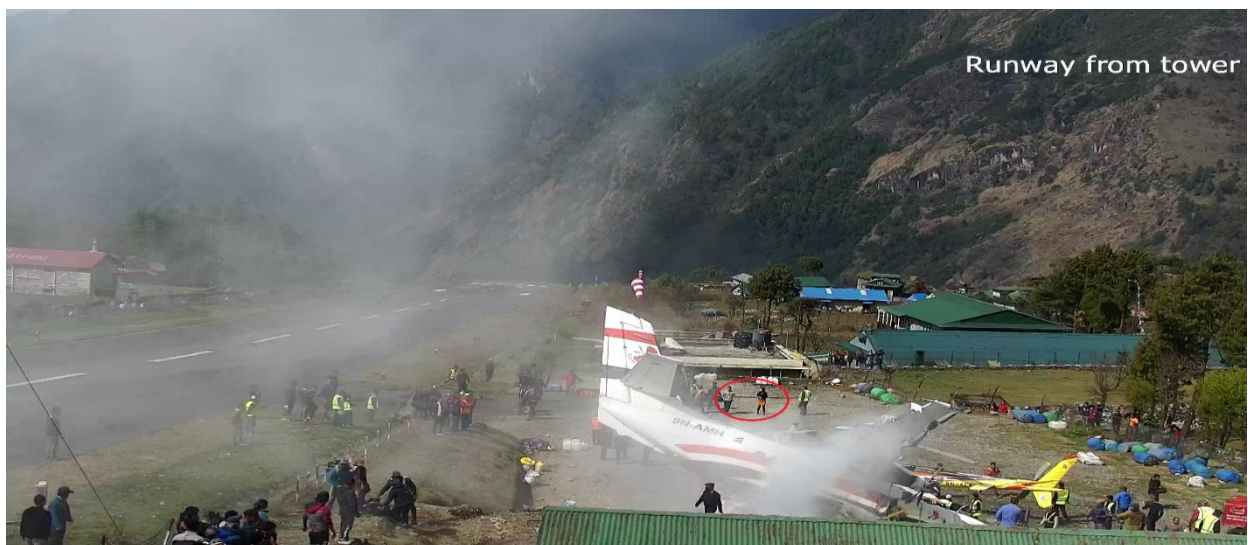
Figure 8 Cabin crew of 9N-AMH after evacuation

As per the pilot, the moving rotor blades of helicopter 9N-ALC cut through the cockpit and slashed the co-pilot. In a post-accident interview, the pilot stated that after a few seconds of impact, he recollected himself and evacuated the aircraft and proceeded to rescue the cabin crew through the emergency exit door located above the left side main wheel assembly. Both the captain and the cabin crew sustained no significant injury. However both were sent for the medical observation.

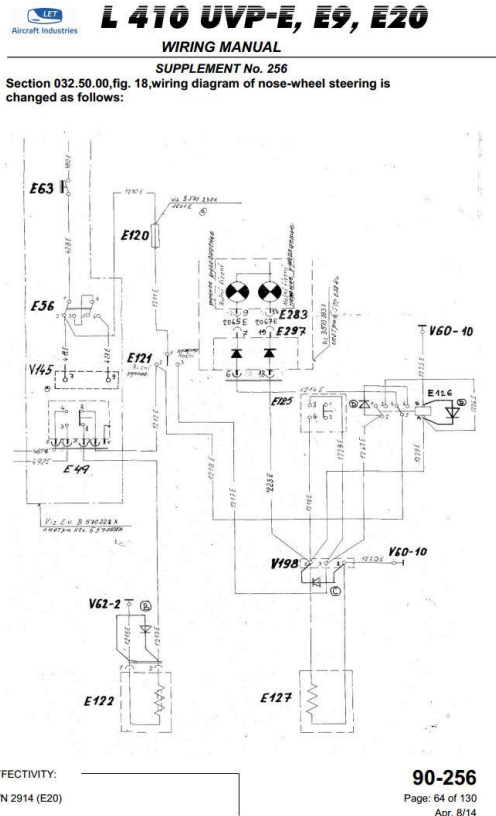
The Steering Wiring Diagram explains the possibilities of CB pop out function and probable causes. Wiring Diagram for Wheel Steering for A/C S/N 2914 is depicted below.

Nose (Manual & Pedal) wheel steering circuit is powered by 28VDC from DC distribution system through Landing Gear CB, Gear Selector (Gear Down position), Nose Wheel Steering CB (CB panel) and Manual / Pedal steering selector (central control panel). Nose Wheel Steering CB performs Nose Wheel steering short circuit protection. If this CB was popped out, there could be short circuit either in Manual or Pedal part of this circuit. Based on it, it is

very hard to determine probable causes, because every component (Weight on Wheels - WOW switch, clutch, valve, relay, protection diodes) of this circuit represents potential short circuit risk. Hence, the commission narrowed down the likelihood of CB pop out is due to short circuit in the WOW micro switch circuit (common component for Manual & Pedal Part of Nose Wheel Steering circuit) as a result of nose oleo collapse after impact.

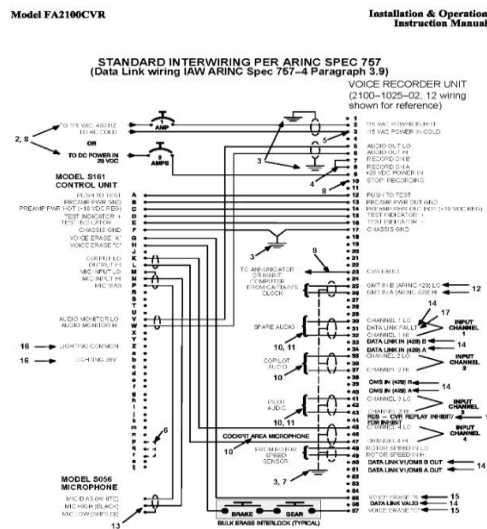
Figure A-5. Interwiring Diagram, Voice Recorder Unit, S161 Control Unit, S056 Remote Microphone

This aircraft was produced without interconnection between CVR control unit (S161 – pin H) and CVR unit (FA2100 – pin 57) as is shown in CVR producer’s Inter wiring Diagram. The ERASE function is deactivated in the aircraft, so, the CVR could not be erased intentionally.

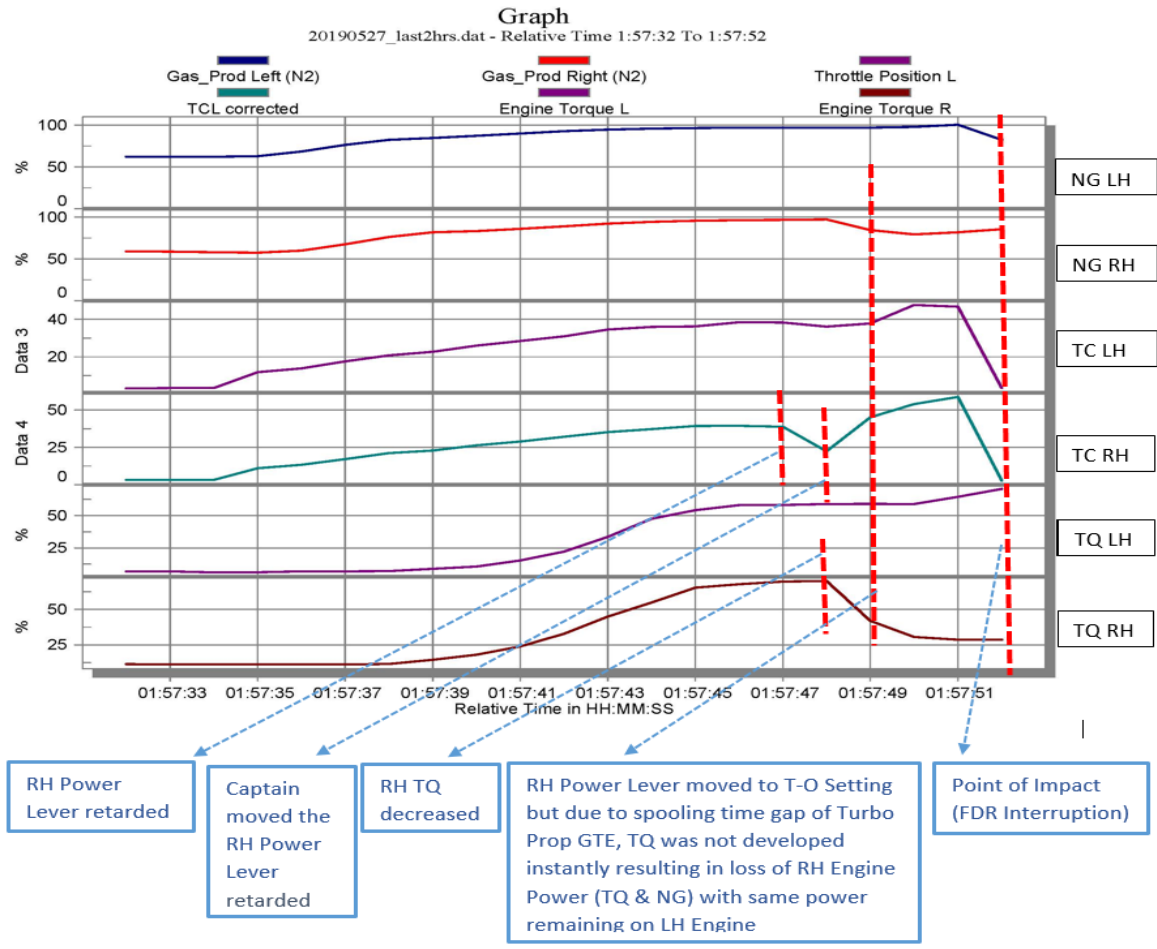
Based on the nature of crash and to support probable cause of accident, Among the 107 parameters that were recorded in the FDR only the following FDR parameters were analyzed critically:

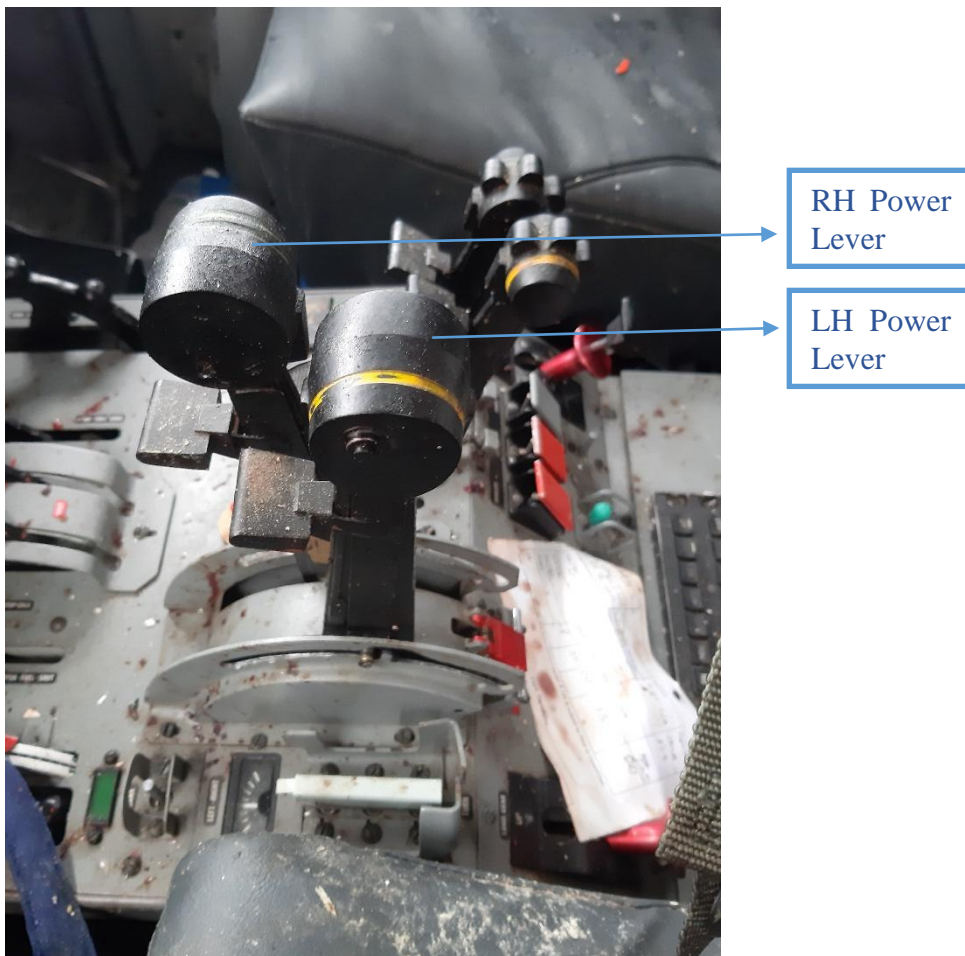
Aircraft hit Manang Air's helicopter 9N-ALC, 13 meter away from fence at upper helipad with engine running on idle power at the time of impact. Helicopter was toppled to the lower helipad 6 ft below. 9N-ALC's helicopter pilot was severely injured as he was trapped underneath and later rescued. The running rotor blades of 9N-ALC helicopter chopped right forward section of 9N-AMH aircraft and hit co-pilot's head, he died instantly at the time of accident. The LH wing of the aircraft broke the skid of helicopter 9N-ALK and came to a stop with toppled 9N-ALC beneath its RH main wheel assembly. Due to impact, 9N-ALK shifted about 8 ft laterally and suffered minor damages (few dents on the fuselage due to scattering of metal pieces during collision impact).

According to PIC, his decision to advance power and to apply uneven braking in the attempts for correction at slow speed was inappropriate. PIC should have aborted the takeoff using reverse thrust and foot brakes
