*Final Report on the accident of ATR72/212A version 500 (Registration:9N-ANC) that occurred on
January 15, 2023 near Pokhara International Airport*

FINAL REPORT

**9N-ANC (ATR 72-212A, MSN : 754) AIRCRAFT OPERATED BY YETI AIRLINES PVT.
LTD OCCURRED AT
POKHARA (AT THE BANK OF SETI RIVER - GHARIPATAN), KASKI DISTRICT, NEPAL ON
15 JANUARY 2023**

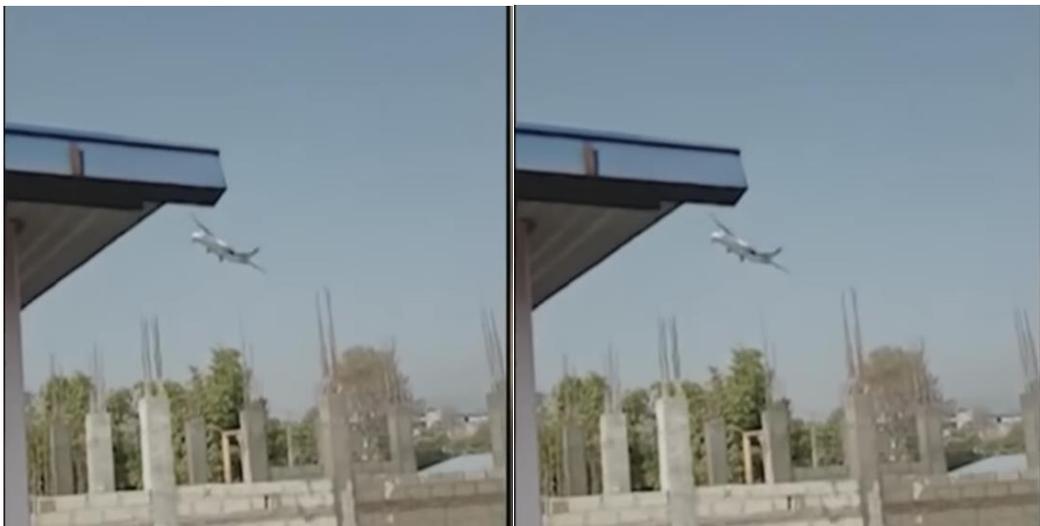
It is noted that at 10:57:18, in the very last stage of flight, the PF handed over control of the aircraft to the PM. At 10:57:20, the PM (who was previously the PF) repeated again that there was no power from the engines. At 10:57:24 when the aircraft was at 311 feet AGL, the stick shaker⁵ was activated warning the crew that the aircraft Angle of Attack (AoA) increased up to the stick shaker threshold.

At 10:57:26, a second sequence of stick shaker warning was activated when the aircraft banked towards the left abruptly. Three seconds later, the radio altitude alert for two hundred feet was annunciated, and the cricket sound and stick shaker ceased. At 10:57:32, sound of impact was heard in the CVR. The FDR and CVR stopped recording at 10:57:33 and 10:57:35 respectively.

Figure 1 Photo captured during last moment of flight

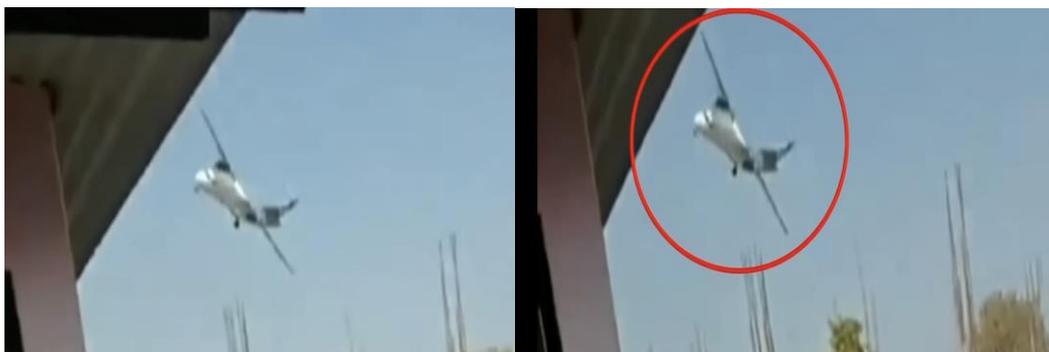
Figure 2 Zoom-in picture of the last moment of the flight

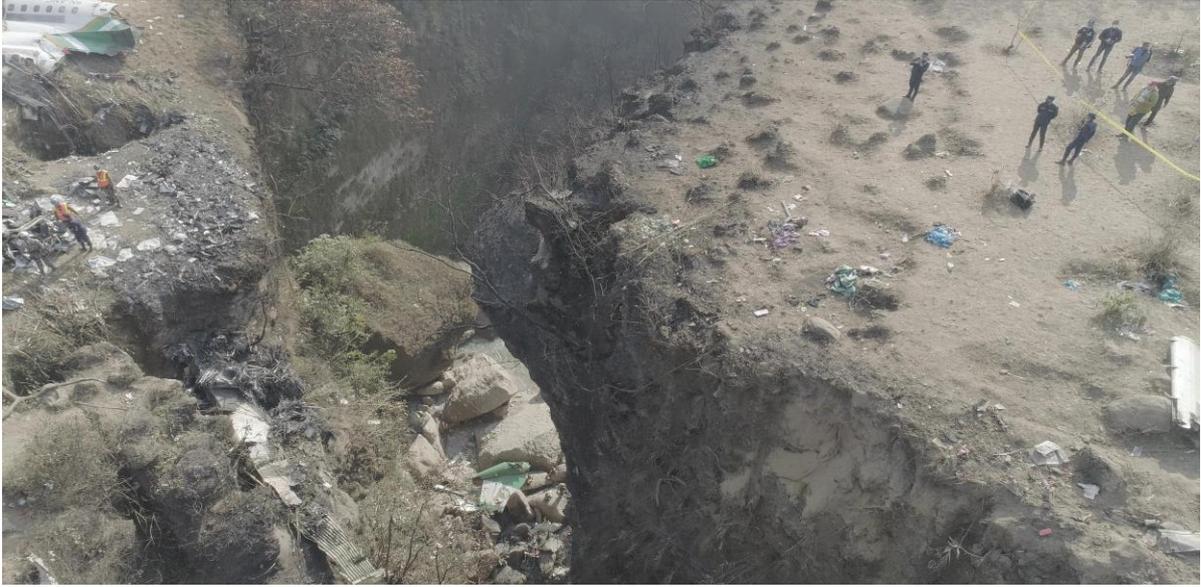
The aircraft was completely destroyed due to the impact and post impact fire. Most of the fuselage structure, engines and its components were consumed by the fire. The propeller blades were found damaged, detached from the engine at various locations near the point of first impact. The wreckage was located at a gorge on the bank of the Seti Gandaki River and around the bank.

Figure 5 Aerial view of the crash site area

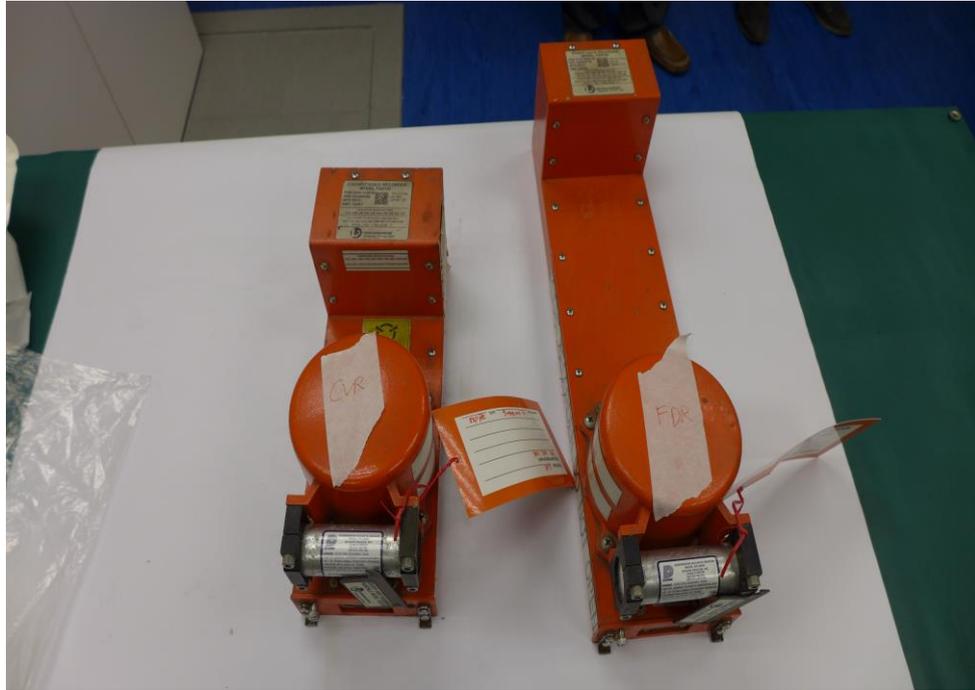
Figure 8 Status of recorders before read-out

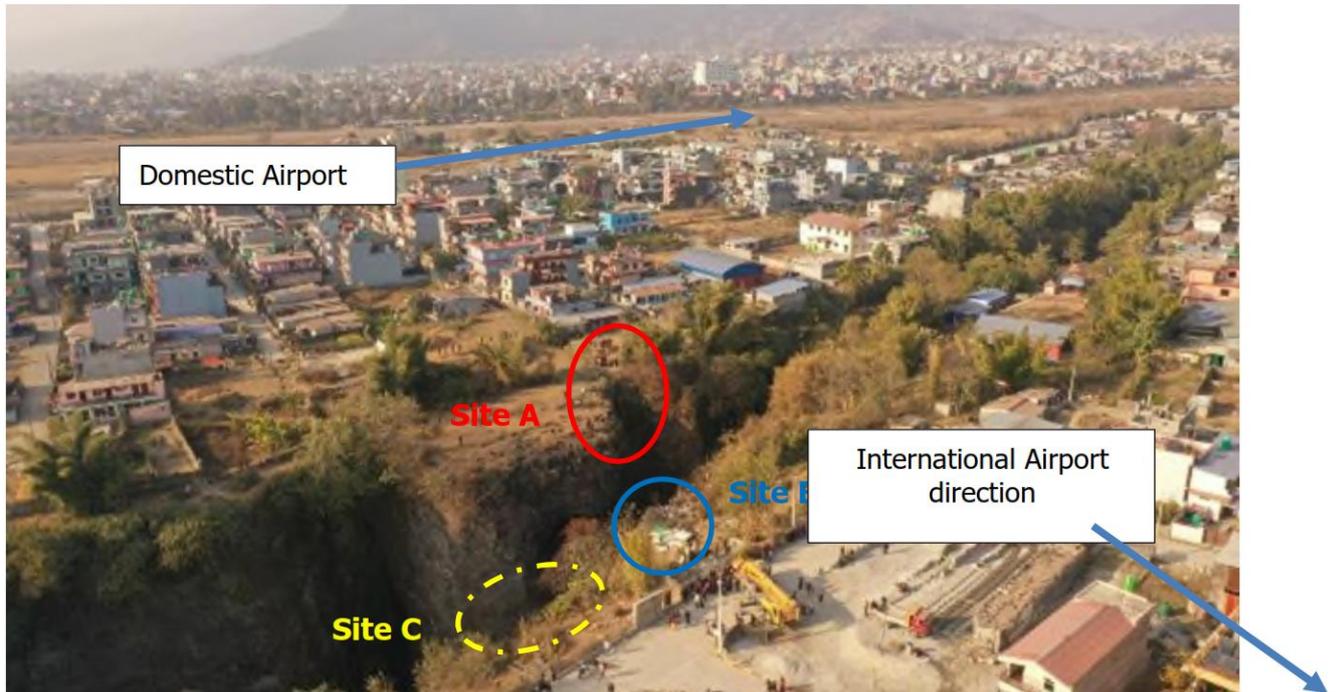
Figure 10 Aerial view of Sites A, B and C

The aircraft initially impacted the ground with the left-wing tip box resulting in disintegration of LH outer wing box, LH aileron tip and PAX door at site A before it toppled over the gorge. The right wing and right engine section lodged into the adjacent wall at Site B whereas the cockpit, rear fuselage section, the overall tail section, the left engine and some of the rear fuselage dropped down the gorge to site C. Some major parts were transferred from the gorge to site B using a crane during Search and Rescue before the on-site investigation.

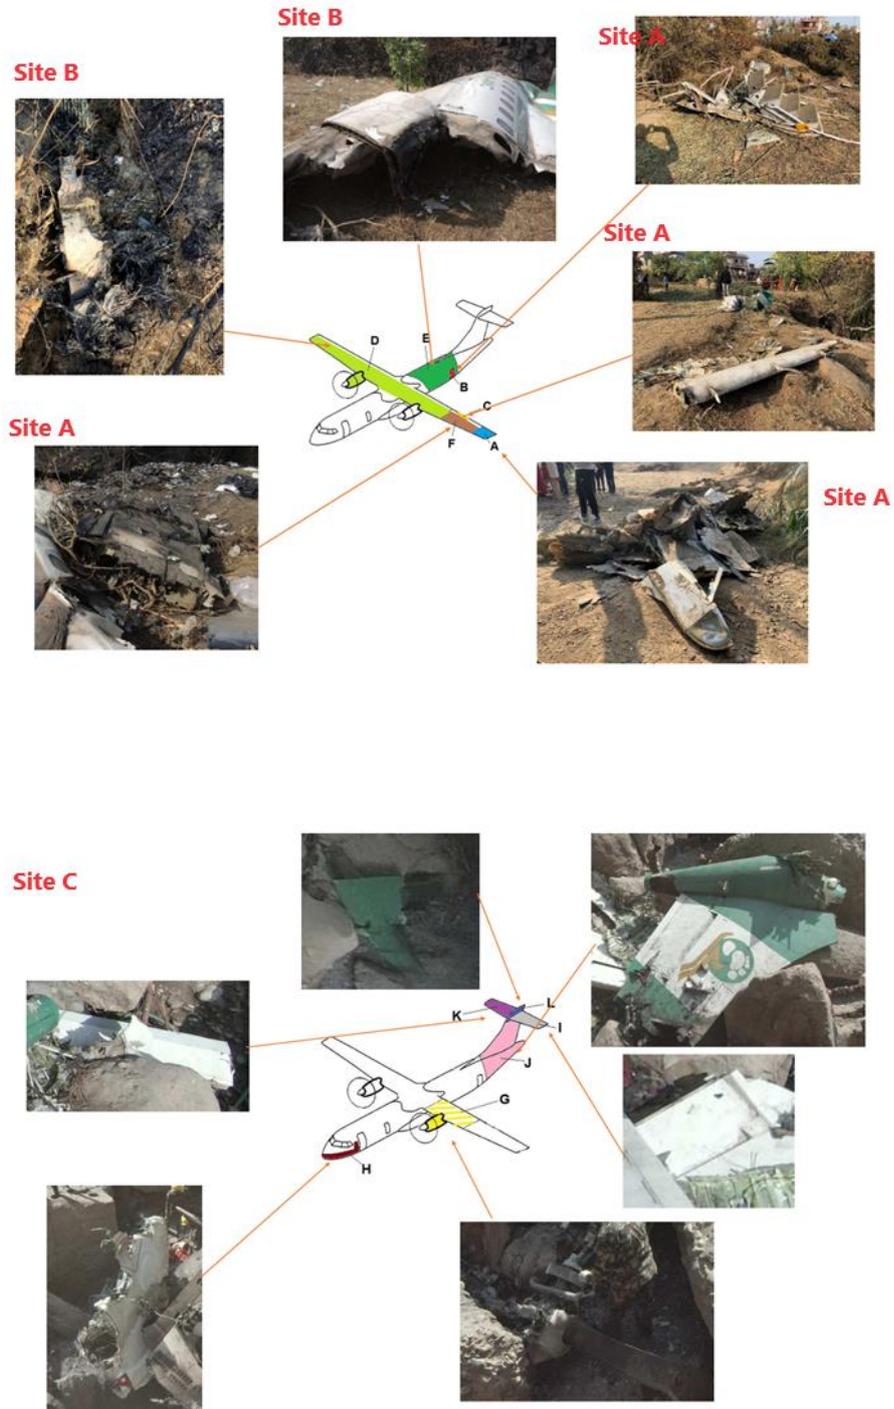
Figure 11 overview of wreckage distribution

The Aircraft structure was completely destroyed and scattered throughout the sites A, B, C and also along the riverbed of the Seti river gorge.

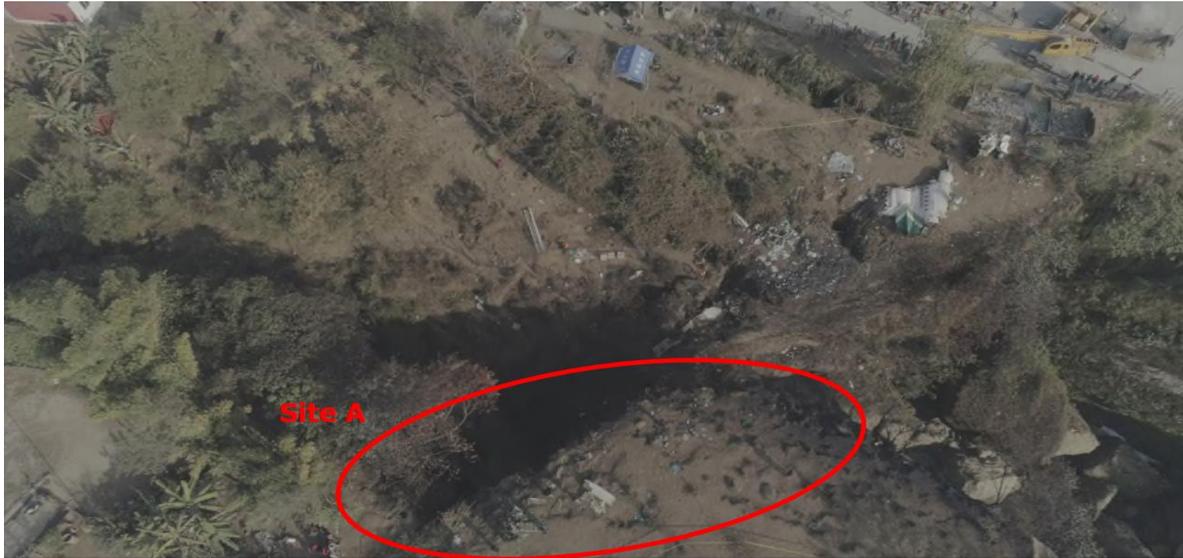
Figure 12 Aerial view of Site A

Site A: identified aircraft impact points plus aircraft parts such as PAX door and LH outboard flap, miscellaneous belly fairing panels and cabin partition, LH outer wing box, panel segment, leading edge, LH aileron tip and portion of aileron box.

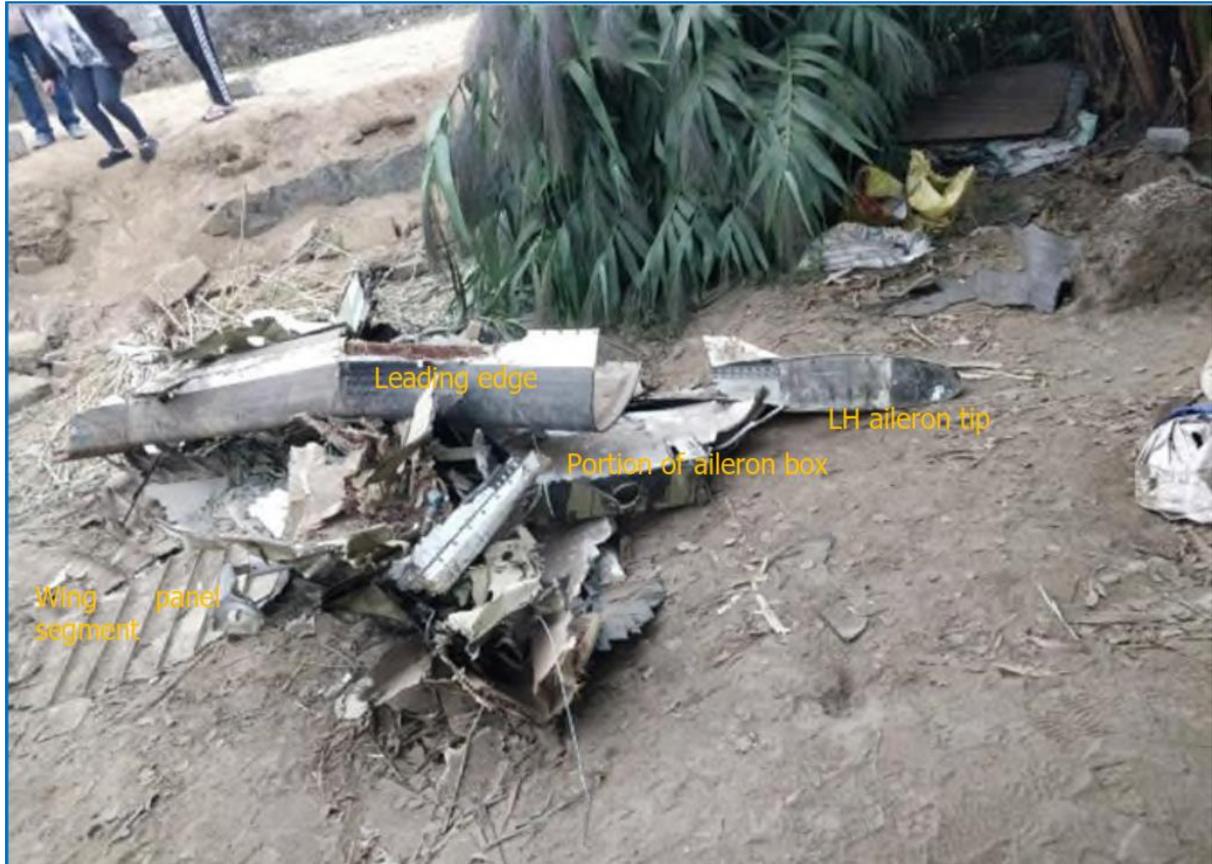
Figure 14 SITE A- Close up of the blue box on the picture above

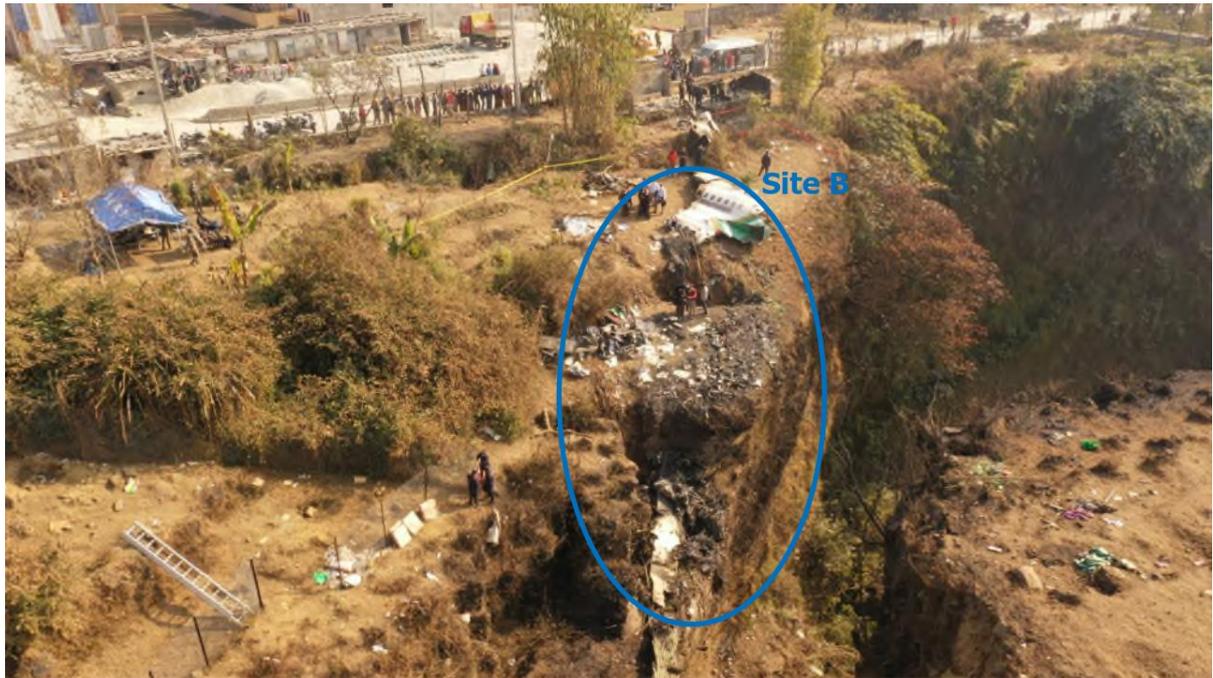
Site B – identified rear section, RH MLG area, portion of wing (RH side plus LH/center upper area) and RH outer wing box plus miscellaneous cabin/seats items, portion of wing/nacelle/engine (RH side plus LH/center upper area), plus fragment from LH MLG shock absorber.

Figure 15 Aerial view of Site B

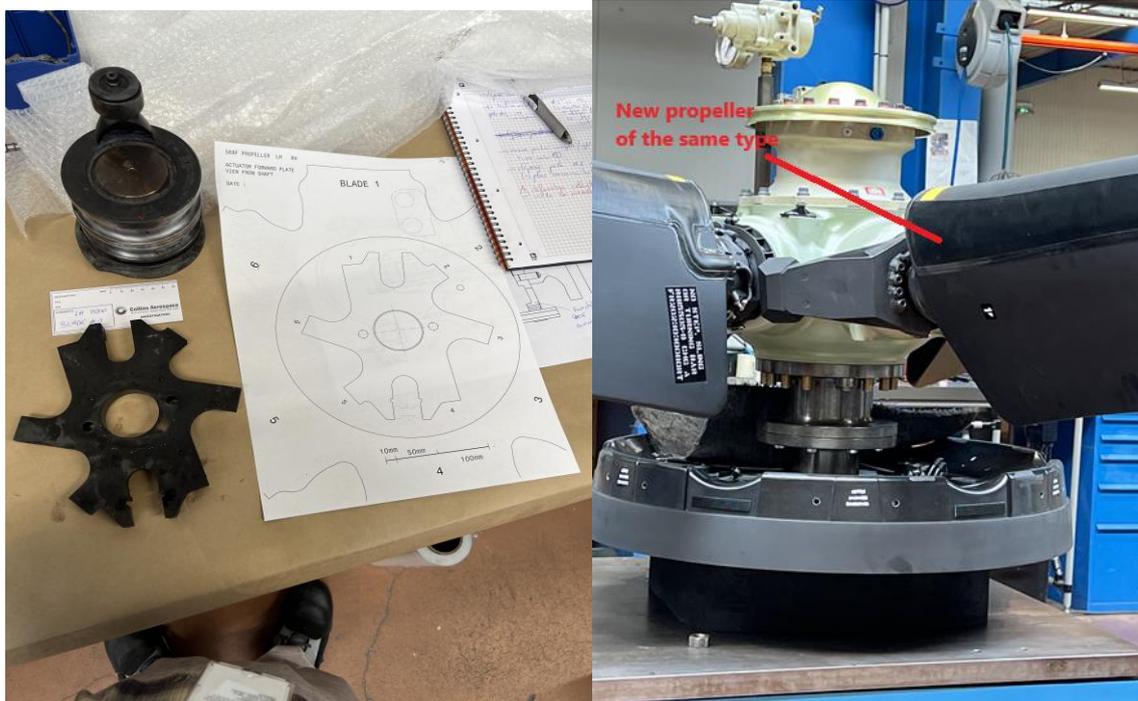
Of the six propeller blades, two of them (4 and 5) were found stuck in a position where the counterweight arm was close to the plane of rotation, therefore in a position close to that of the flag. Damage to the hub to the right of blade 5 due to the counterweight of this blade was also noted. The repositioning of the counterweight in relation to this damage was also noted. The repositioning of the counterweight in relation to this damage corresponded to a blade close to the flag position. The other blades were partially free to rotate around their axis. The pitch change device piston (located in the centre of the hub) was slightly offset from the position corresponding to that of the flag.

Figure 23 Examination applying different tools and methods

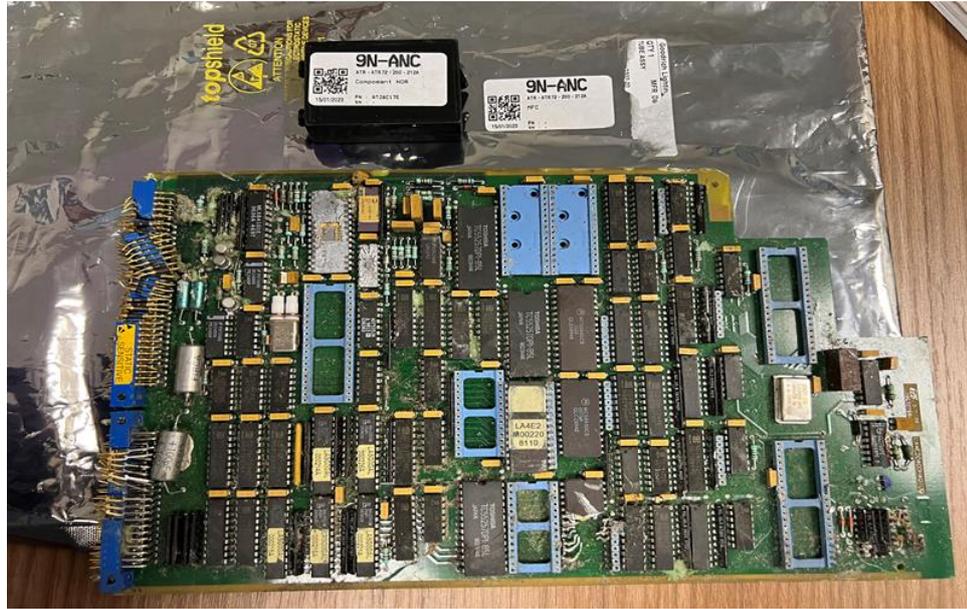
The Super Advanced BITE of the read and decoded MFC 2B non-volatile memory from the retrieved CPU card reveals no automatic feathering command activation by the MFC 2B for the accident flight. Both modules of each MFC were interfaced with one Auto Feathering Unit so with one engine, it can be concluded that no automatic feathering activation was commanded by the MFC on the right engine for the accident flight on January 15th 2023.

Fig. 25 Inner electric circuit and the memory chip

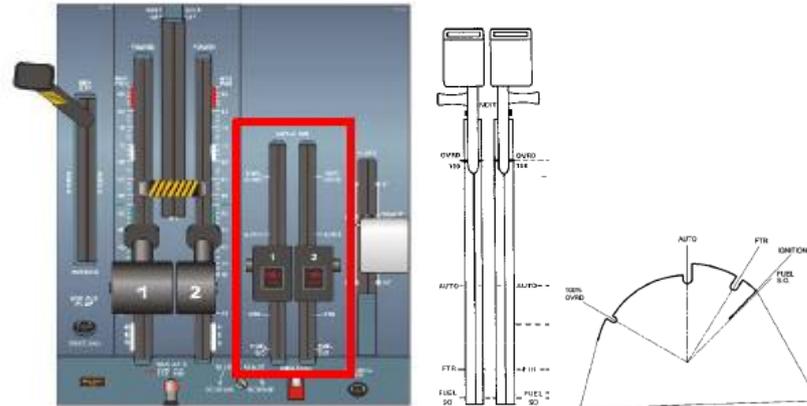
Fig:28 location of condition levers (Source- ATR)

The witness marks from the pedestal indicates that the left condition lever was in the feathered position. Although the right hand condition lever did not have witness marks it is probable that the lever was also in the feathered position based on the FDR data and MFC examination corroboration.
