**ACCIDENT INVESTIGATION REPORT**  
**ON**  
**9N-AJU Cessna Grand Caravan (Charter Flight)**  
**OPERATED BY**  
**MAKALU AIR AT EKLABHUJ KHARKA, SOUTH OF SIMIKOT AIRPORT**  
**DISTRICT, NEPAL**  
**ON 16<sup>th</sup> MAY 2018**

**SUBMITTED BY**  
**AIRCRAFT ACCIDENT INVESTIGATION COMMISSION**  
**TO**  
**THE GOVERNMENT OF NEPAL**  
**MINISTRY OF CULTURE, TOURISM AND CIVIL AVIATION**

*December, 2019 (Poush, 2076 B.S.)*

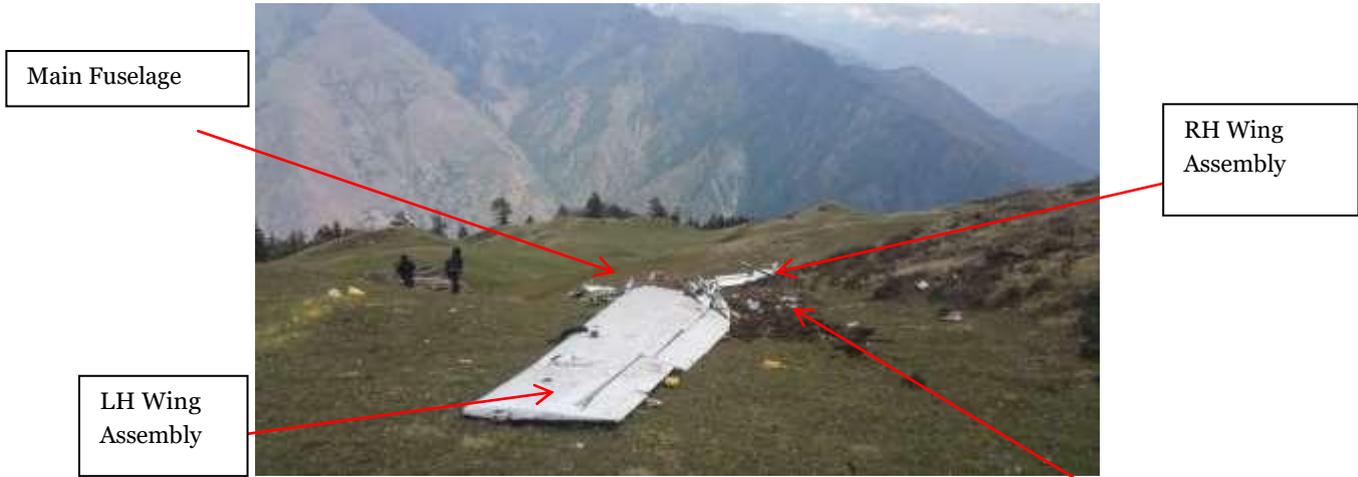
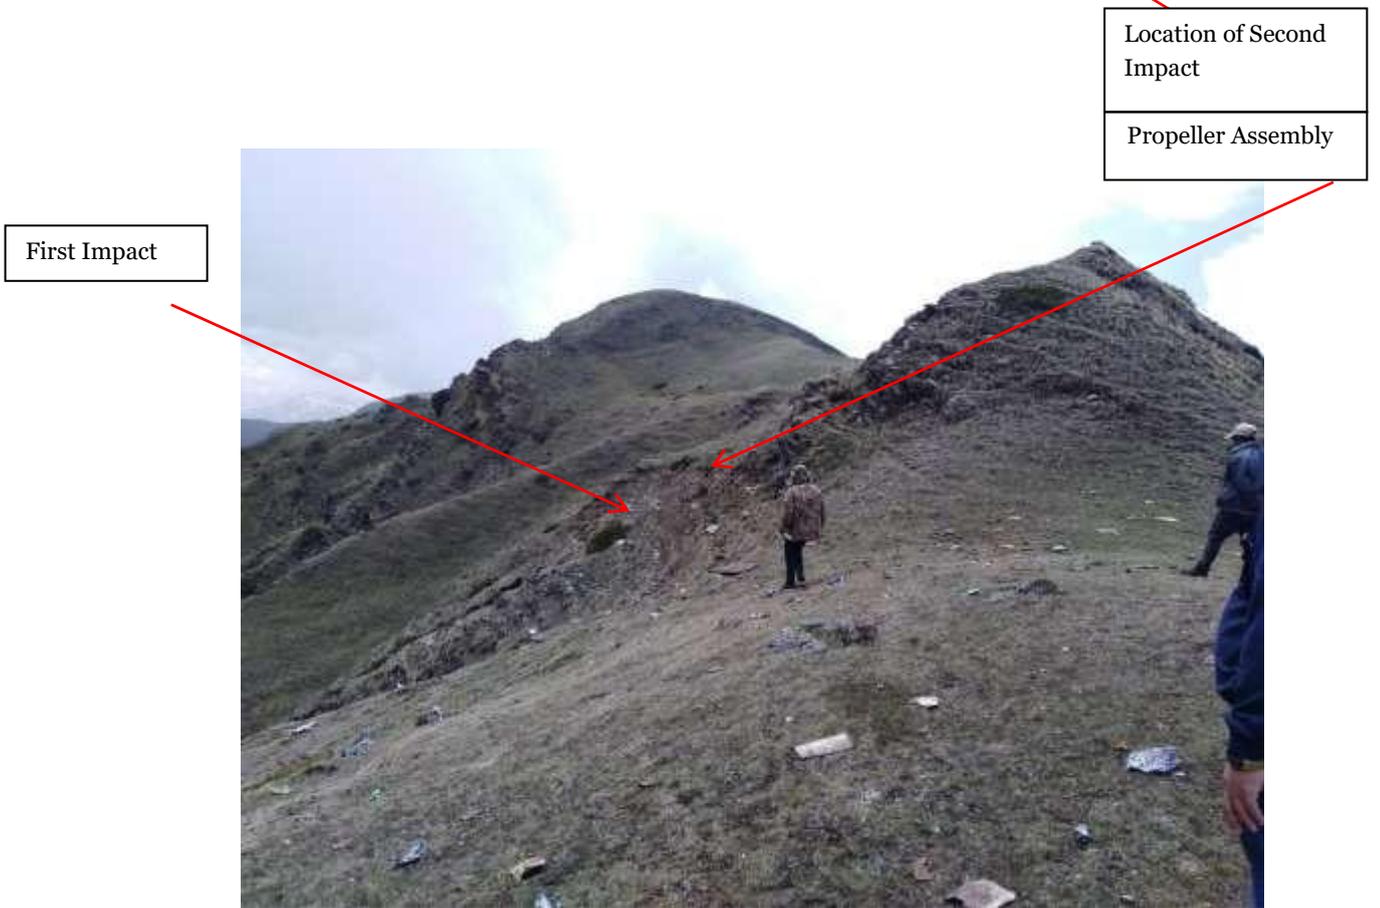
- iv. The propeller and the nose section of the fuselage hit the ground first and then flipped over the other side of the ridge, landed at about 100 meter beyond other side of the ridge where its engine and wings assemblies were detached. The remaining part of the fuselage came to rest about 150 meters from the first impact point. (Refer Figure of crash site location Appendix)
