**Government of Nepal  
Aircraft Accident Investigation Commission, 2022**

**Final Report**

**Accident Investigation of 9N-AET, DHC-6/300  
Owned and Operated by Tara Air Pvt. Ltd.  
At Sanusare, Mustang on 29<sup>th</sup> May 2022**

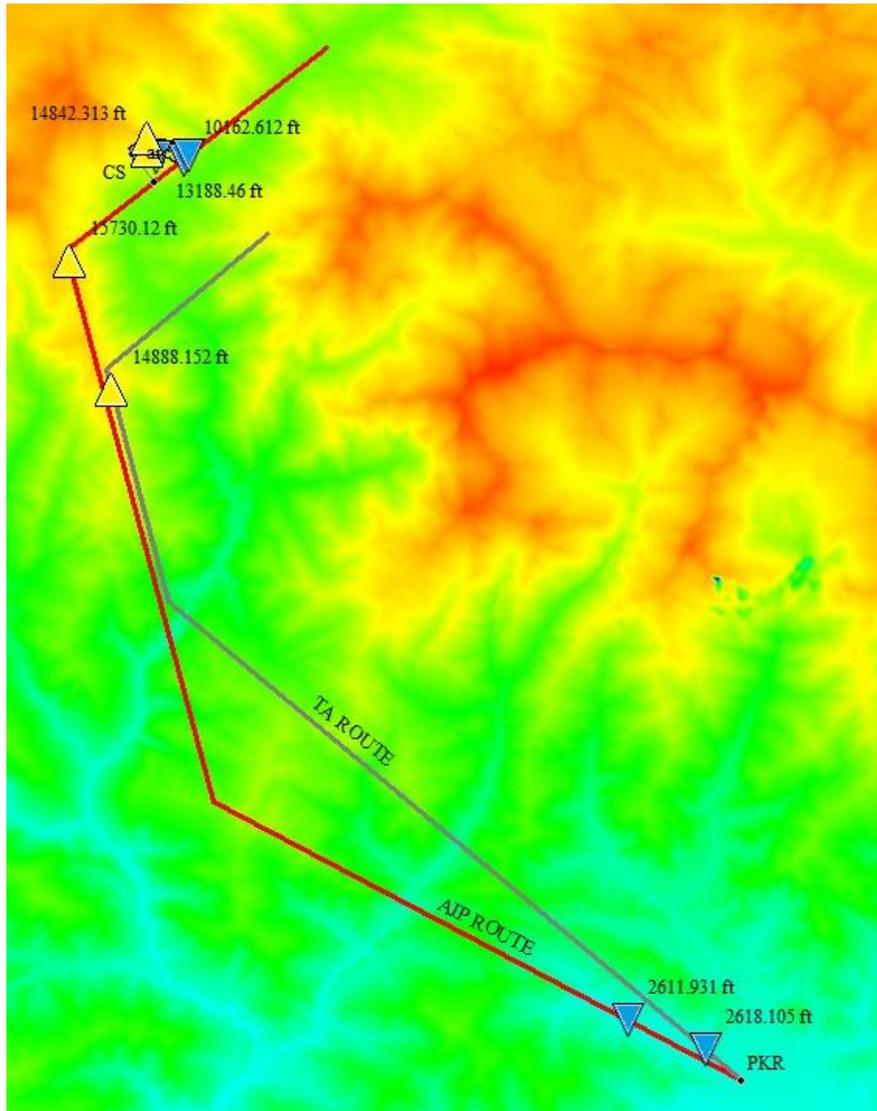
Figure 1 AIP route vs TRA 197's route from PKR to JOMSOM

CVR recordings show that after TRA 197 crossed Ghodepani, the PIC was not comfortable with the en-route weather. However, the flight was continued following the advice of SMT 601. At 0426 UTC, TRA 197 made the first contact with Jomsom AFS and reported its position to which Jomsom Tower conveyed the prevailing weather as "Wind South Westerly up to 30 kts, QNH 1019, Temp 18°". The PIC of TRA 197 reconfirmed twice if the wind was maximum, up to 30 Kts and currently South Westerly-25kts. The crew was discussing about the bad weather being encountered and the PIC himself voiced his dissatisfaction about the behavior of other pilots who conduct VFR flights in such unfavorable weather. The CVR recordings reveal that the aircraft was encountering clouds and the PIC was trying his best to remain clear of the clouds. During the course of flight, TRA 197 hadn't reported any abnormalities encountered and neither any technical defect on aircraft either to Jomsom tower or Pokhara Tower. As per CVR, PIC was searching for light and brighter areas and adamantly heading towards it. As per CVR and V2 tracker data, the aircraft was maintaining 12000 ft and was in a climbing attitude.

During the continuous attempts of crew to avoid the clouds with Terrain Avoidance and Warning System [TAWS] inhibited, the aircraft met with an unfortunate CFIT accident into the rocky terrain at an altitude of 4050 meter AMSL at Sanusare Mountain, Thasang Rural Municipality, Mustang. As per V2 tracker, last position of 9N-AET was 7.7 nm SW of Jomsom Airport. The aircraft was completely destroyed by the impact and there were no survivors.

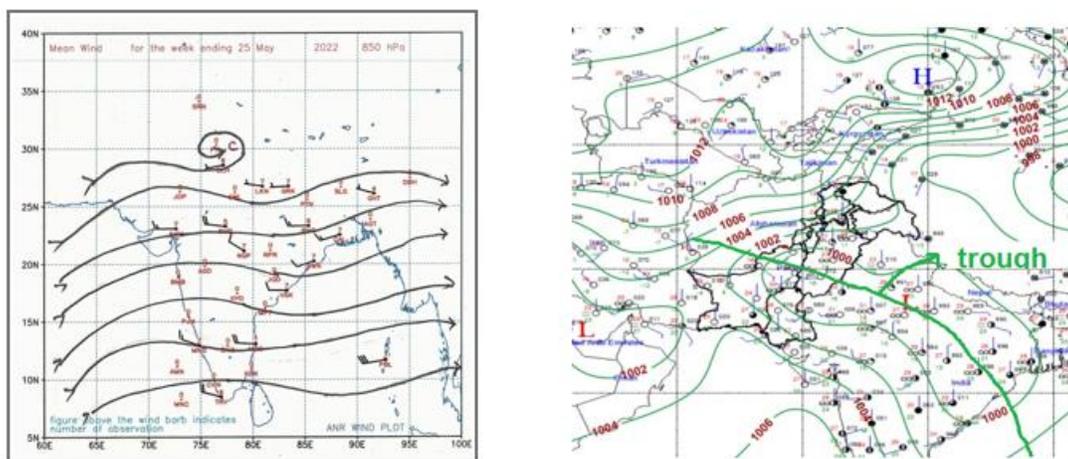
Figure 4 a) Westerly wind and b) weak trough extending from Bay of Bengal

The weather situation prevailing in Nepal and surrounding areas in South Asia on 29 May 2022 have an effect of:

- Weak Westerly wind and
- Low pressure system over head Bay of Bengal

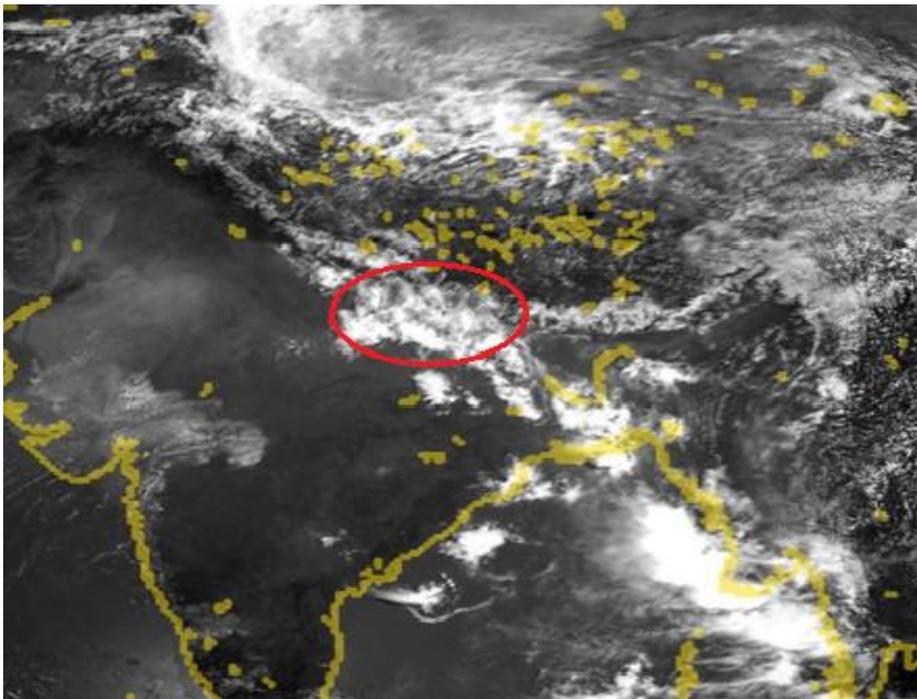
Figure 5 Visible image at 04 Z, 29 May 2022 (Source : Weather News, Japan )

Pokhara Airport observed a light rain and drizzle in the morning till 06:35 NST with horizontal visibility of 3000 m as observed in METAR from Pokhara. However, visibility increased to 6000 m starting from 07:35 AM with no rain. And, the weather improved to partly cloudy with dominance of dense cloud at some parts of the valley as seen in satellite image given below.

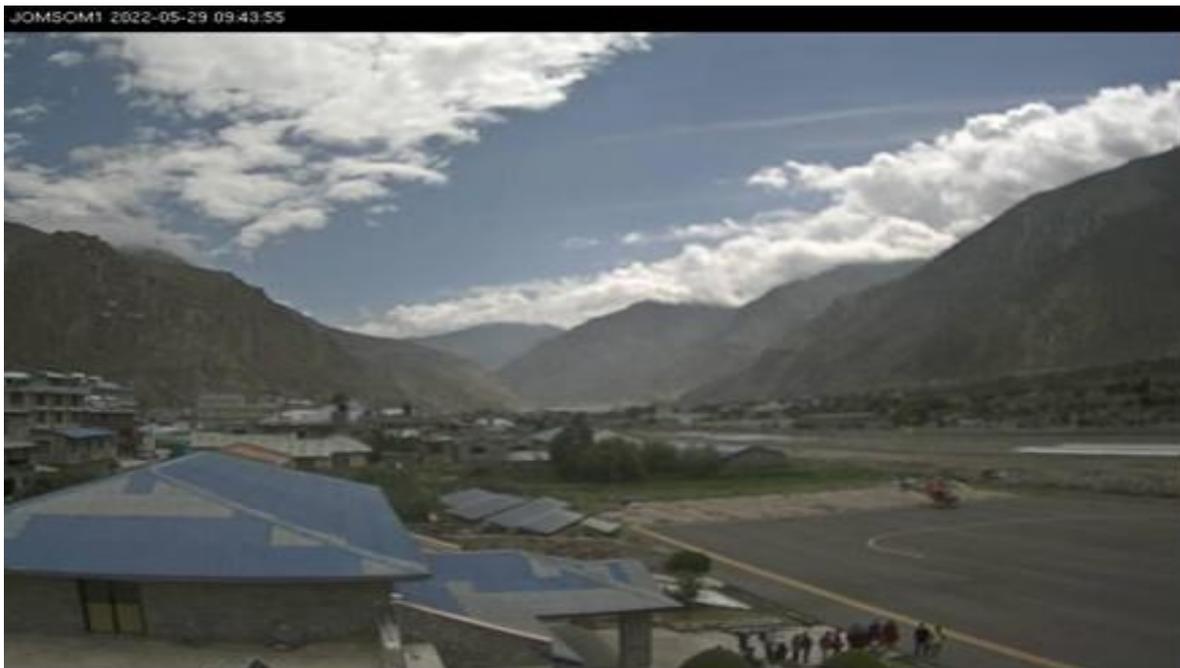
Figure 6 Live camera image of Jomsom Airport, at 04Z, 29 May 2022(Source: Weather News, Japan)

The weather situation in Jomsom airport in the early morning was cloudy with light rain. However, the weather improved to partly cloudy at the accident time with some blue sky. A wind of SW 26 knot surface wind at 10:05 AM, 29 knot at 10:15 AM and 31 knot at 10:25 AM prevailed at Jomsom Airport.

As per the CVR data it is proved that the en-route weather at the time of accident was cloudy and weather was IMC. There was no possibility of VFR flight. It is noticed that the nearer weather observatory installed by Department of Hydrology and Meteorology was stationed near by the accident site Lete and as per weather report obtained from Lete climate station, it is found that the

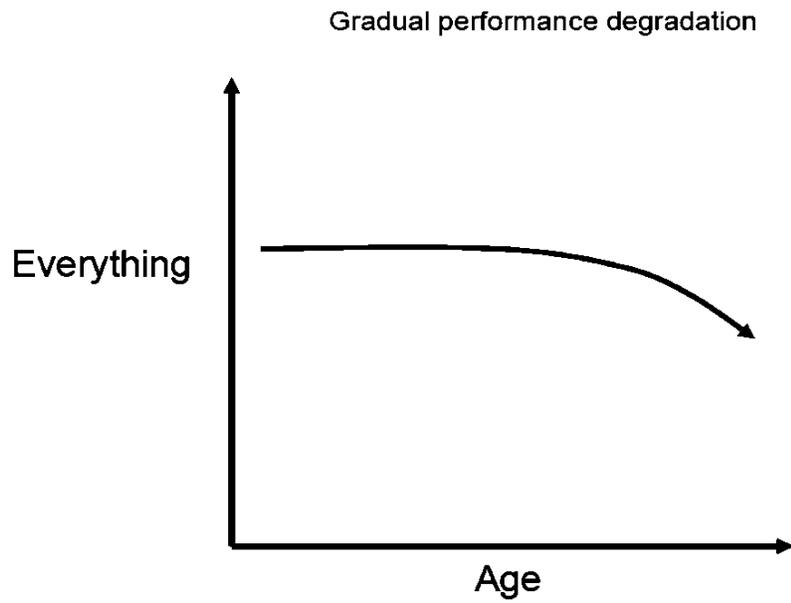
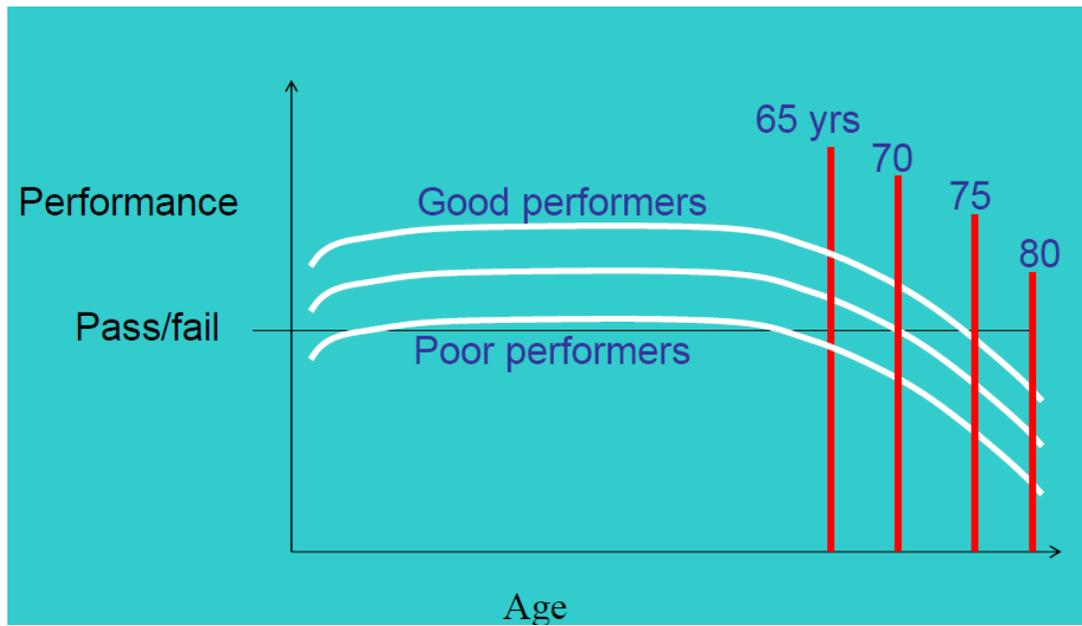
In this accident the PIC was 62 years old and he was flying in high altitude, difficult route in adverse weather conditions. At the same time, the Copilot was relatively junior and with very little experience. The flight was the second flight of the copilot in that sector. Since the copilot was new and un experienced in that sector, it added additional pressure to PIC while controlling and flying in that condition. The crew pairing was not satisfactory based on the nature of flight. So, in this case the issue of Pilot Incapacitation and age automatically raises and the analysis in this issue is pertinent.

Incapacitation of the crew increases with age. Skill and Performance of the pilot can be affected by the increasing age, as shown as below.

The ICAO standard normally talks about international flight operation. PELR approved by CAAN has provision same as that of ICAO standard regarding the Age of Pilot. The PELR requires customization to Nepalese terrain and context, further study, analysis and common consensus regarding the age of Pilot while flying the difficult high altitude STOL Airport and critical routes.

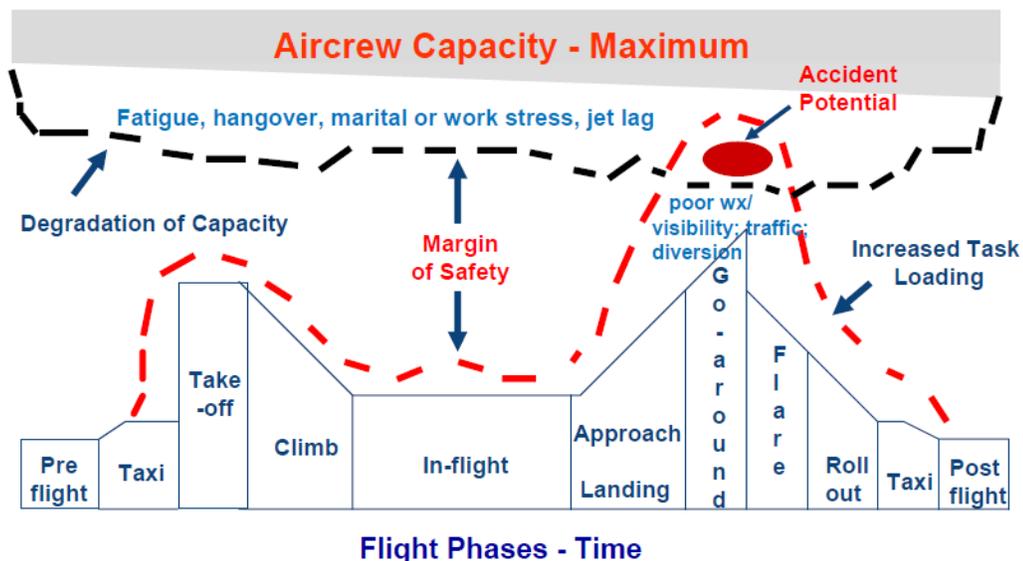
Figure 26 Accident potential at high workload condition

He has not assigned any operational role to the copilot. As per CVR report, somewhere he did not respond to the copilot's input regarding the deviation from the track. Lack of CRM and workload management of the crew is also one of the major contributory factors in the accident.
