GOVERNMENT OF NEPAL
AIRCRAFT ACCIDENT INVESTIGATION COMMISSION

FINAL REPORT

9N-AHH TWINOTTER (VIKING DHC6-400) AIRCRAFT ACCIDENT
OPERATED BY TARA AIR PVT LTD

SOLIGHOPTE, DANA VDC MYAGDI DISTRICT, NEPAL

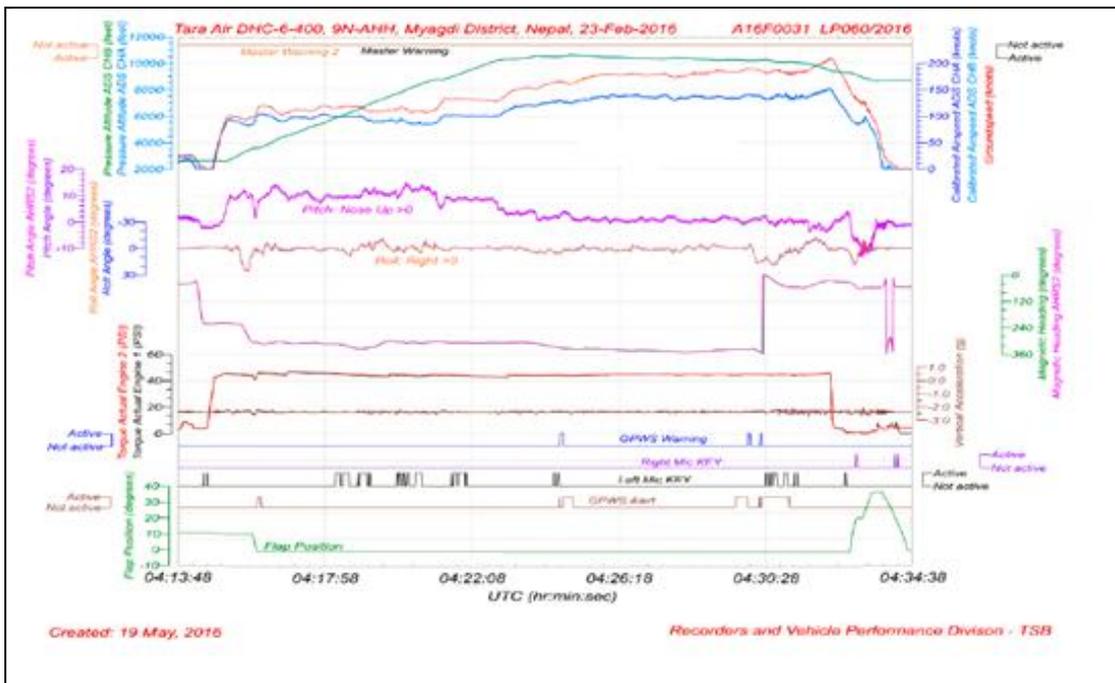
Figure 3: FDR plot of previous day flight

The previous flight of the aircraft was on 23rd February 2016, a day before the accident, for Pokhara-Jomsom-Pokhara sector with the same set of crew. No failures were recorded or reported regarding the aircraft and its system including navigation systems. The CVR/FDR readout of the previous day flight revealed the following:

- Although Pokhara airport was opened for Departure ONLY and Bhairawaha airport was closed due to weather, the aircraft departed for Jomsom.
- The aircraft flew in IMC condition until Ghorepani after which VMC weather prevailed and the crew were able to maintain visual through-out the rest of the flight.
- The EGPWS caution and warning were activated several times during the flight.
- During return flight from Jomsom to Pokhara, they were able to maintain VMC until Ghorepani after which, they had descended in an IMC until 7,800 ft.

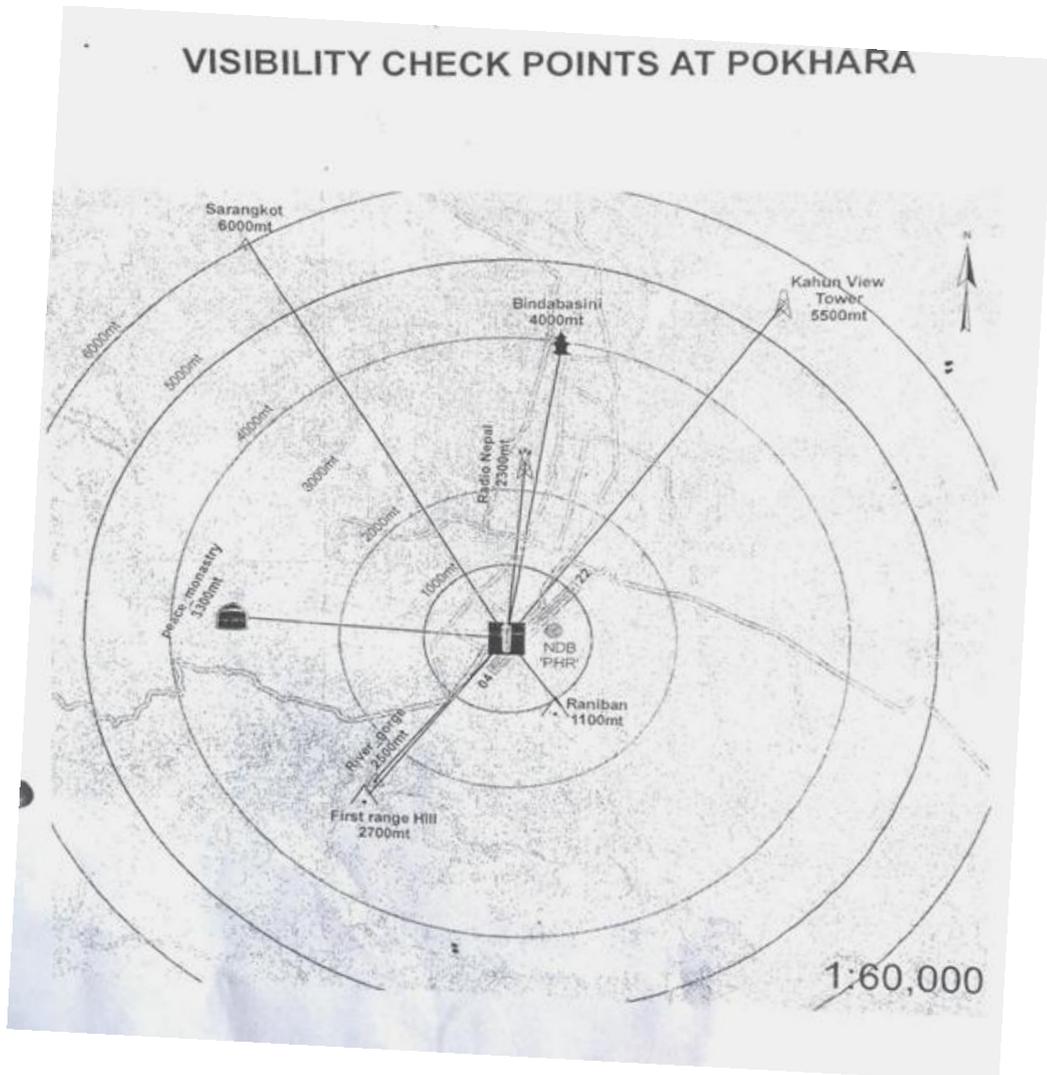
Figure 12: Visibility Check Point Chart

Pokhara tower and Meteorological Office both used same visibility check point chart to determine visibility, however, a difference of 1000m in visibility was noted between the weather reported by Pokhara Met office and Tower. As per interviews with ATC officers, the aircraft was released on an overall visibility of 5000m at Pokhara airport.

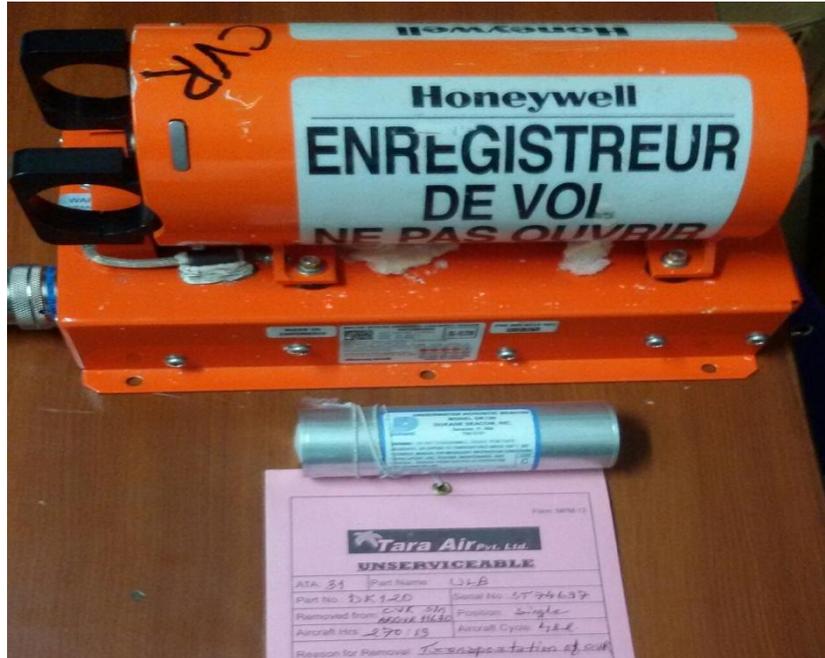
Figure 13: CVR collected from 9N-AHH

A four channel Honeywell AR120 Cockpit Voice Recorder (CVR) with 120 minute recording capacity was installed on the aft section (414.50 inch) of the fuselage. The CVR is integrated with Apex system and captures radio communication, intercom communication, and input from a flight compartment area microphone. CVR was recovered in normal condition without any sign of damage. The CVR installed on the aircraft was P/N 980-6023-002 S/N ARCVR-11630.

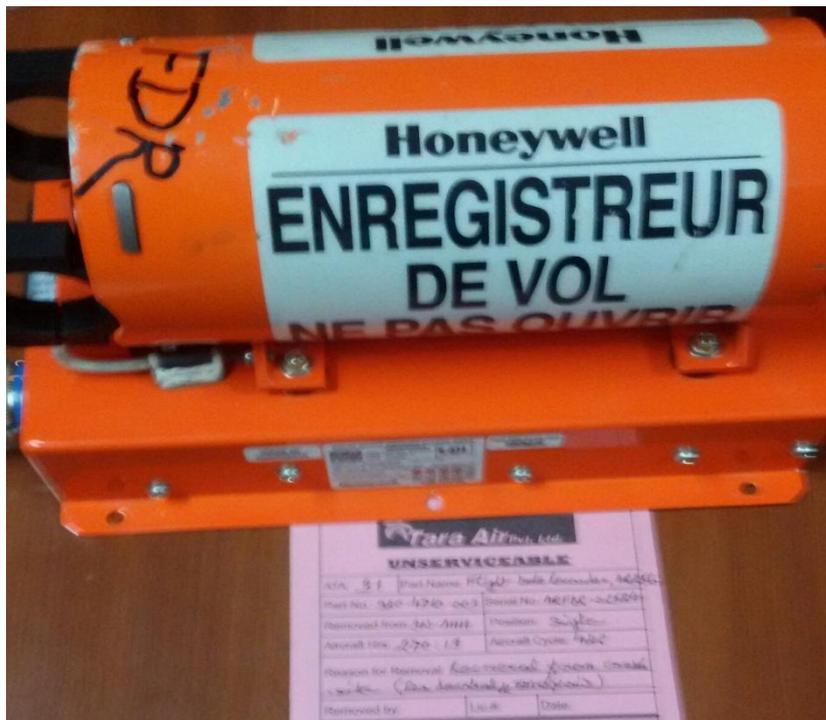
Figure 14: FDR collected from 9N-AHH

A Honeywell AR-226 Flight Data Recorder (FDR) with 25 hours recording capacity was installed on the aft section (429.40 inch) of the fuselage. The FDR captures all 88 mandatory parameters specified in regulatory requirements and also captures auto feather status, auto feather activation, and all warning and caution level CAS messages that are displayed by the Apex system. FDR was recovered in normal condition without any sign of damage. The FDR installed on the aircraft was P/N 980-4710-003 S/N ARFDR-02584. Transcript of the flight recorders is attached in Appendix I.

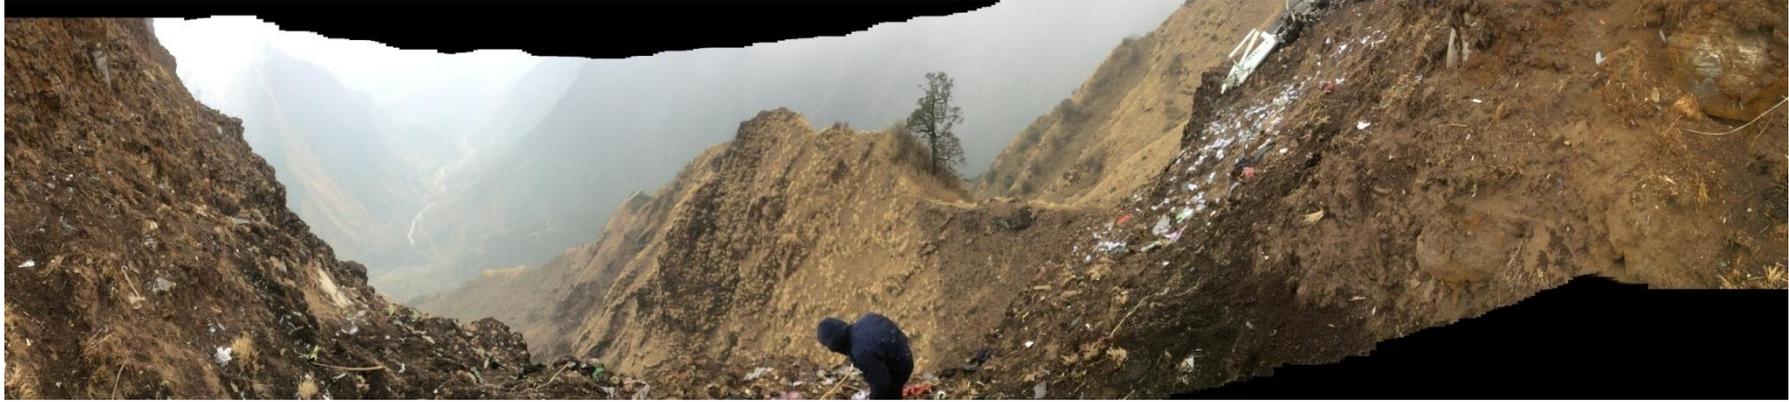
Appendix-B: Wreckage Information

RH Engine and its accessories were found in burnt condition, RH propeller was detached from the engine and blades were scattered at various locations near the point of first impact as shown in Appendix – B. LH engine and propeller were found unburnt in main wreckage area with twisted blades.

The fin and tail portion of the aircraft were lying around 300 meters downhill from the first impact point. The main landing gears were detached from the fuselage and left landing gear was found 150 meters ahead downhill from the main wreckage position, right landing gear and nose wheel were located below the first point of impact as shown in Appendix - B. FDR, CVR and ELT were located intact at their installed position along with a section of empennage which was approximately 1000 m downhill from the crash site.
