**GOVERNMENT OF NEPAL
AIRCRAFT ACCIDENT INVESTIGATION COMMISSION**

FINAL REPORT

**9N-AKY LET 410 AIRCRAFT ACCIDENT
OPERATED BY GOMA AIR PVT LTD**

27 MAY, 2017

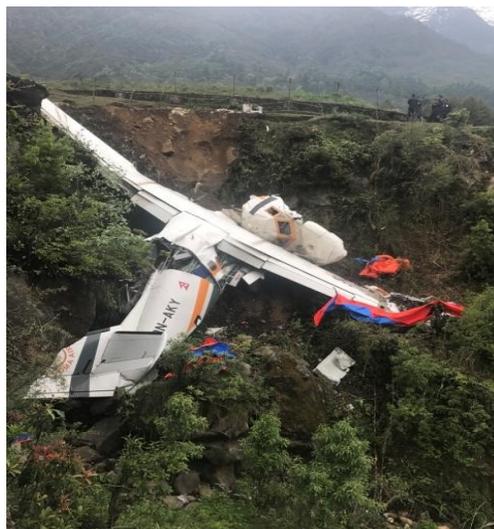
Figure 1 : Geographical reference of the crash site: 27416N, 864343 E
Elevation: 8800 feet AMSL
Point of Ultimate Impact

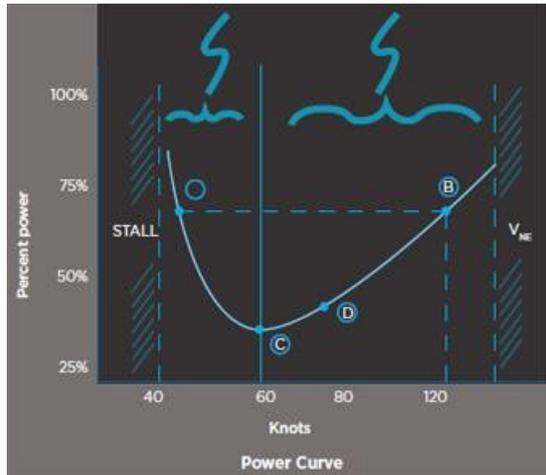
Figure 21: Power curve

- A- Hypothetical airplane at 40 knots
- B- Fly at its maximum cruise speed of 120 knots
- C- Airspeed and power combination that produces maximum endurance where the lowest fuel flows occur
- D- For just a little more fuel consumption, airspeeds rise significantly to travel maximum range

If the speed is low at any altitude, the Angle of Attack required for climb/ level flight will be so large that the air can no longer flow smoothly over the upper curvature of the wing. The result is a separation of airflow from the wing, loss of lift, a large increase in drag and eventually a stall if the Angle of Attack is not reduced. Reducing the Angle of Attack was not possible in this case as the aircraft was already below the committed landing point on very short final for landing. Ultimately, the aircraft stalled 130 feet short of runway 06 threshold.

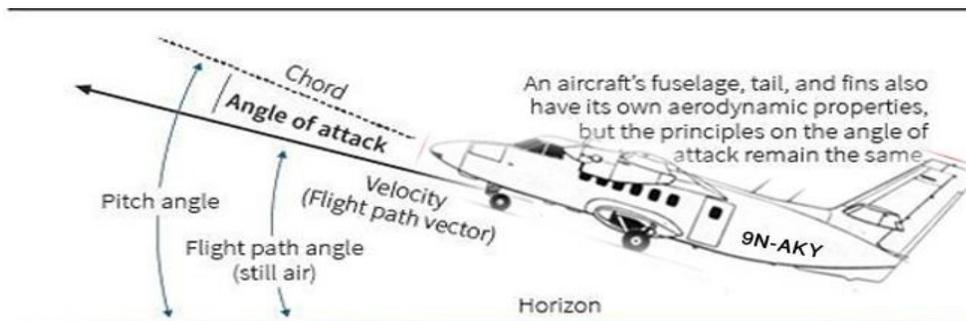
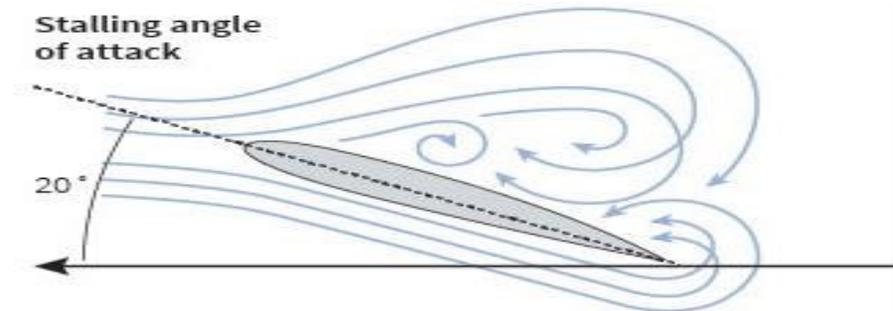
2.3.5 Relations between Angle of Attack and Stall

When a wing finally stalls, lift will no longer be produced. As the aircraft's weight is unopposed, it will drop towards the ground. But with sufficient altitude, stall recovery can be obtained by decreasing the angle of attack.
